2022 LEISURE SAFETY DIGEST

INTRODUCTION

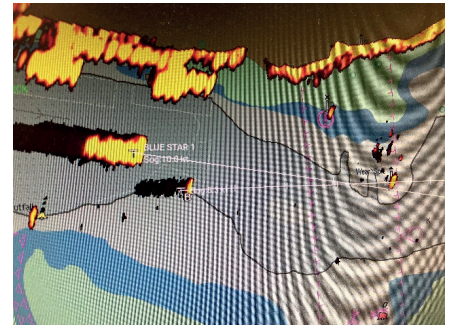
9. As can be seen from this image, the vectors of the two vessels converge and therefore the Master of the ferry must consider this a potential collision situation and take suitable action. As he is confined to the channel, there are few options other than rule 34 as he needs to maintain his speed to retain steerage.

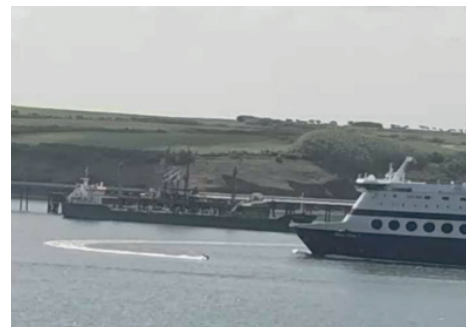
Early summer and a jet ski is observed transiting east in close proximity to the starboard side of the ferry, then at less than 100 metres crossed the bow of the ferry, before transiting west in close proximity to the port side of the ferry. The Water Ranger was tasked by VTS to intercept the jet ski and talk to the helm.

2. In the first incident, had there been a mechanical failure, or if the helm had fallen off the ski, there would have been no time for the ferry to take avoiding action. Due to the proximity of the jet ski, it is also unlikely that that the jet ski would have been visible from the bridge of the ferry.

3. The photograph above was shown to the jet ski owner. He thought that he was at least two ferry lengths ahead when he crossed and was shocked to see how close he had been.
