Pembroke Port, Pembroke Dock

Preliminary Bat Roost Assessment

856531

JULY 2017

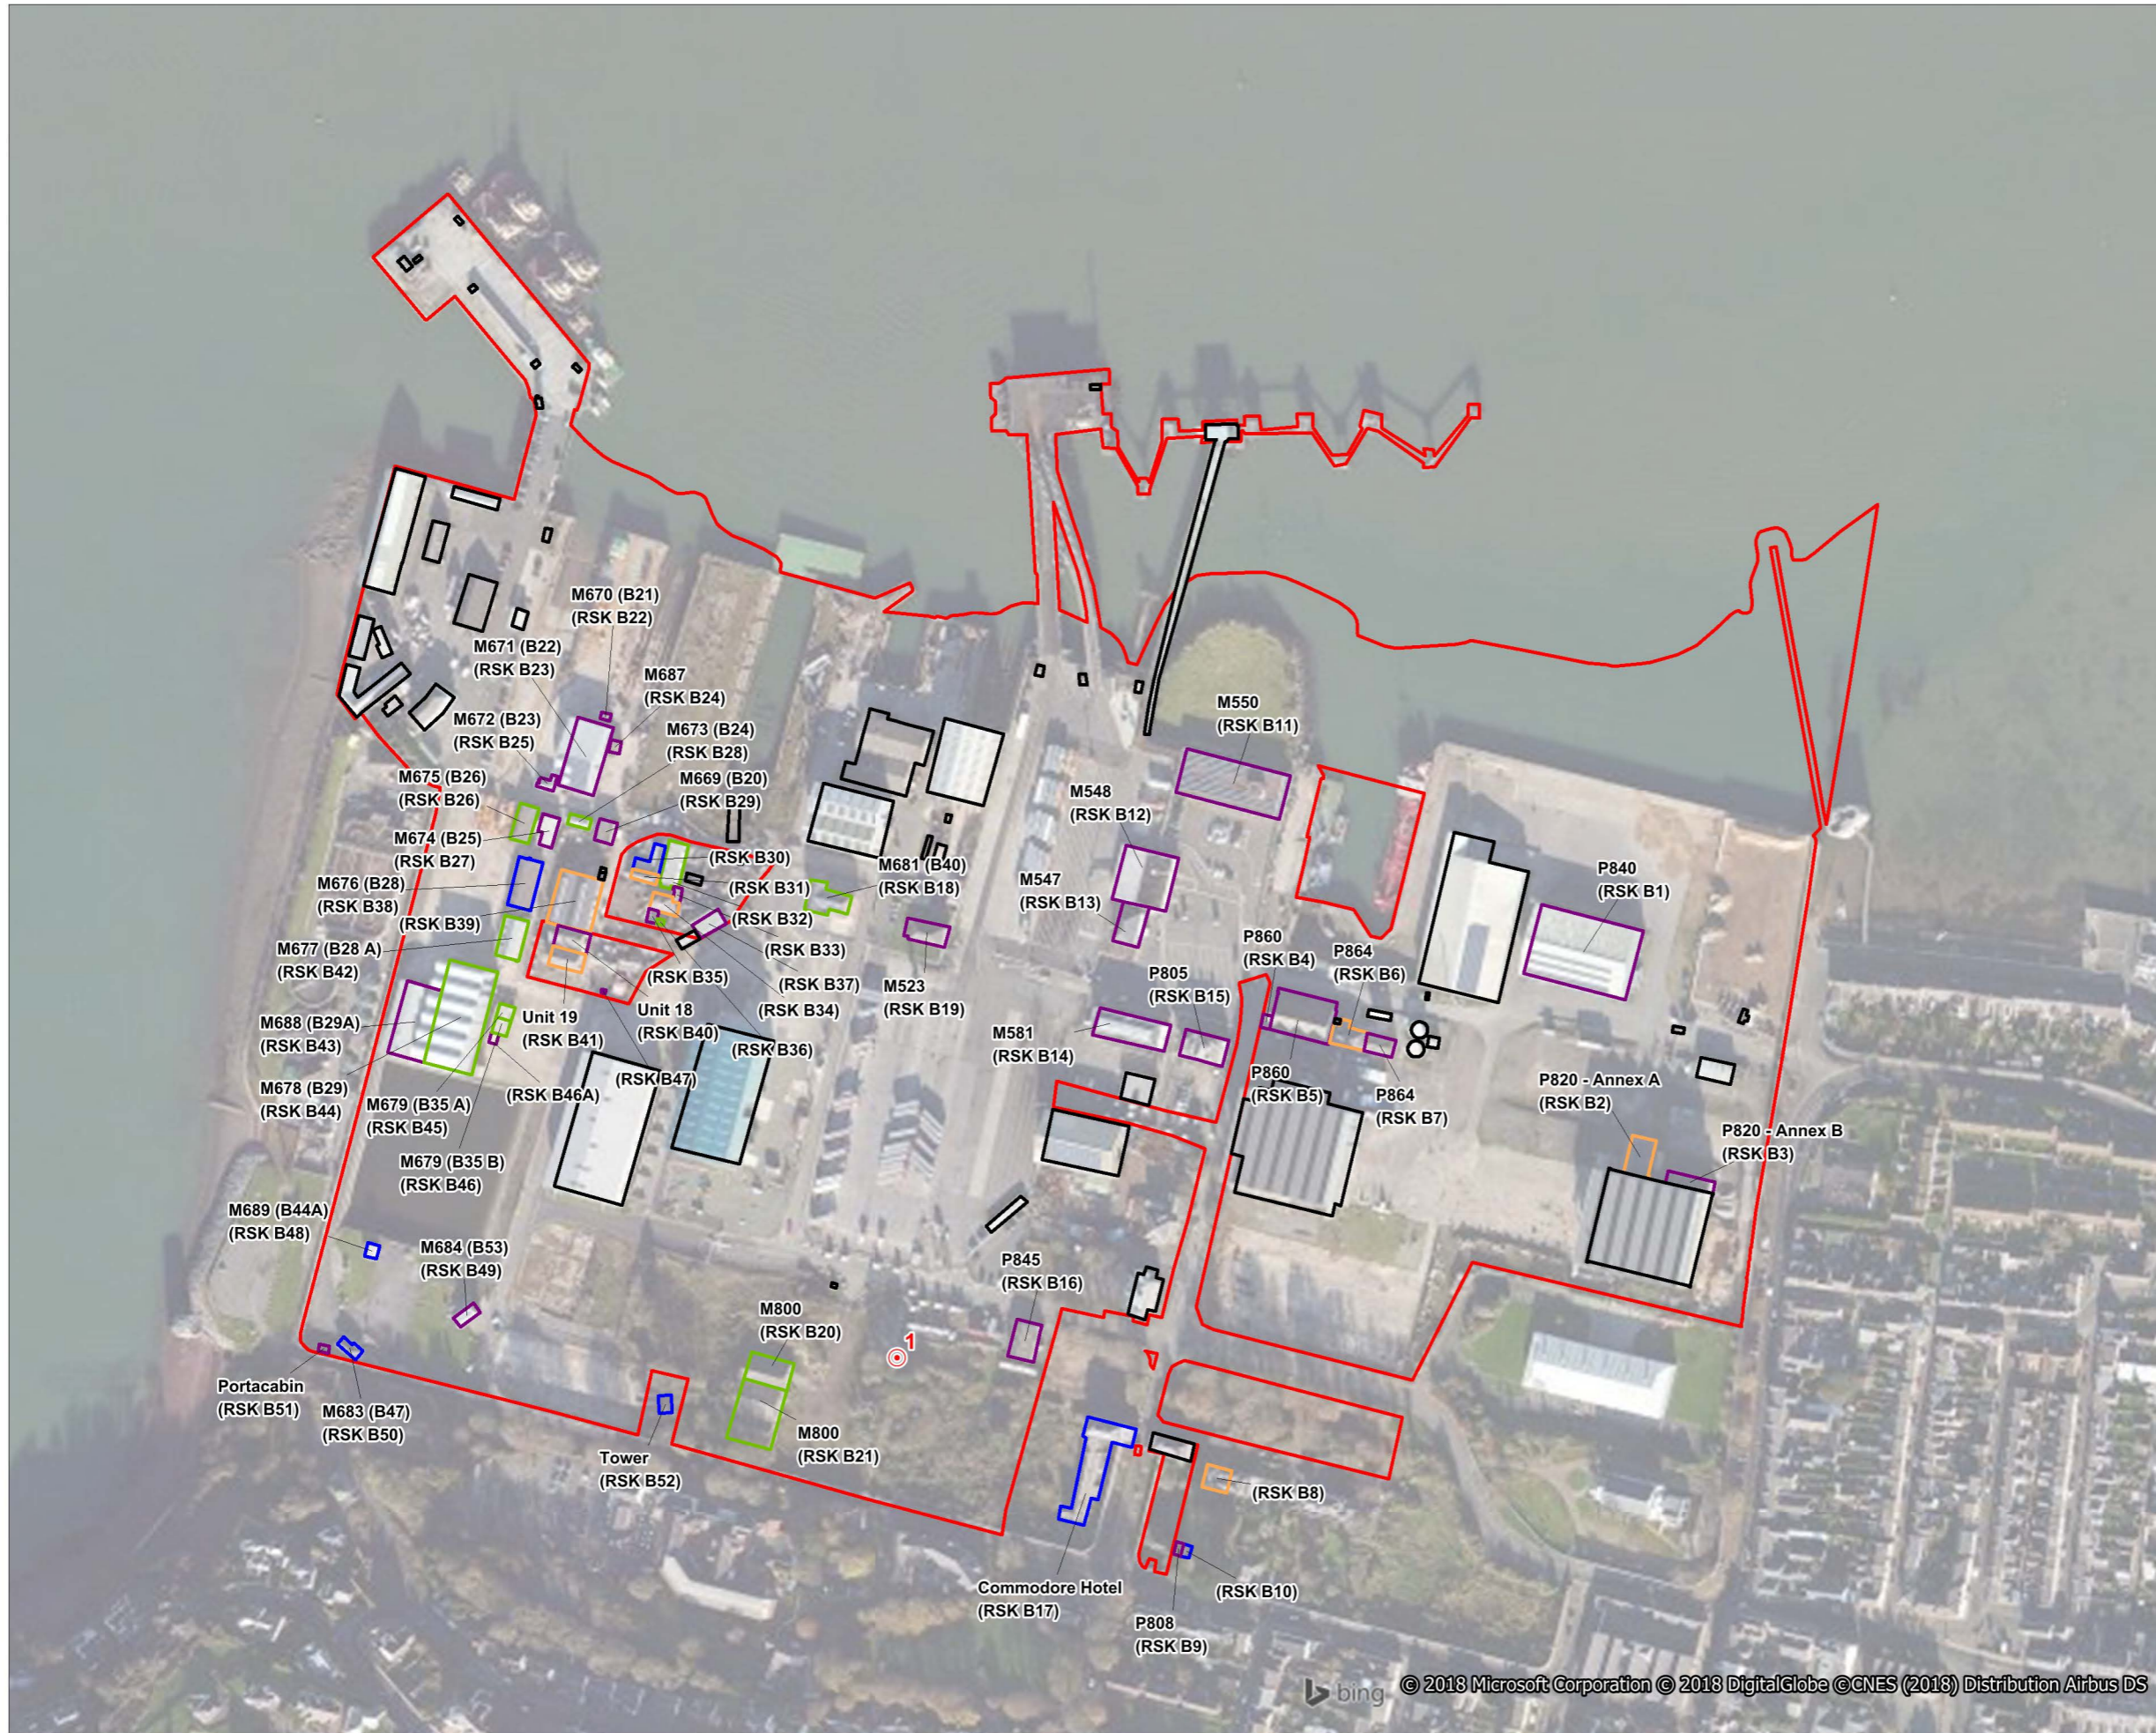
A total of 50 buildings, 47 within and 3 outside the site boundary, were surveyed and are illustrated in *Figure 2*. Building B9 was scoped out of the survey as it will not be affected by the proposed works.

Due to the number of buildings surveyed, an abbreviated set of survey results is available in *Table 2*. *Table 2* includes only those buildings where possible bat droppings were found or which contained potential roosting features categorised as being of low, moderate or high potential for roosting bats and therefore require further survey/s under the current guidelines (Collins et al 2016). The full results of the Preliminary Bat Roost Assessment are available at *Appendix C* and include a description of each building, their potential to support roosting bats, and any evidence recorded during the survey.

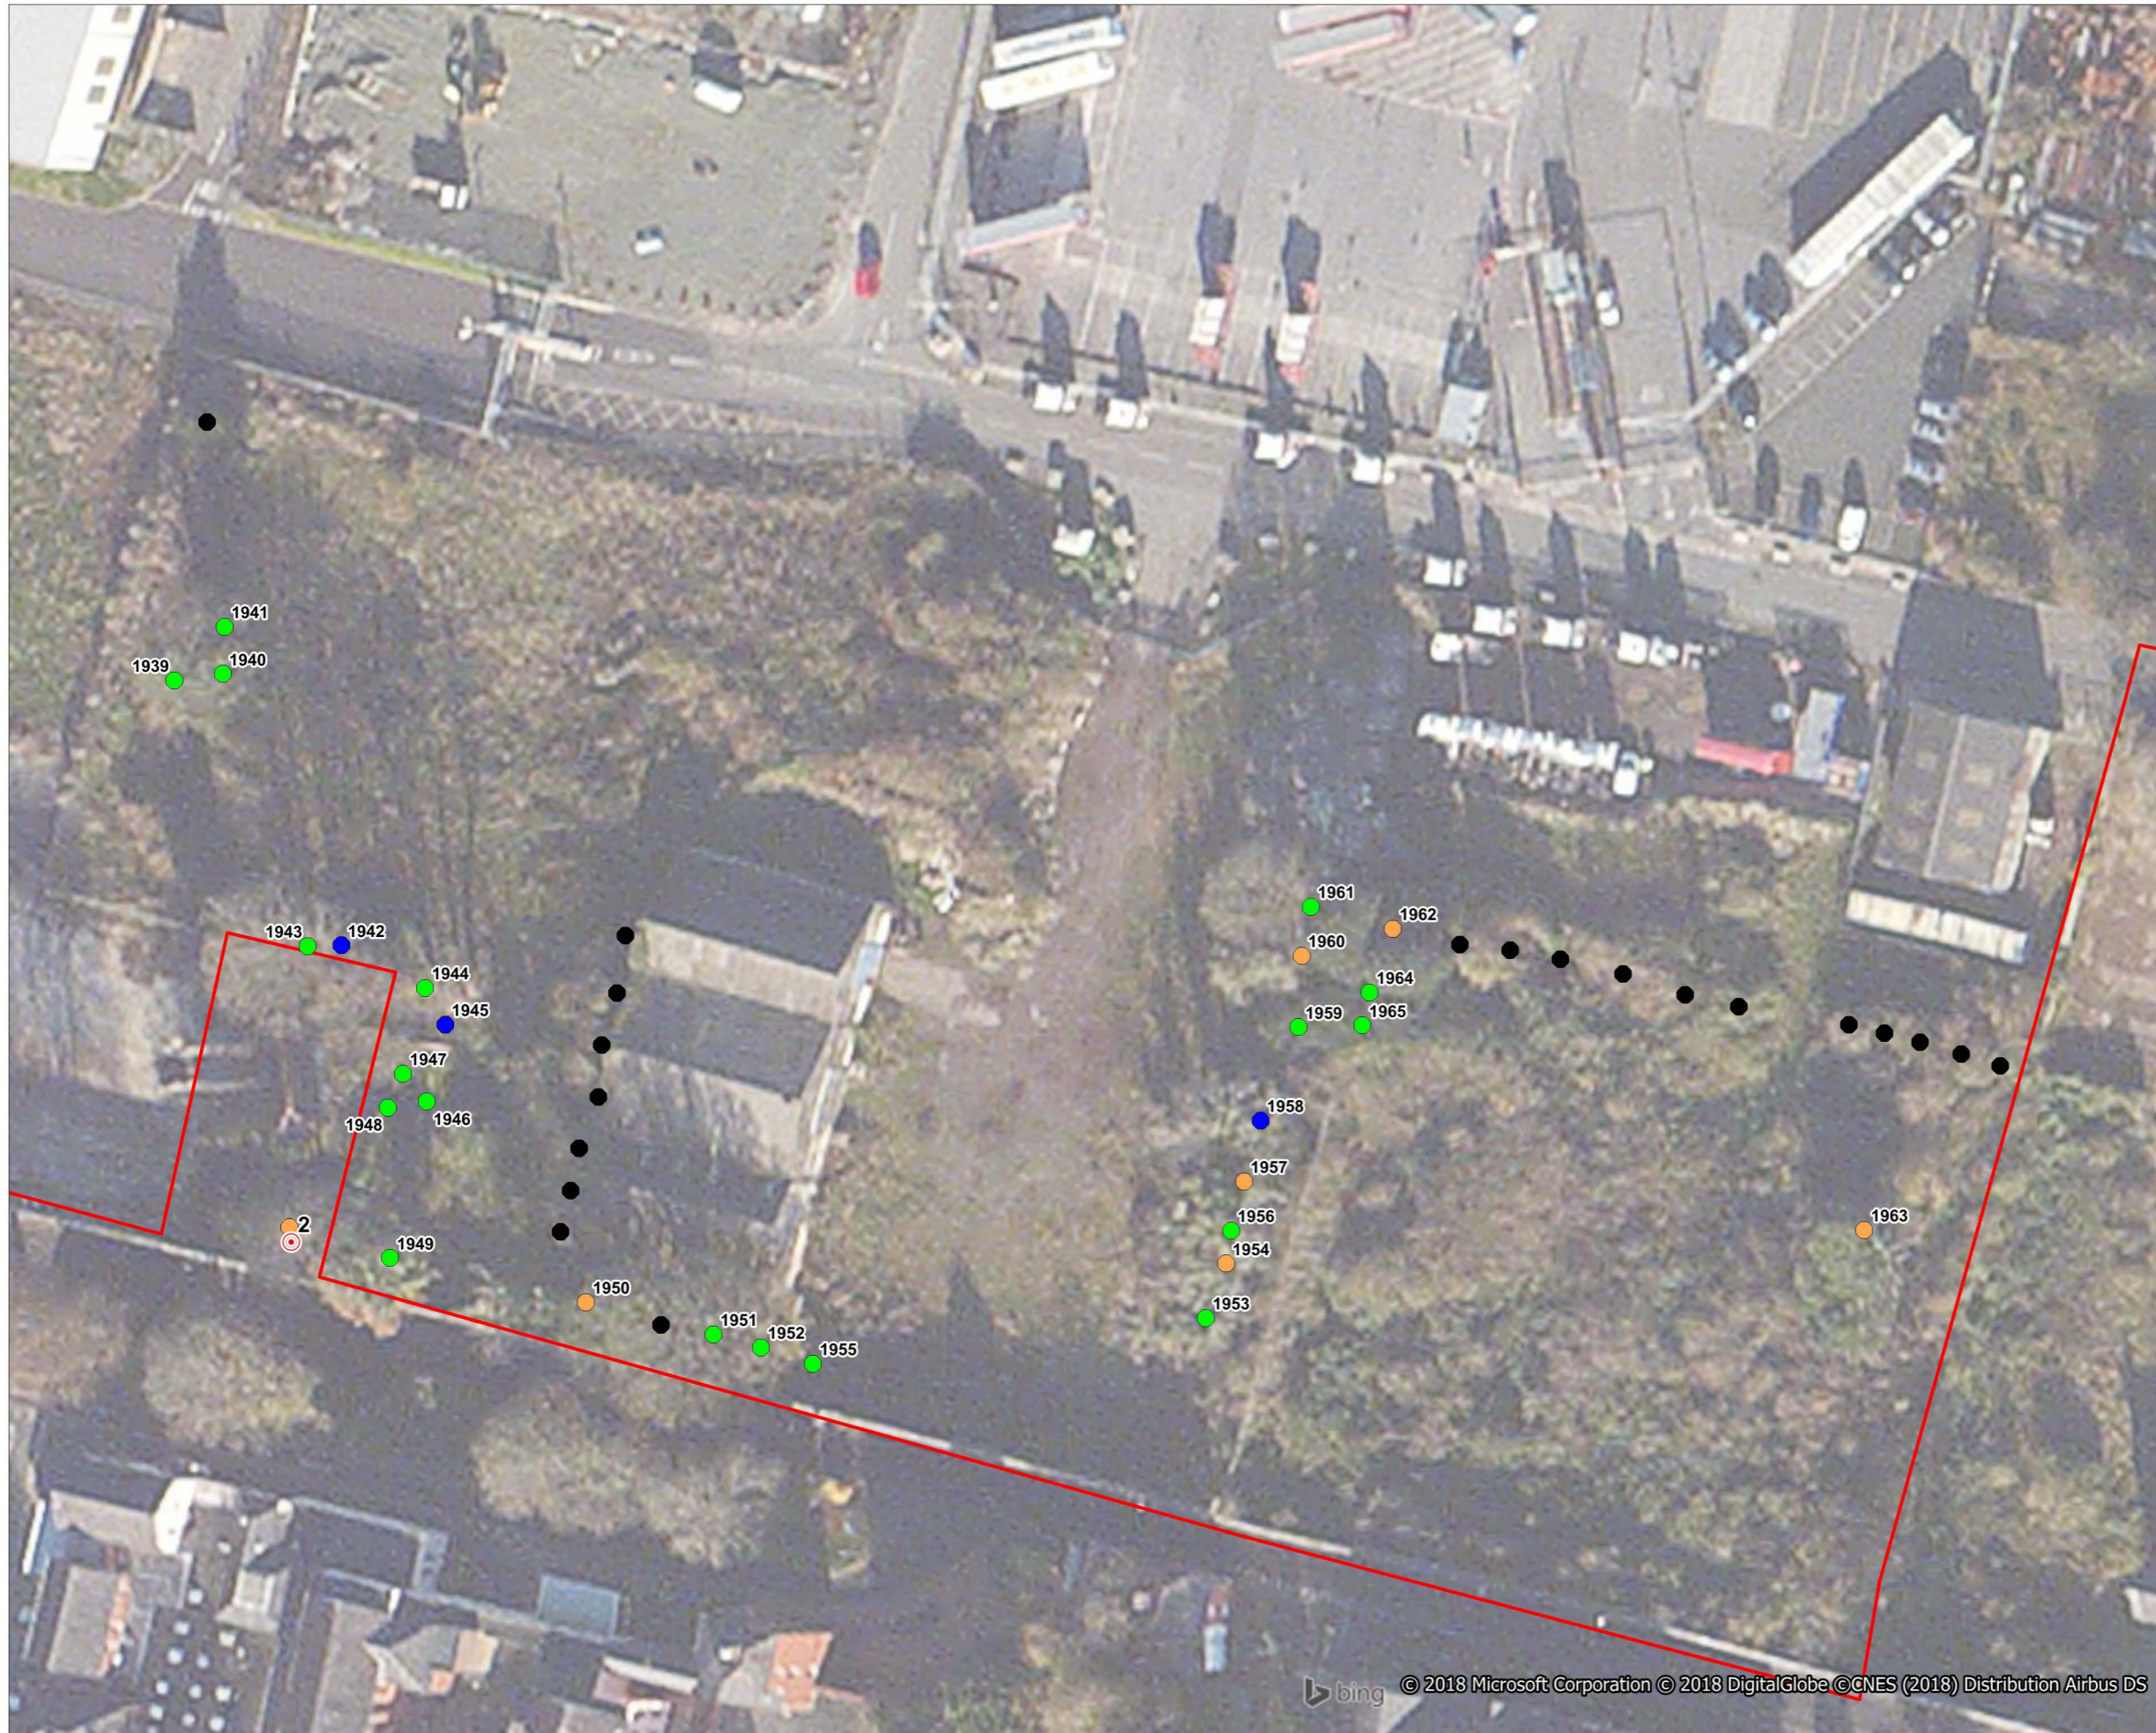
More than 40 trees located within the site boundary were included in the survey. Trees were tagged if they had potential for roosting bats or there was a possibility of confusion in identifying a specific tree. During the survey a tree located at *Target Note 2*, c. 5 m outside the site boundary and within the port wall, was identified as having the potential to be affected by the proposed works. Due to its apparent suitability for bats, close proximity to the site and location adjacent to an area of proposed de-vegetation it was scoped into the survey.

Due to the number of trees surveyed, an abbreviated set of survey results is available in *Table 3*. *Table 3* includes those trees which were identified as containing potential roosting features categorised as being of moderate or high potential for roosting bats and therefore requiring further surveys under the current guidelines (Collins et al 2016). The full results are available in *Appendix C* and include a description of each tree, its potential to support roosting bats, and any evidence recorded during the survey.
