PEMBROKE DOCK MARINE INFRASTRUCTURE

Gate 4 – Timber Pickling Pond / Graving Dock Infill

FEBRUARY 2019

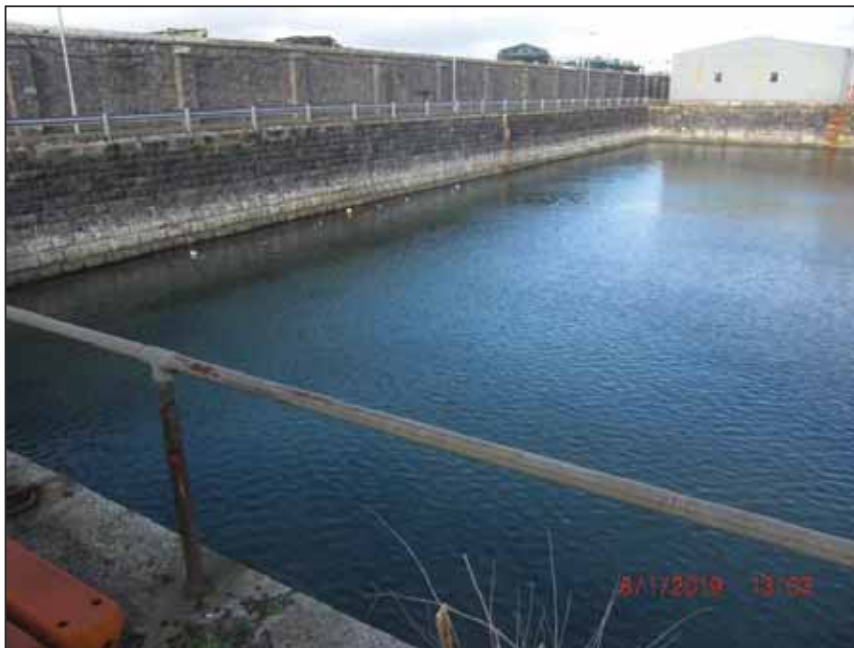
View of the west wall of the Timber Pickling Pond

Limestone retaining walls - These are located on the north, south and west sides of the pond. These ideally should remain intact, including the granite copings

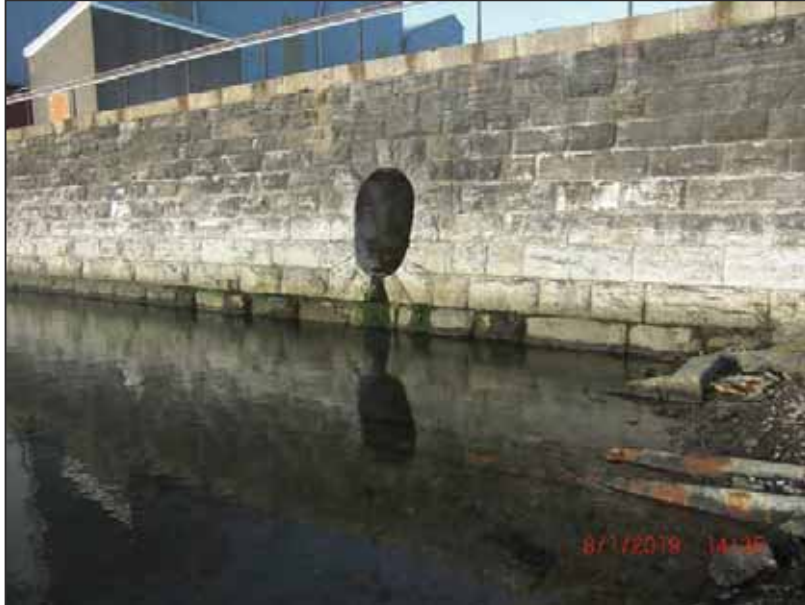
View of the north wall including the culvert outlet

There is an existing large brick culvert that exits through the north wall of the pond. It appears that this is no longer in use and does not carry any drainage, but this would need to be confirmed. It is believed that the original use was to drain water from the Graving Dock which was pumped through a network of culverts into the Timber Pickling Pond (see **Appendix A** - 1862 drawing + **Appendix D**). This is still a potential informal drainage route and consideration will need to be given to blocking the exit into the pond prior to infilling.

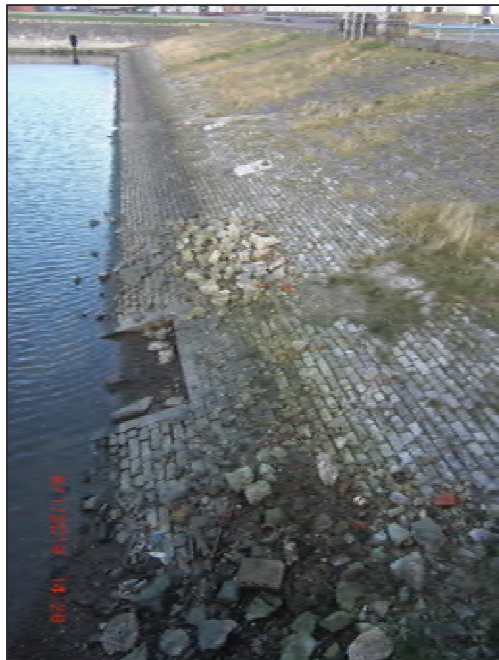
Sloping Stone Revetment - This is located on the east side of the pond. Corroded pipes are located at the northern end which are noted on the 1862 drawing as saltwater supplies for an adjacent smithery tank and Saw Mills (now demolished). There is evidence of damage caused by past work across the revetment. Any further damage to the revetment should be minimised and remain localised where possible (i.e. minimal breakout to allow piling etc.).

Sloping stone revetment to the east side of the pond

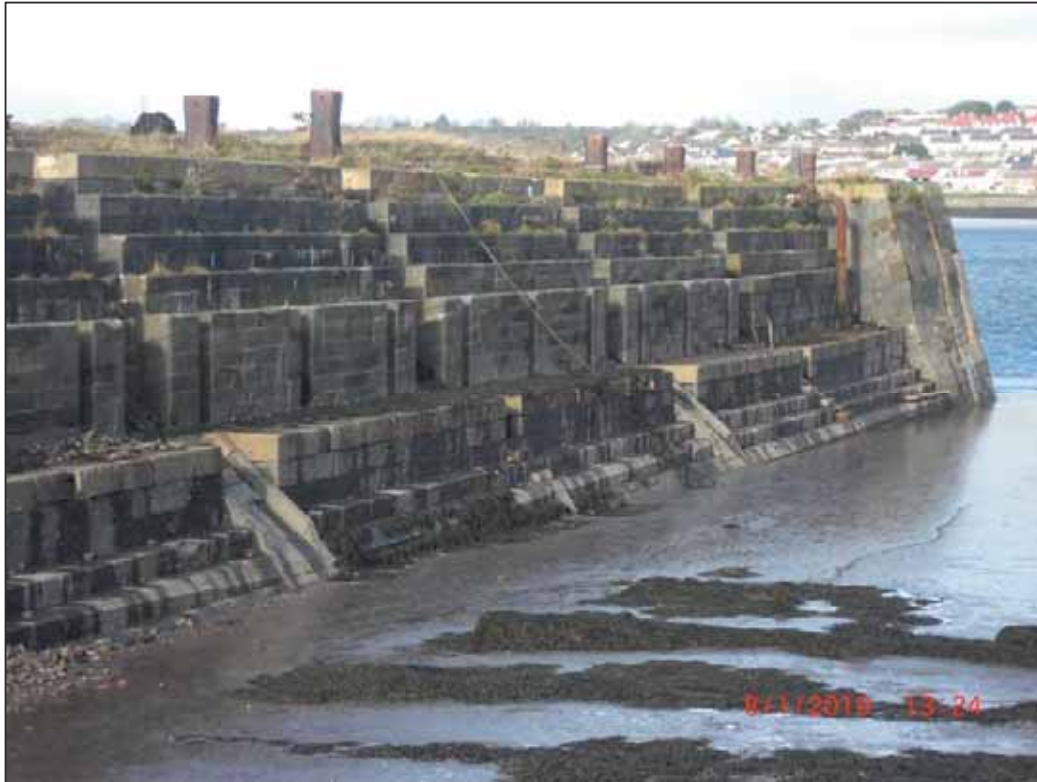
Limestone Ashlar Altars and granite copings - These are located on the east and west sides of the dock and should be preserved intact where possible. Any foundations to the proposed buildings should be designed not to damage the fabric of these walls, so the buried footprint of the structure needs to be fully understood. The infilling should allow for a protective layer of sand or other suitable material to all faces including the granite copings. As described above, the entrance to the docks should remain visible.

West side of the graving dock showing the limestone ashlar altars

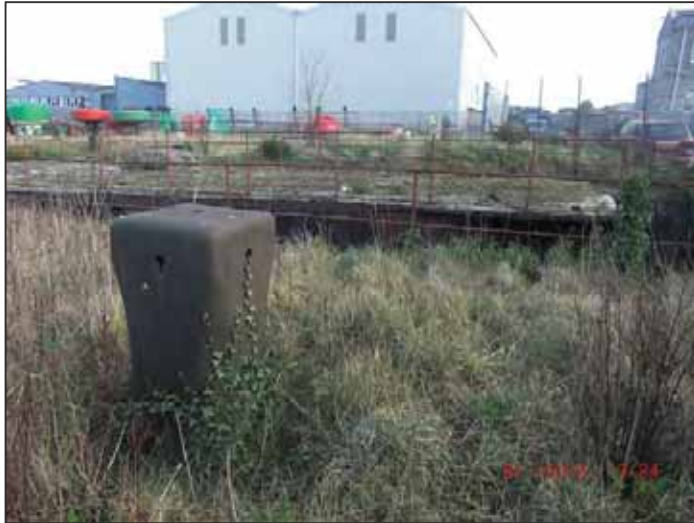
Original Bollards and Capstans – Location and details should be recorded. Where possible these should remain in-situ, which is likely to be at the dock entrance area. Where it is not possible for them to remain in-situ they should be carefully removed intact and either stored or reused on site, ideally where their original function can be readily understood.

Existing iron bollard on the east dock wall

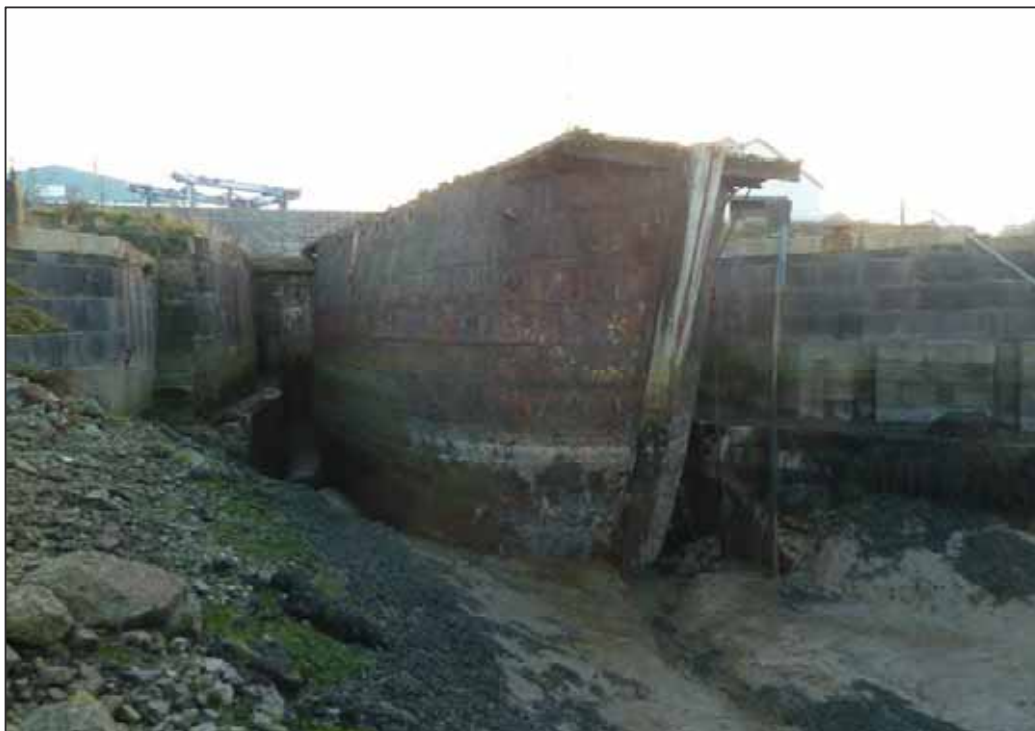
Existing Caisson Gate – The caisson gate is currently located at the south end of the dock. It appears largely intact, but a specialist survey would be required to determine its exact condition. It is a very good example of a ‘ship’ type caisson, i.e. with a cross section resembling a ship’s hull. It is a clear, legible link with the Graving Dock structure, with the grooves to secure the caisson in place still visible in the walls at the dock entrance. If possible, and subject to structural condition, the caisson should be retained in a location such that its connection to the Graving Dock can be appreciated.

The existing caisson gate

After due consideration, the preferred option is to use a mass wall and recover the existing caisson for restoration as described in **option 2**. This option requires the least amount of in-service maintenance in the marine environment which has significant health and safety benefits. It also allows a significant proportion of the dock entrance to remain visible, which will aid the interpretation of the dock once the remainder is infilled. Restoring the existing caisson, possibly for display in an appropriate nearby location, gives a good visual link and will maximise its remaining life. The building design for this area should ensure that any piling required is outside of the footprint of the Graving Dock (including any buried elements) to avoid damage to the structure.

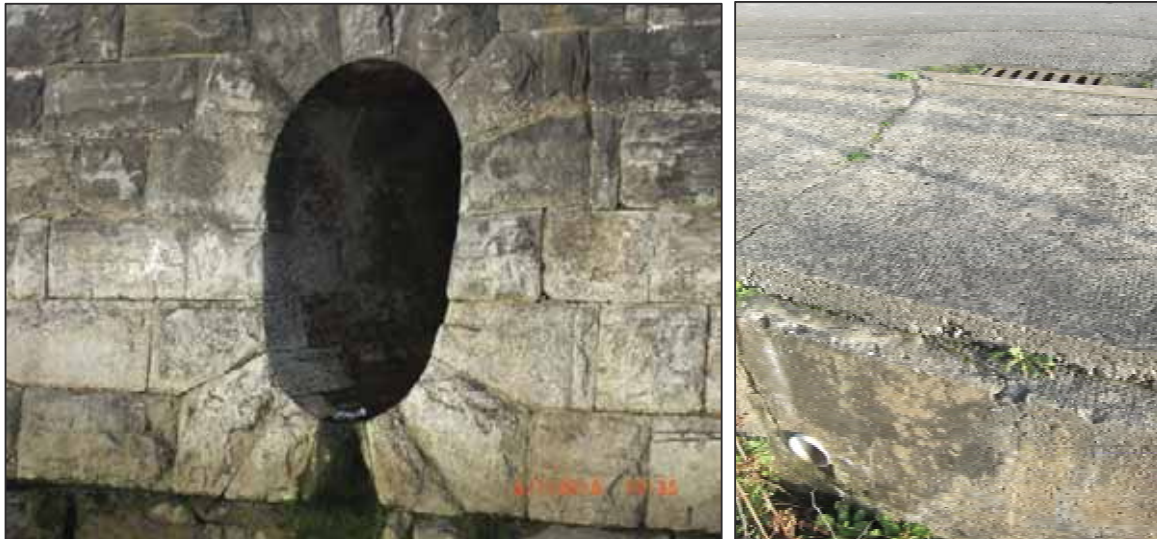
There is a considerable amount of existing surface water and foul water drainage around the site of the Timber Pickling Pond. To the north of the pond, the pavement area has a network of drainage gullies. Anecdotal evidence suggests that these drain into a combined foul/surface water sewer that runs along the access road to the east of the pond though the combined topographic and service survey of the area notes two separate discharge points into the pond along the pond's northern edge (both 100 & 150mm dia.). The existing vacant buildings (**Units 29 & 29A**) to the north of the Pond discharge roof rainwater runoff directly onto the pavement which then drains into the pond. Gullies on the access road to the east of the pond also drain directly into the pond through 100mm dia. pipes which pass through a small concrete retaining wall. In addition, the concrete paved area to the southeast is shown on the service drawing to discharge through a 150mm dia. pipe into the pond.

Existing culvert outlet on the north wall and a road gully and outlet on the east wall

A new surface water drainage system will need to be devised for the development that eliminates runoff into the pond area and that properly intercepts and routes surface water to a separate discharge point from the site.

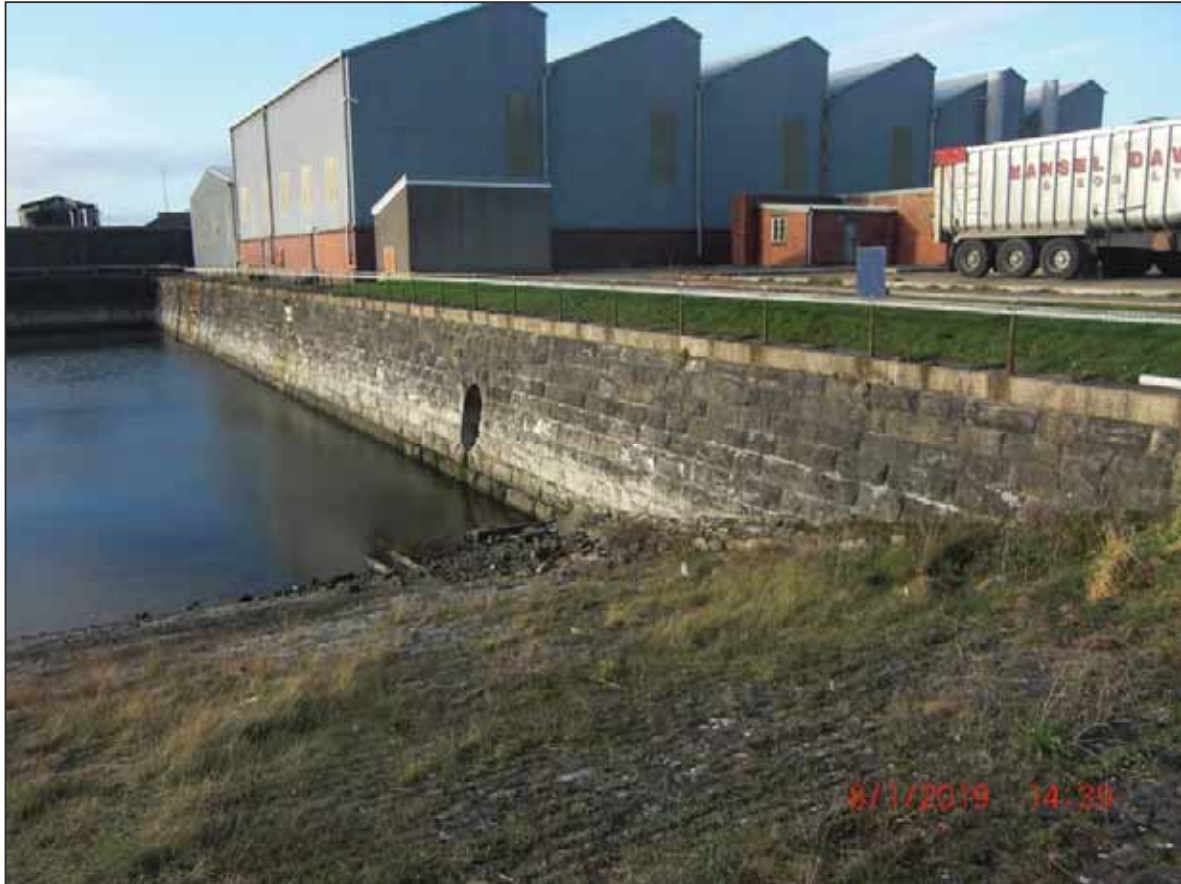
The northern wall of the timber pickling pond with Unit 29 behind.

The building proposed for this site will need to be designed such that the foundations do not damage the walls of the timber pickling pond. Due to the need for movement routes along the western and eastern sides, the building line will be located inside the pond east and west walls. The building structural grid will need to be large enough to ensure that the northern and southern pond walls are “spanned” and that foundations are located away from the walls. This can be achieved by careful consideration of the foundation locations. Piled foundations for the building structure are thought to be most appropriate but this will involve local “holes” being taken out of the limestone pitching forming the eastern side of the pond and penetrations through the puddle clay on the western side. The ground water in this area is high and likely to also be linked to the tide, therefore there are no expected implications to the puddle clay due to penetrating with support piles. As mentioned above, the puddle clay may however need to be removed to control settlement. There is also the possibility of hard spots developing over the copings. The specification and placement of the fill should limit these hard-spots but it would be prudent to make allowances in the design of the floor slab should this be ground bearing.

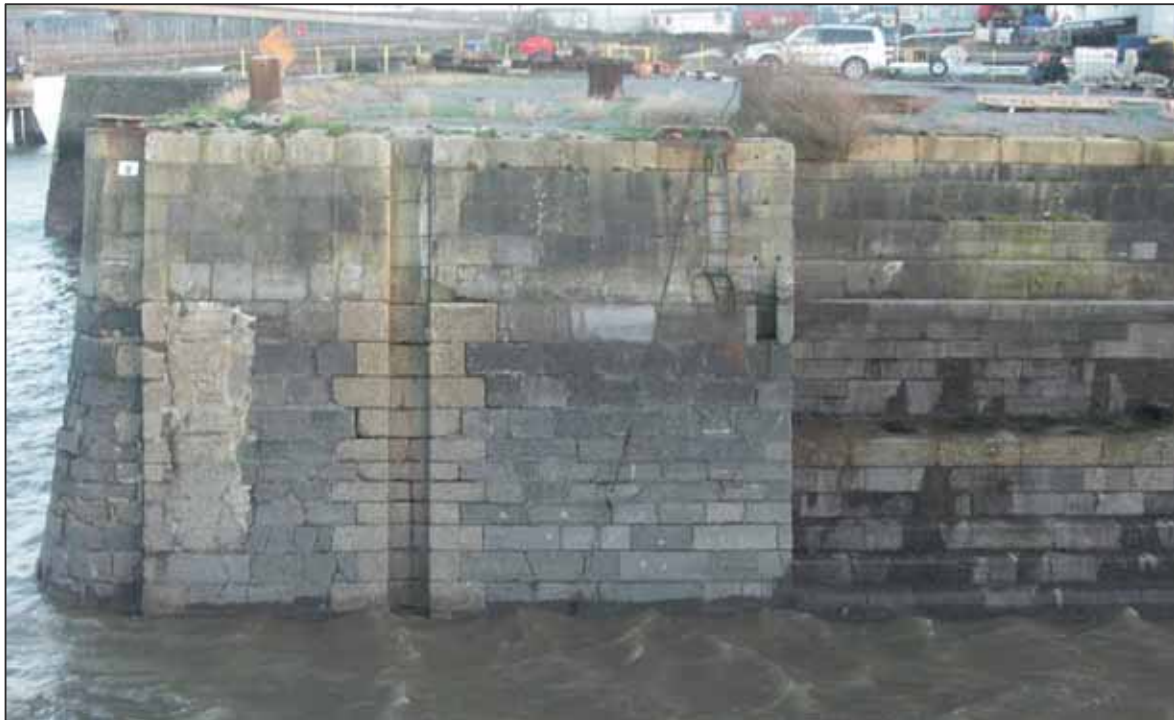
The entrance to the graving dock which will be maintained under the preferred option

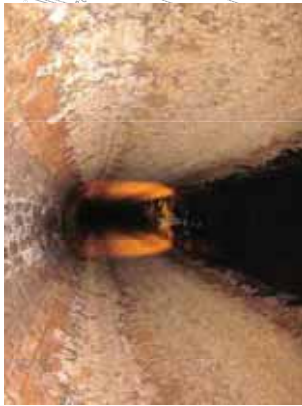
1 SLOW BEND WITHIN CULVERT

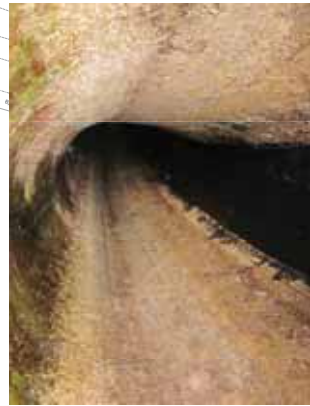
2 BEND NEAR ENTRANCE

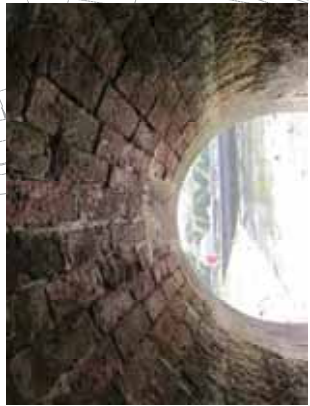
3 ENTRANCE TO PICKLING POND
