4 PHASE 3

The transition to iron (c. 1861 – 1926)

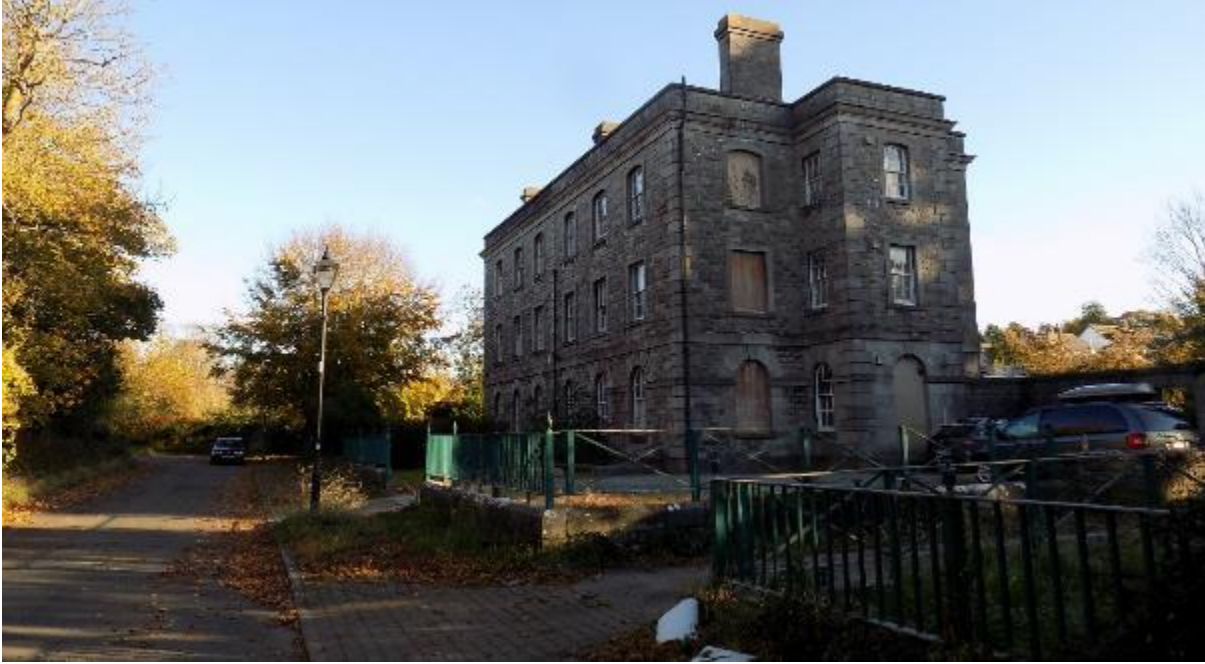
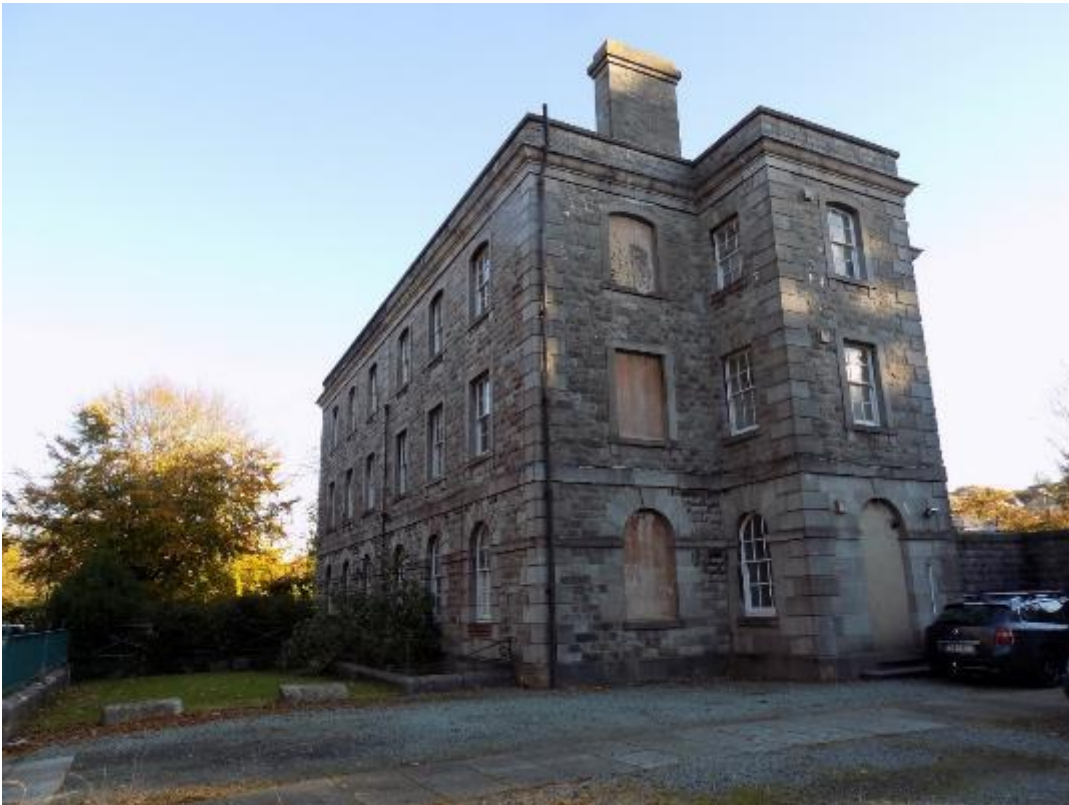
Structure 3.1 - No. 4 and No. 5 The Terrace

4.3 *Circa 1877 pair of houses built for Constructor and Chief Engineer of the Royal Dockyard, on a site planned in 1820 layout, but to different design. Rockfaced grey limestone with slate hipped roofs, three-storey six-window front with single bay full-height porch projections on each end wall. Moulded cornice and parapet. Corniced stone stacks. The design is loosely related to the 1817 design of Nos. 2 and 3, but taller Victorian proportions and heavier detail. Ashlar plinth, ground-floor impost band, plaitband, cornice and coping. Ashlar rusticated angle quoins, channelled pier between houses and surround to openings. 12-pane sash windows. Ground floor has arched windows with rusticated surrounds carried down to plinth, first floor plain flush surrounds with sill-brackets and second floor has cambered-headed flush surrounds with sill-brackets. End walls have similar 3-window elevations with similar blank openings each side of projecting porch bay, which have matching windows to north and end elevations, the latter with ground floor arched doorway, blocked on No. 4, double doors to No. 5. Rear is similar, with deep basement and plainer rock-faced stone walls.*

4.6 Late 19th century pair of houses, constructed to continue the pattern of the adjacent earlier buildings along The Terrace.

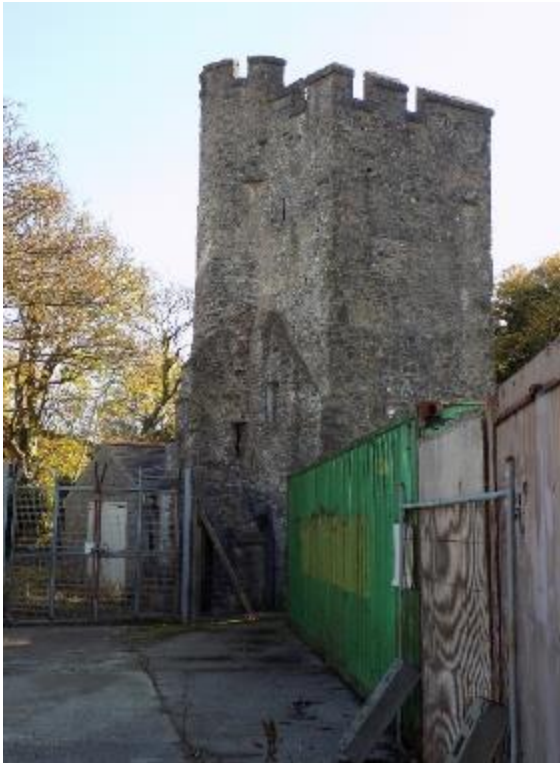
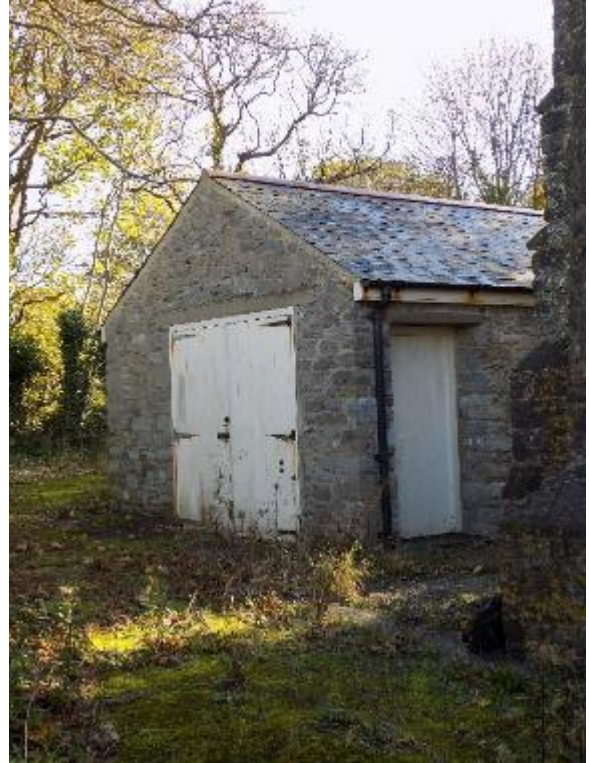
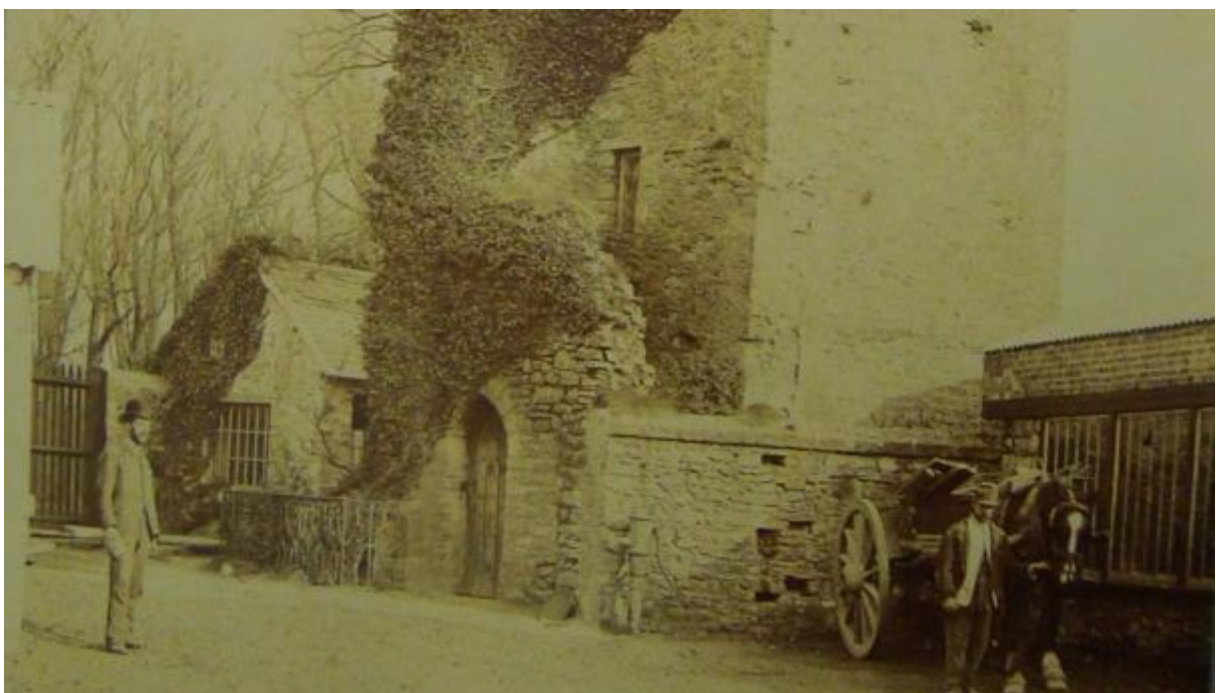
Structure 3.2 - Shed adjacent to Paterchurch Tower

4.23 Small stone-built shed with slate roof. Inserted double doorway under a concrete lintel in north gable. Door to west elevation.

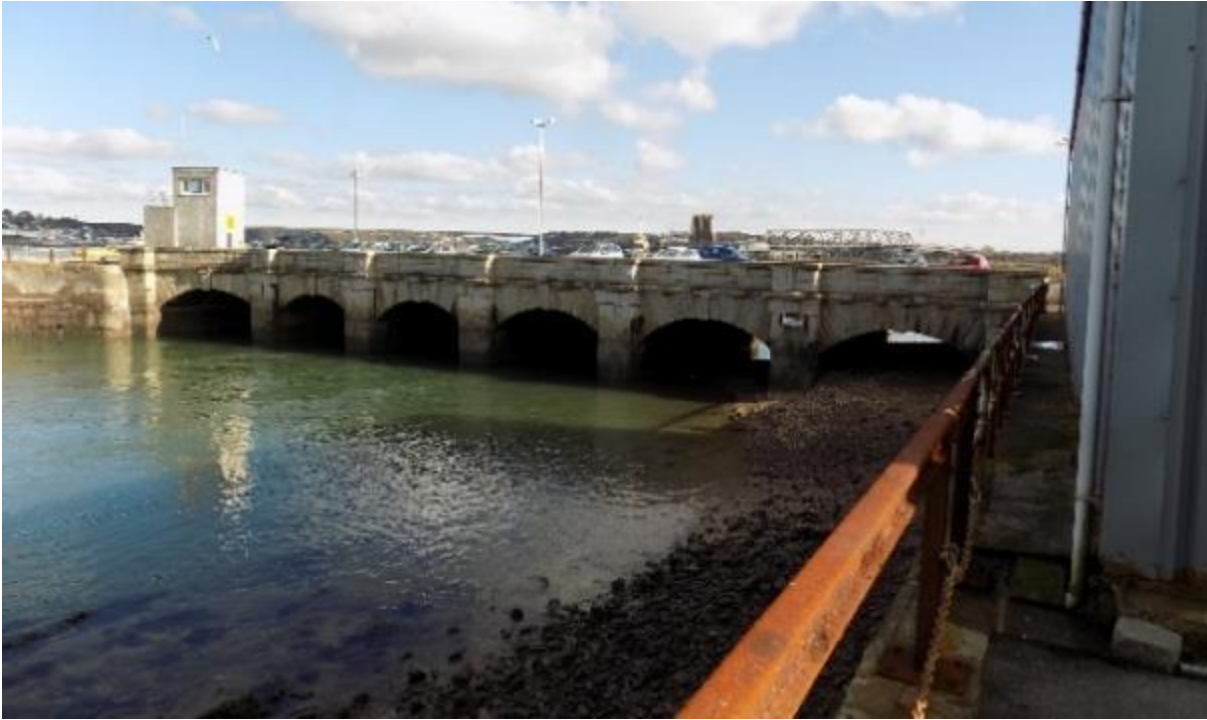
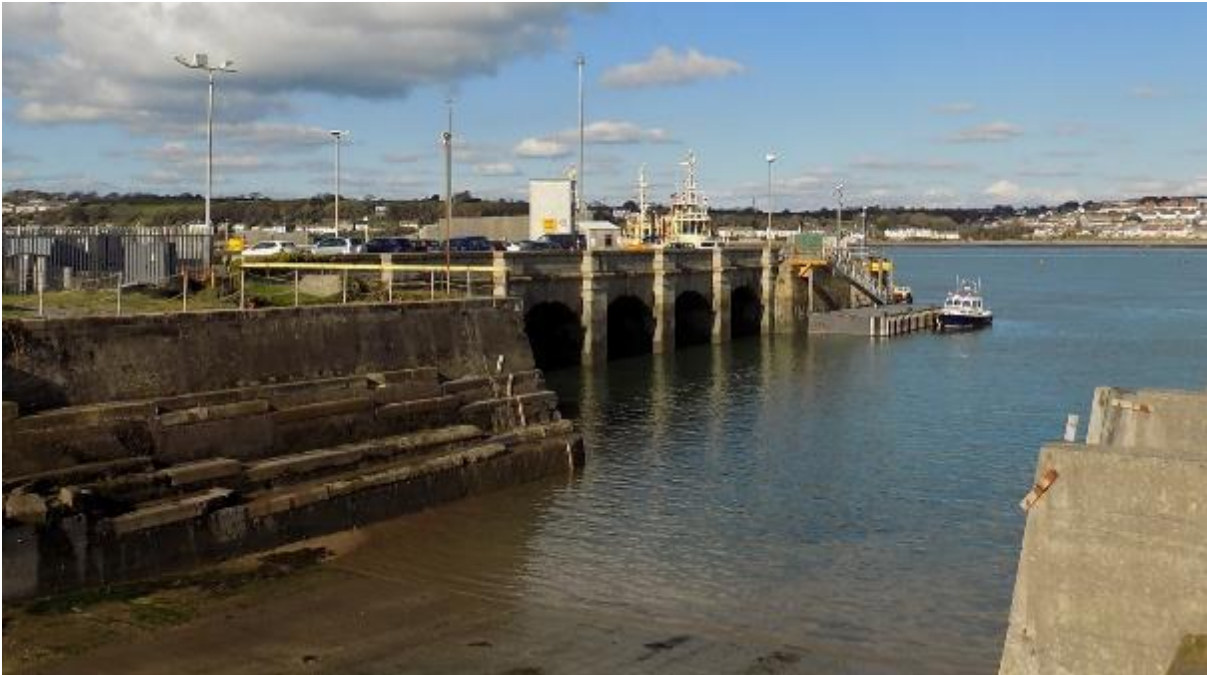
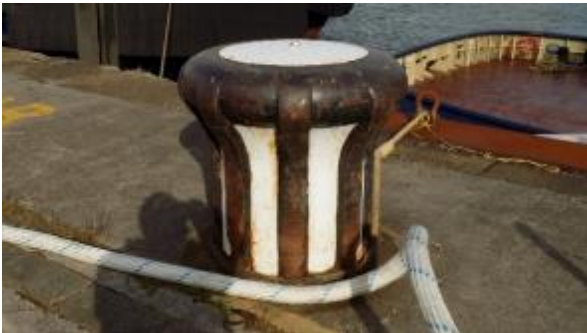
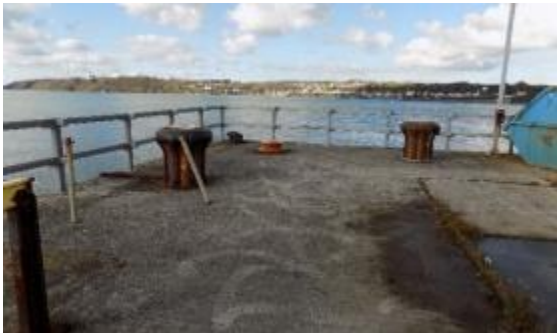
Structure 3.3 - Carr Jetty

4.36 *Approached by six-arch broad bridge from foreshore, tooled granite facings and engineering-brick arches. Cambered arches with long voussoir blocks and raised keystones under bull-nose cornice and parapet. Raised piers between with rounded angles, block capitals under cornice which is broken forward and raised parapet piers. Granite coping. Jetty is canted to north-west, to give a long mooring on north-east, and L-plan at north-west end to give mooring along north-west side. North-east side is faced in granite with granite dressings and copings, flight of steps down. North-west end is similar as is projecting west end, but south-west side of jetty appears to be faced in concrete, with granite copings.*

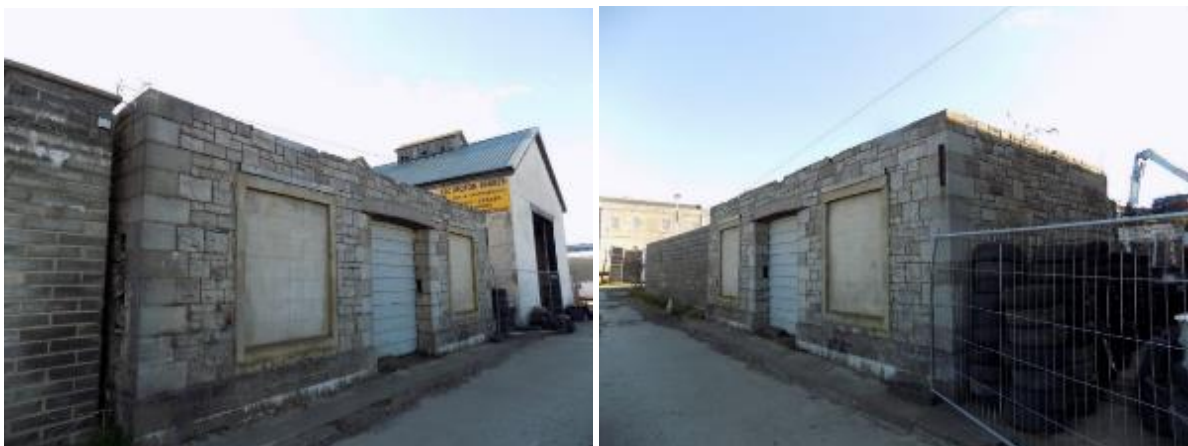
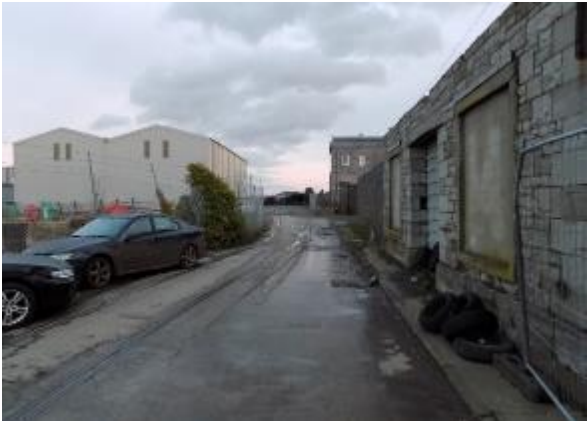
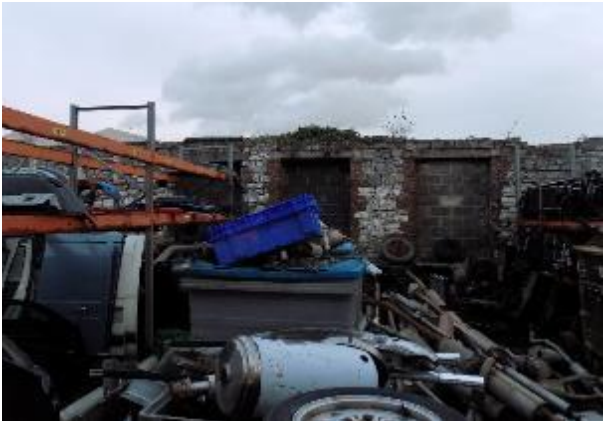
Structure 3.4 - Former Shed for Docking Gear (later Hayes Building 7H Store)

- 4.64 The building is in poor condition and its roofless shell barely conceals the scrap metal contained within its fragmented walls. The wider cluster of buildings of which this non-listed asset forms a part is in multiple ephemeral uses associated with the repair and scrapping of cars. It is part of a fragmented, varied industrial site with no strong, single-overriding purpose. This part of the dockyard has no public access. The change in the character of the function of this part of the dockyard has adversely impacted on the building's significance.
- 4.65 Having lost its roof and the upper part of its gables, the remains of the building no longer form a significant part of the broader dockyard 'tableau' when viewed from the northern side of the Haven.

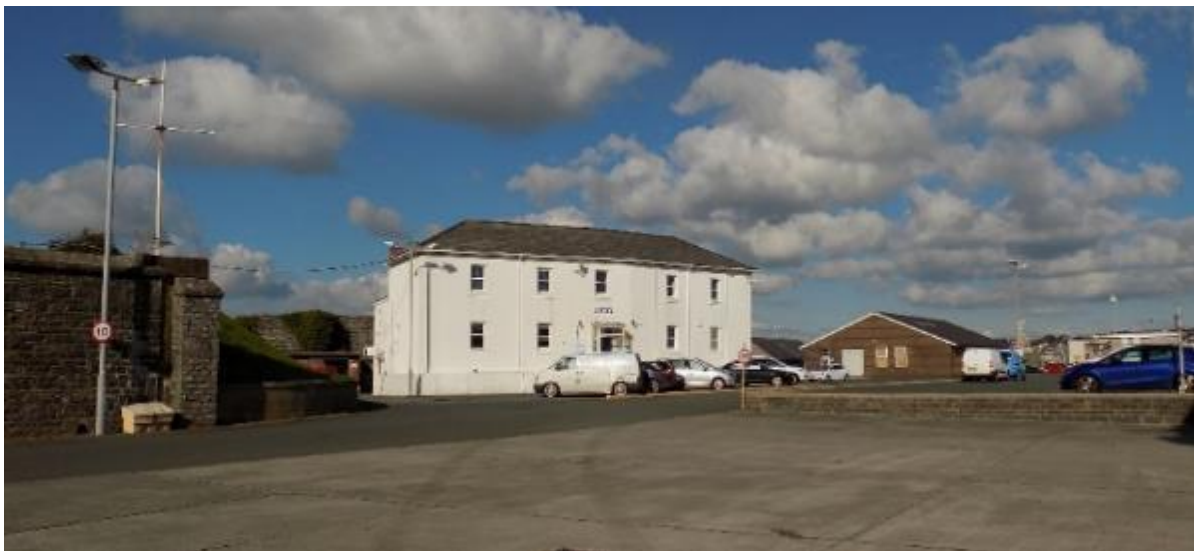
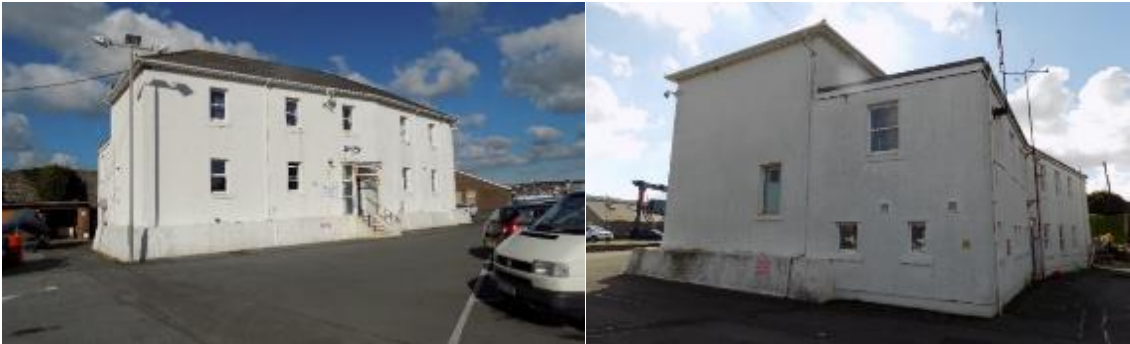
Structure 3.5 - Building 15 Former Pater Fort Soldiers' Barracks (now Switzer Offices, formerly Admiralty Main Office, previously Admiralty Building 8A Offices) (MHPA Bldg. M667)

4.70 Small two-storey barracks for former coastal battery, built 1879. Two storeys under hipped slate roof. Slightly angled 2-bay barrack wings to either side of a 1-bay wide central staircase. Central door approached up 6 stone steps. 20th century external render, entrance door, replacement sash windows, steel and glass flat-roofed porch and full-width, flat-roofed, single-storey extension to rear.

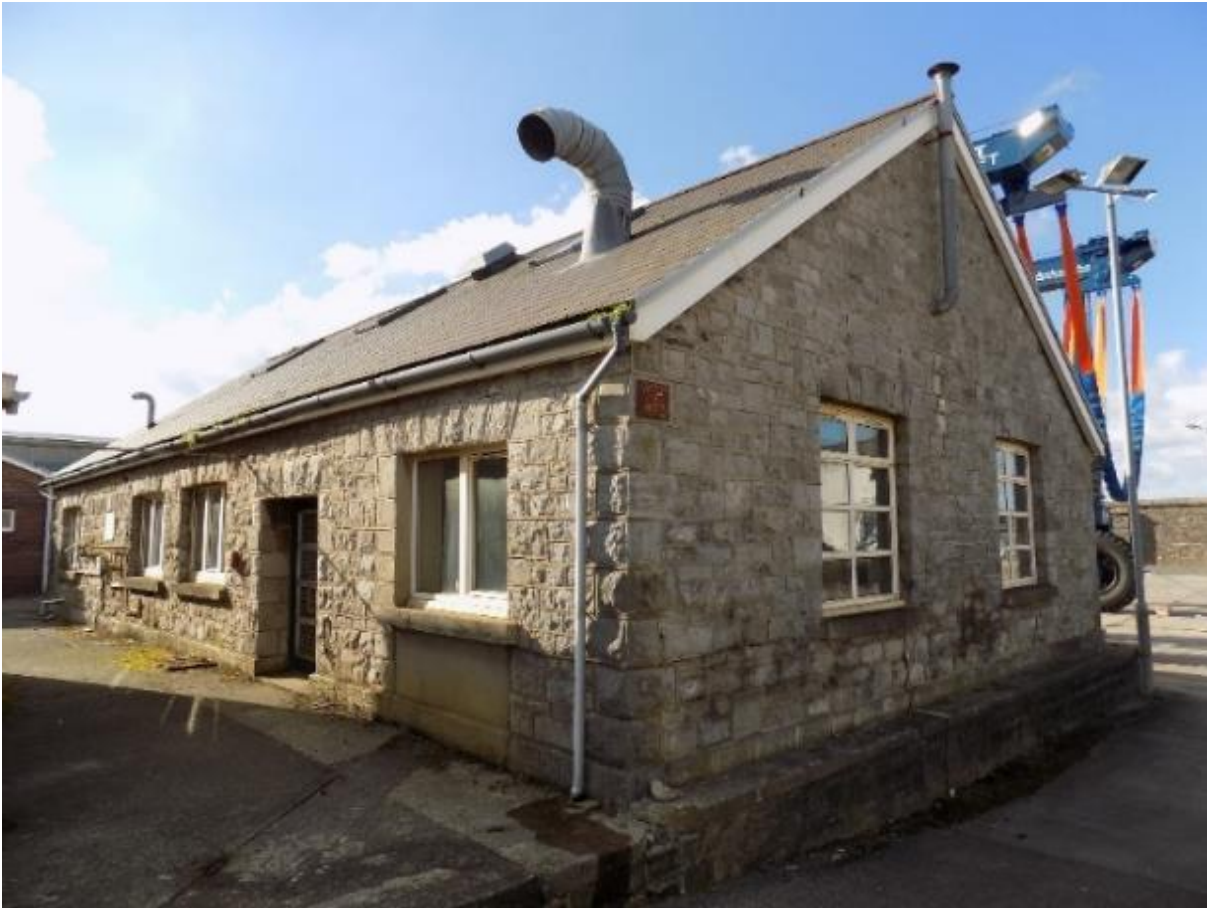
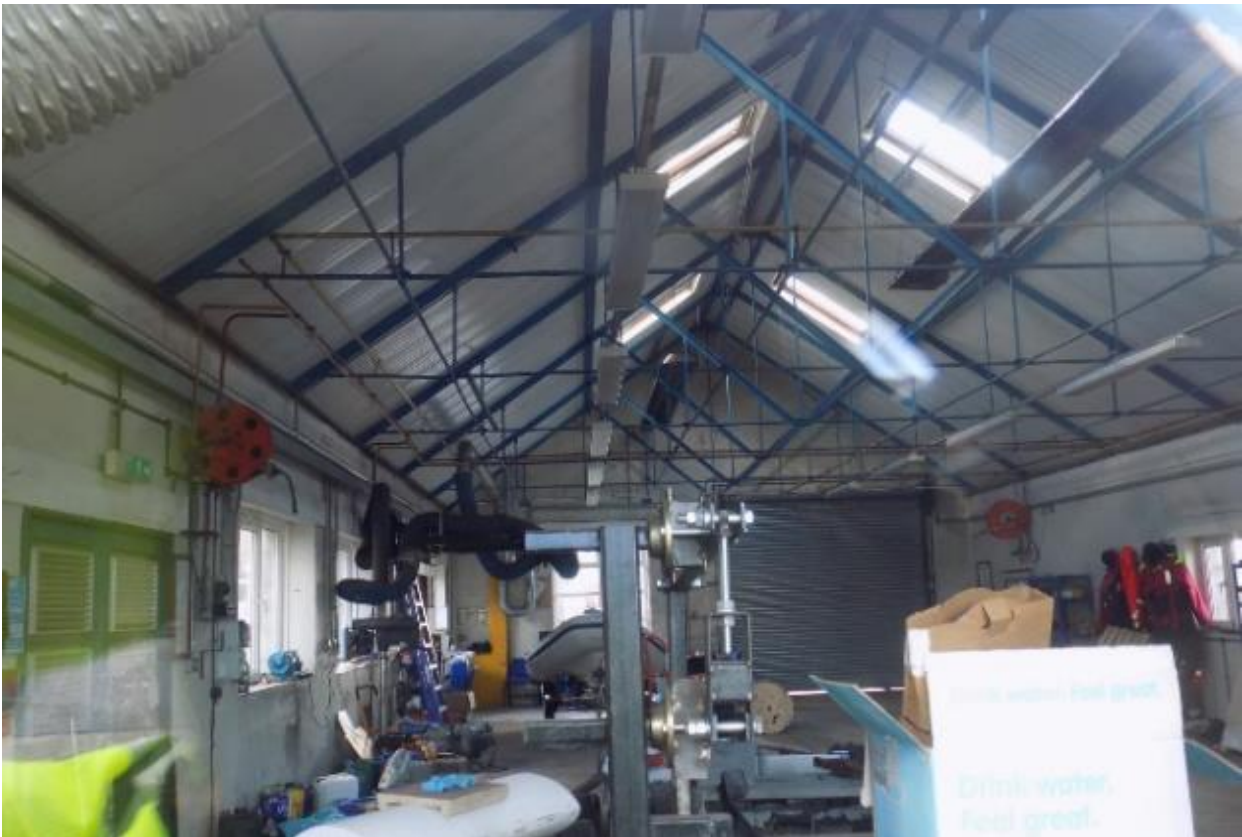
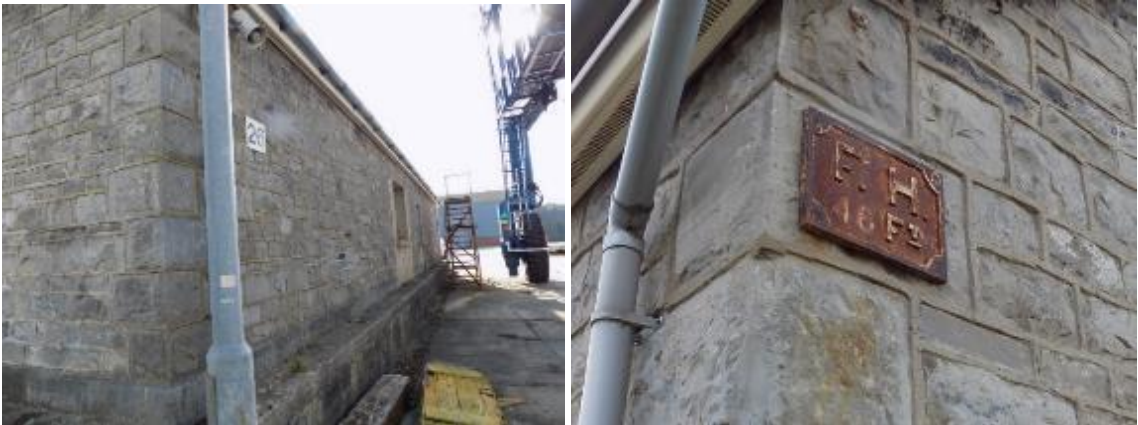
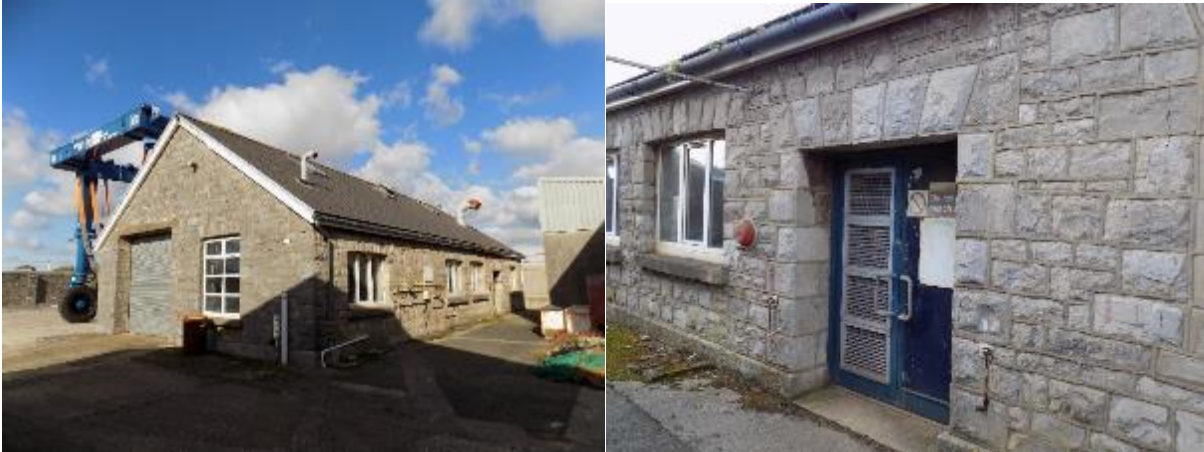
Structure 3.6 - Building 26 Workshop (Former Admiralty Workshop, previously Building 2H Hayes Joiner's Shop, previously Iron Store) (MHPA Bldg. M675)

4.84 Built sometime between 1877 and 1901. Rectangular stone-built shed with wrought-iron trussed roof, originally an Iron Store associated with the construction and repair of iron-clad warships in the adjacent Graving Dock, Building Slips Nos. 1, 2 and 4, Western Camber and Carr Jetty (**Structures 2.17, 2.15, 2.16, 2.19, 2.18** and **3.3**). Rockfaced grey limestone walls with ashlar plinth and quoins. Seven windows and one doorway under straight heads of snecked voussoirs with drafted margins. Stone sills. Inserted double doorway under a concrete lintel in south gable. Cast iron fire hydrant "F.H. 46 ft." sign on north gable. Upvc replacement fenestration throughout. Slate roof. 'Fireproof' structure of wrought-iron trusses, purlins, rafters and laths.

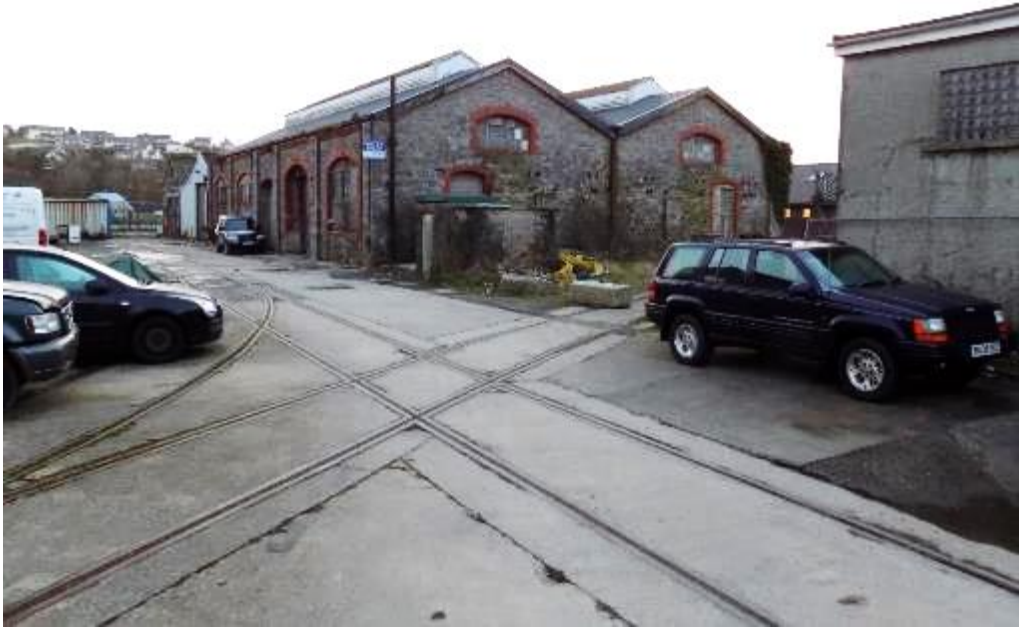
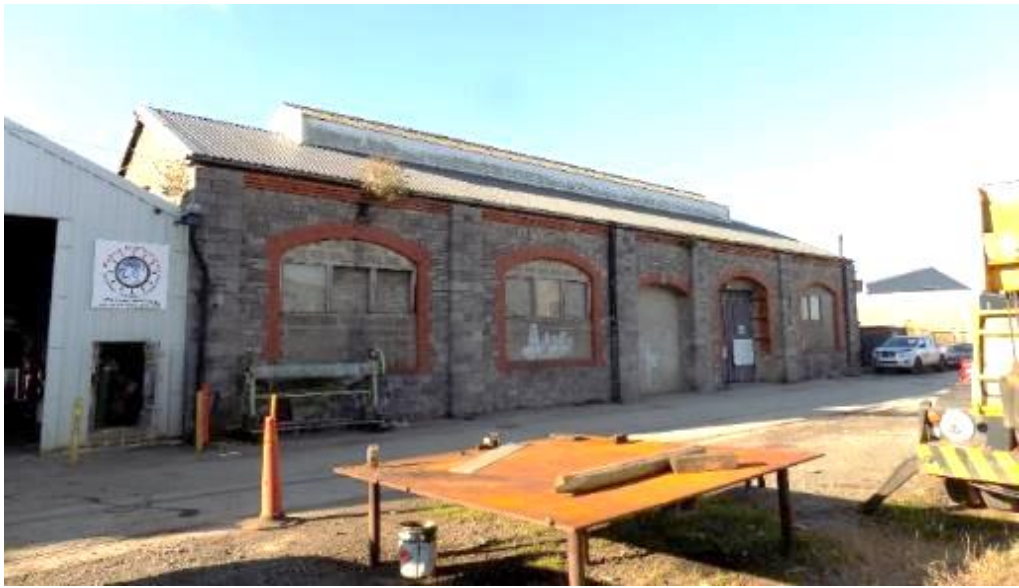
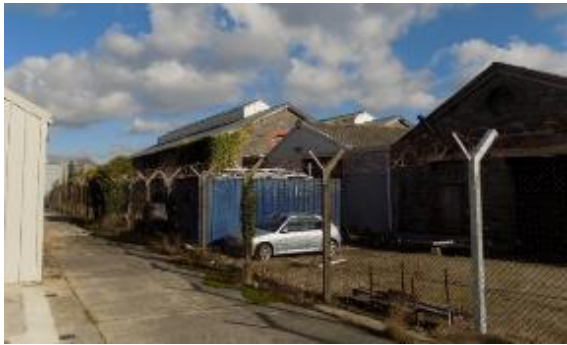
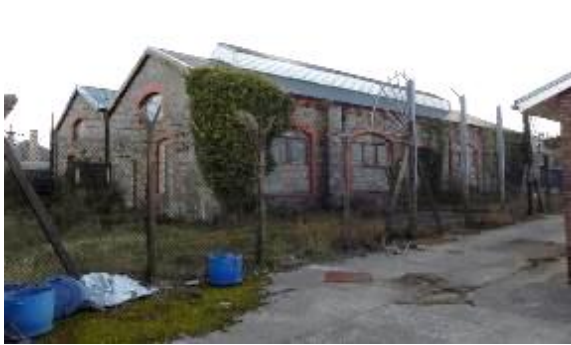
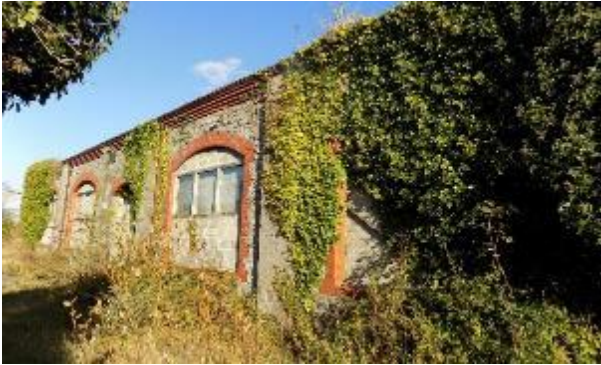
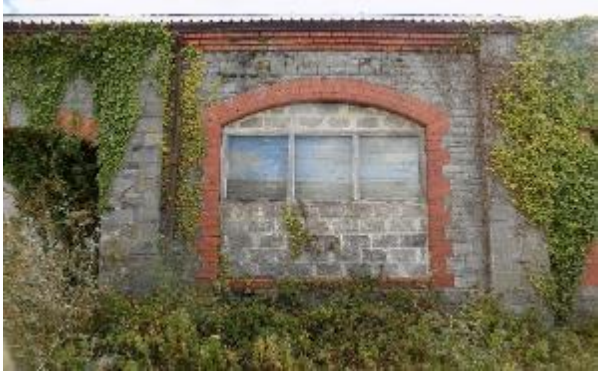
Structure 3.7 - Former Pattern & Gunnery Fitting Shop (later Hayes Building 4H Machine Shop) (MHPA Unit 17)

4.100 Built sometime between 1877 and 1901. Large stone-built shed. 2 parallel ranges of 5 bays, originally Pattern & Gunnery Fitting Shop associated with the construction and repair of iron-clad warships in the adjacent Graving Dock, Nos. 1, 2 and 4 Building Slips, Western Camber and Carr Jetty (**Structures 2.17, 2.15, 2.16, 2.19, 2.18** and **3.3**). Rockfaced grey limestone walls of pier and panel construction. Red brick corbelled eaves and margins and segmental heads to windows and doors. East and west elevations each have 4 windows, 2 to either side of a large central doorway. North gables each have 2 windows. With the exception of 1 window in each of the two south gables, all windows are now blocked. Raised louvred ridges to each range. Modern profiled steel roof-covering. Interior not accessed or visible. Roof thought to be of 'fireproof' structure of wrought-iron trusses, purlins, rafters and laths.

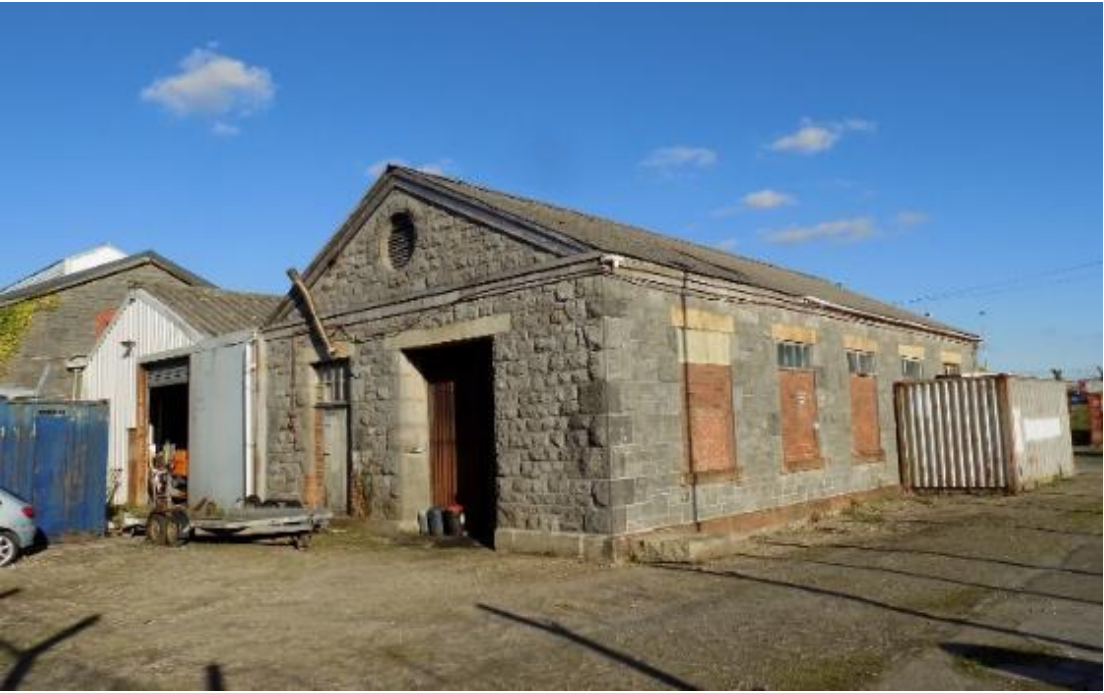
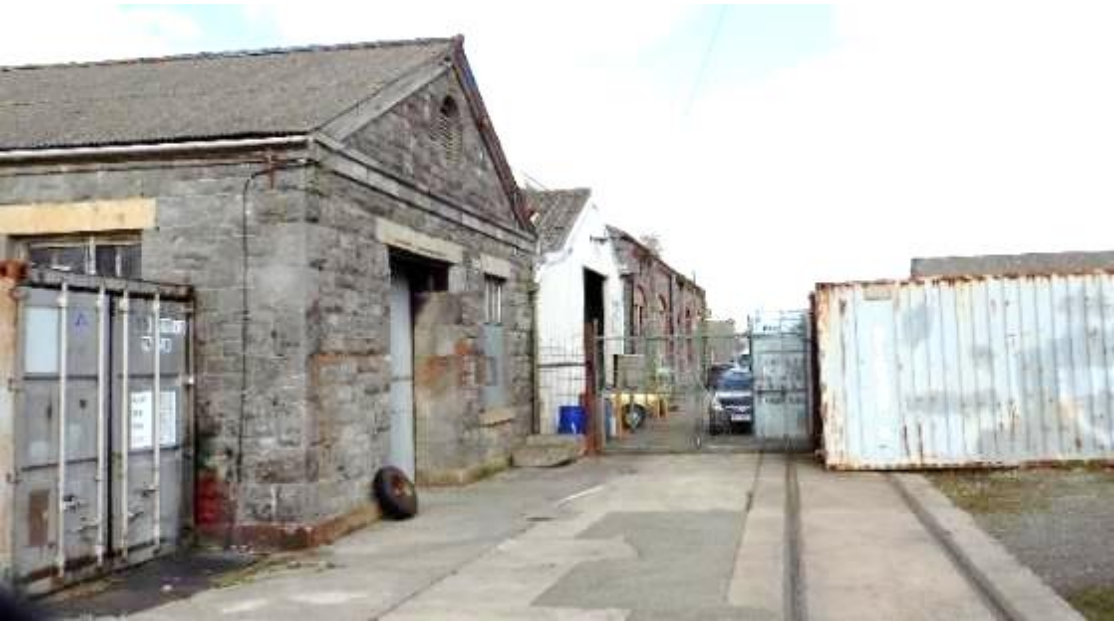
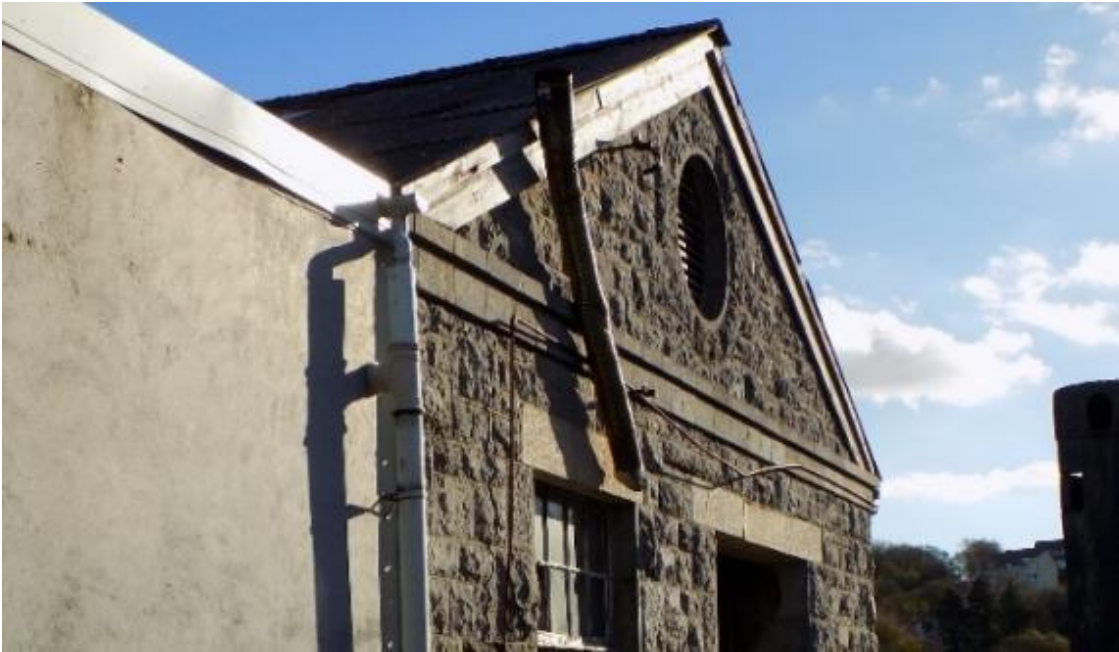
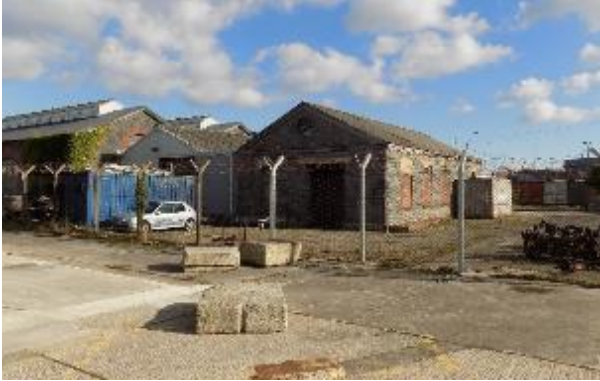
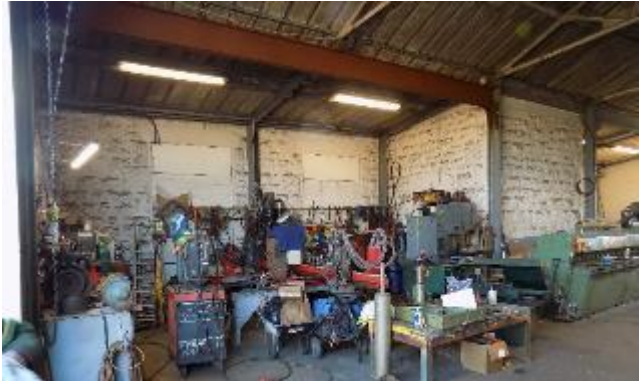
Structure 3.8 - Former Testing House (later Hayes Building 5H Stores) (MHPA Unit 19)

- 4.115 Located c. 100 m south of Building Slip No. 1 (**Structure 2.15**), towards north-west corner of dockyard.
- 4.116 Built sometime between 1877 and 1901. Large 5-bay T-plan stone-built shed, with later steel-roofed annexe to north, originally a materials Testing House associated with the construction and repair of iron-clad warships in the adjacent Graving Dock, Nos. 1, 2 and 4 Building Slips, Western Camber and Carr Jetty (**Structures 2.17, 2.15, 2.16, 2.19, 2.18 and 3.3**). Rockfaced grey limestone walls with ashlar plinth and snecked quoins with drafted margins, monolithic stone or concrete heads and sills to openings. Ashlar eaves course wraps around the ends to form (with the wooden barge boards) a pediment to the east and west gables, each pierced by a central oculus. Five regularly-spaced windows to north elevation. One window and one large double door to east and west gables. North elevation (now enclosed by steel-roofed annexe) has four windows (painted over), two to either side of a large projecting central bay. Windows mainly of timber, most now boarded or painted over. Later asbestos roof-covering. Interior not accessed. Roof thought to be of 'fireproof' structure of wrought-iron trusses, purlins, rafters and laths.

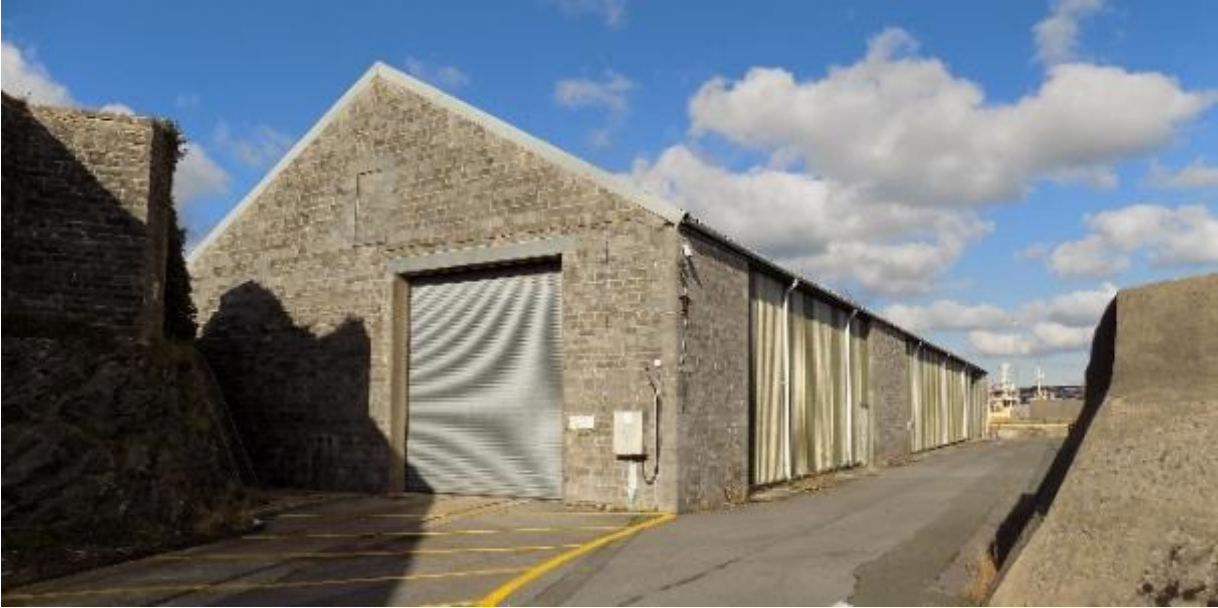
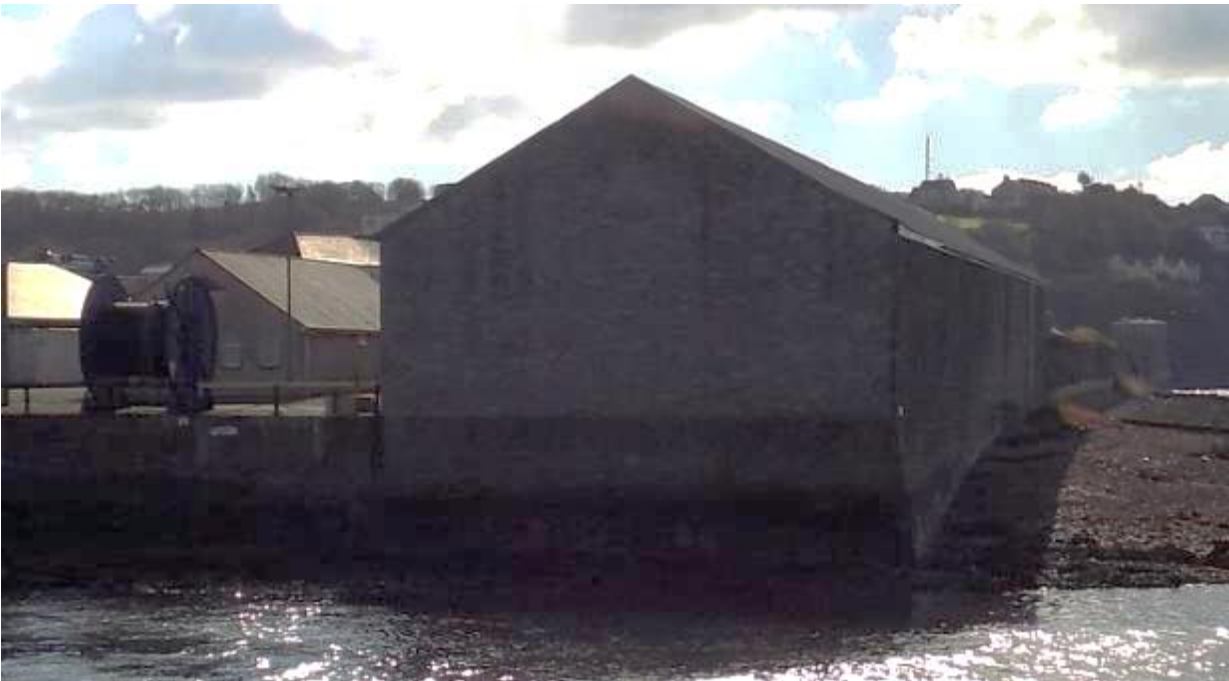
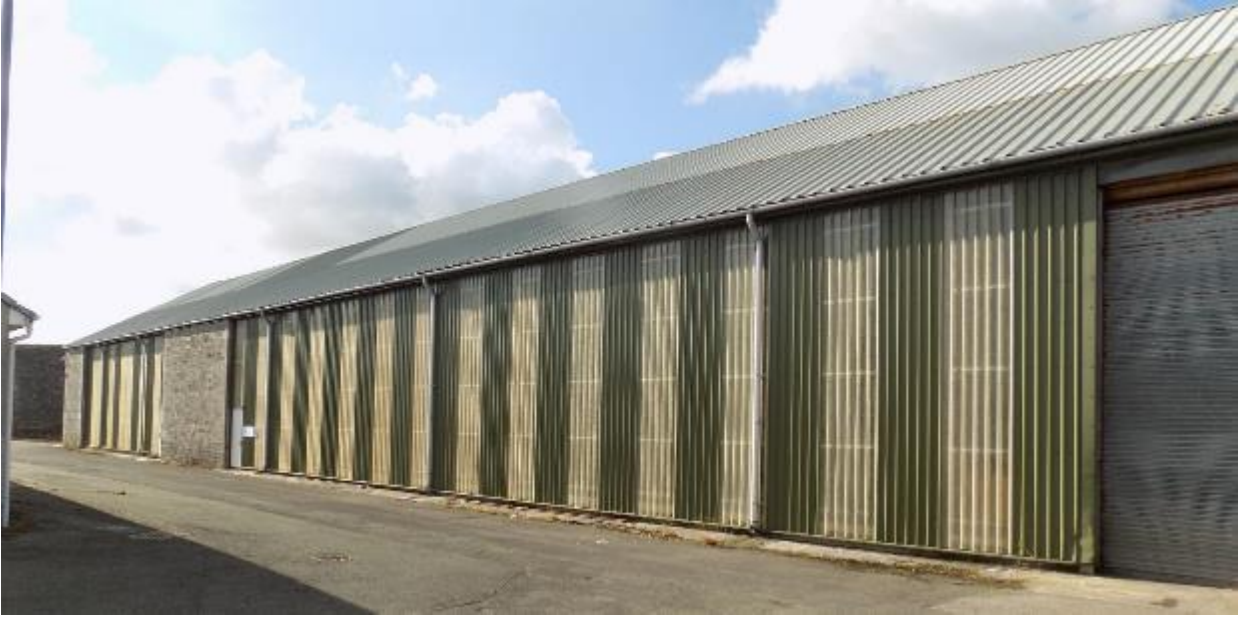
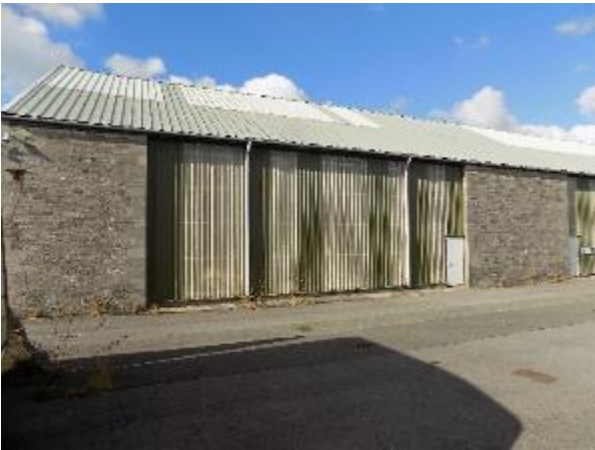
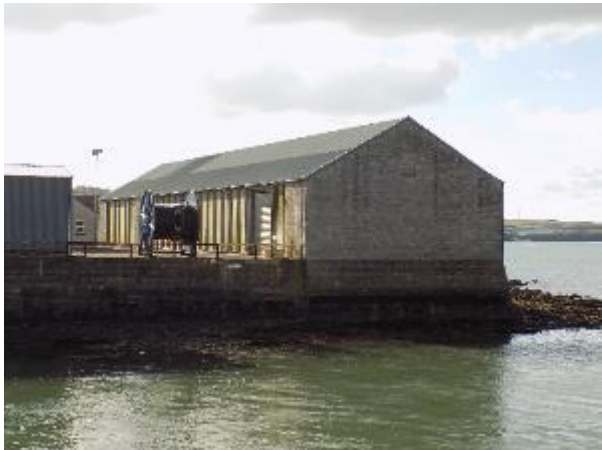
Structure 3.10 - Former Battery Room &c. (later Hayes Building 8H Workshop)

- 4.148 Located c. 20 metres south-west of the Graving Dock (**Structure 2.17**), towards north-west end of dockyard.
- 4.149 Rendered 4-bay shed with vented roof, built for servicing and charging lead-acid batteries of warships in the adjacent Graving Dock for repair. Modern lean-to at south end. Cement rendered externally, modern profiled steel roof cladding on original steel trusses. Large double doors with railway tracks to north gable. 4 large windows to east and west elevations. 3 large fenestrated raised ridge sections with timber fenestration. Inserted modern internal mezzanine at the south end. No internal features of note, save for railway track inset into the floor.

- 4.150 First shown on 1909 dockyard map. Marked as 'Battery Room &c.' on 1921 map.
- 4.151 Group value with Former Oakum Store, Graving Dock and Former Guard Office (**Structures 2.22, 2.17 and 2.23**) and surviving cluster of undesignated later 19th century ship-wrighting buildings in the north-west corner of the dockyard, all associated with the construction and repair of iron-clad and steel warships.

- 4.154 This building is of historic interest as one of the few buildings within the dockyard that survives from the iron-clad ship-building era.
- 4.155 Following the closure of the majority of the naval dockyard in 1926, the building was leased to Messrs T.W. Ward & Sons as part of a small civilian dockyard. Ward's land was re-acquired by the Admiralty in 1940 for a small repair yard to employ c.300 men, to repair naval vessels including landing craft and larger vessels up to the size of C Class cruisers and destroyers. C.1946 it became part of the private Hayes Shipyard, whose major source of work was Admiralty repair contracts.
