4 PHASE 3

The transition to iron (c. 1861 – 1926)

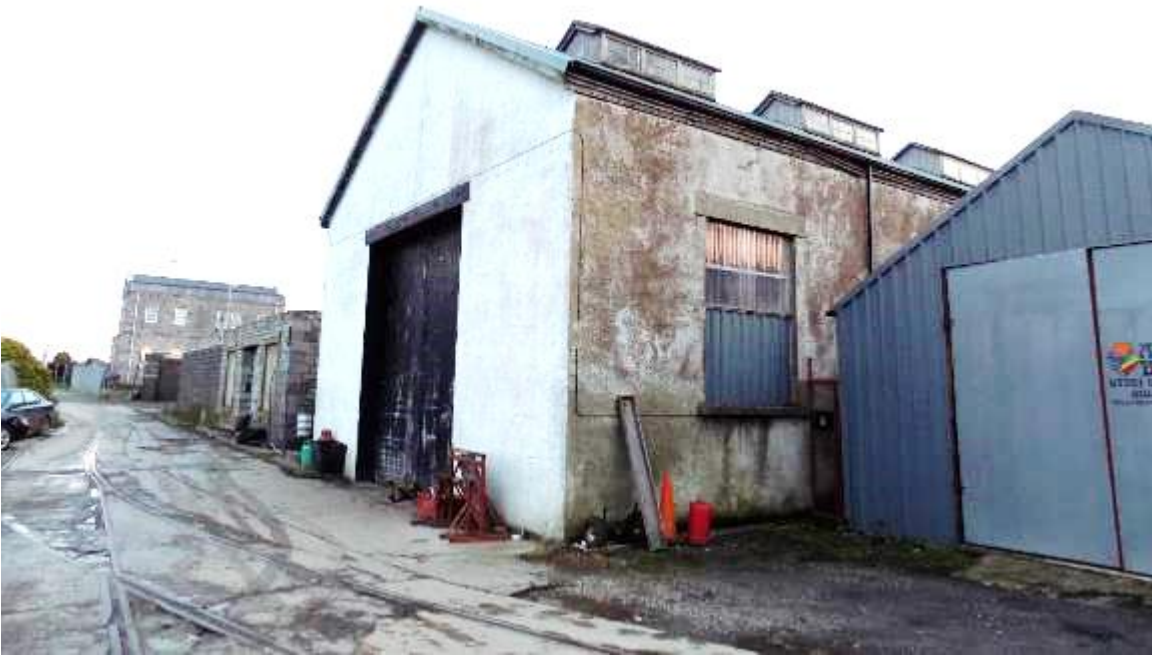
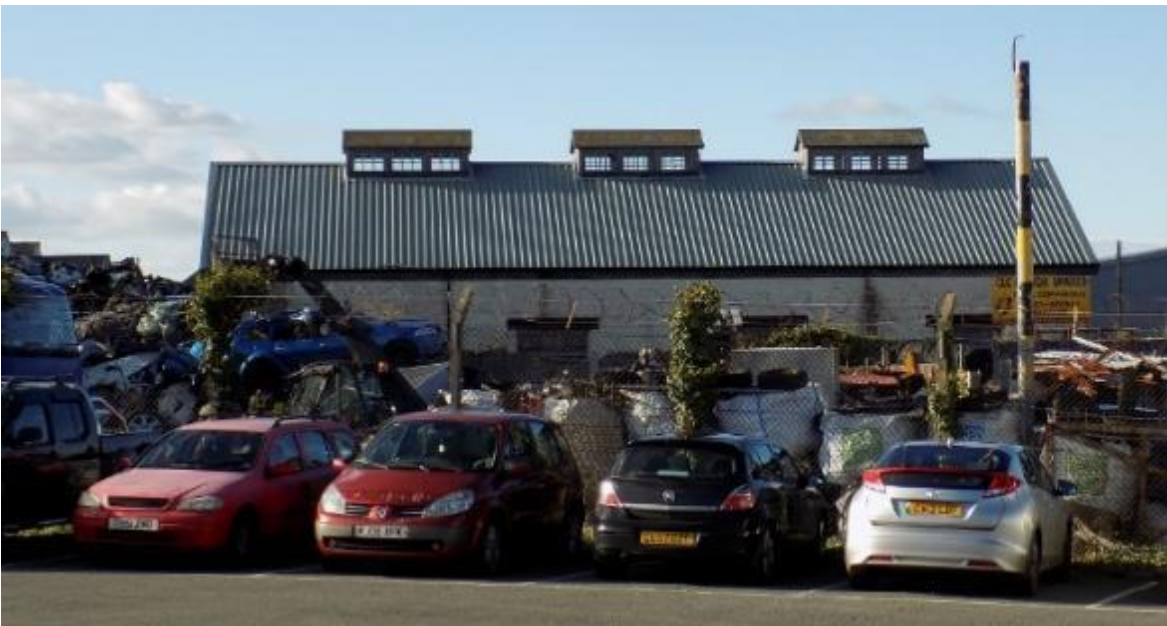
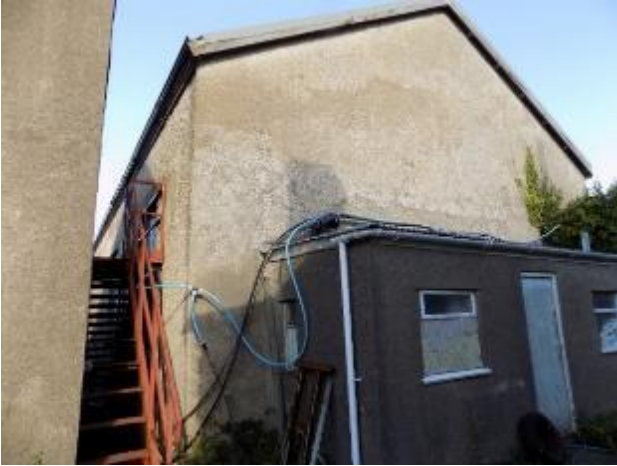
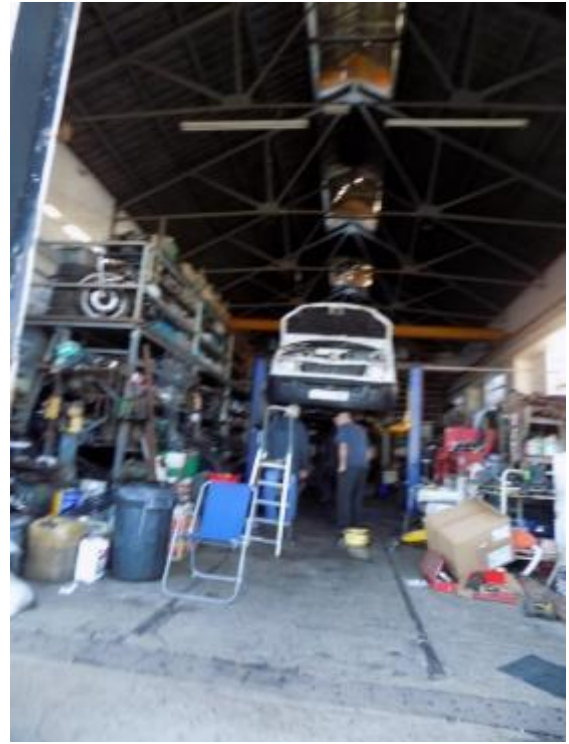
Structure 3.10 - Former Battery Room &c. (later Hayes Building 8H Workshop)

- 4.148 Located c. 20 metres south-west of the Graving Dock (**Structure 2.17**), towards north-west end of dockyard.
- 4.149 Rendered 4-bay shed with vented roof, built for servicing and charging lead-acid batteries of warships in the adjacent Graving Dock for repair. Modern lean-to at south end. Cement rendered externally, modern profiled steel roof cladding on original steel trusses. Large double doors with railway tracks to north gable. 4 large windows to east and west elevations. 3 large fenestrated raised ridge sections with timber fenestration. Inserted modern internal mezzanine at the south end. No internal features of note, save for railway track inset into the floor.
