**PEMBROKE DOCK PORT – PHASE I
GROUND INVESTIGATION**

INTERPRETATIVE REPORT

Report No. G624/IR

April 2015

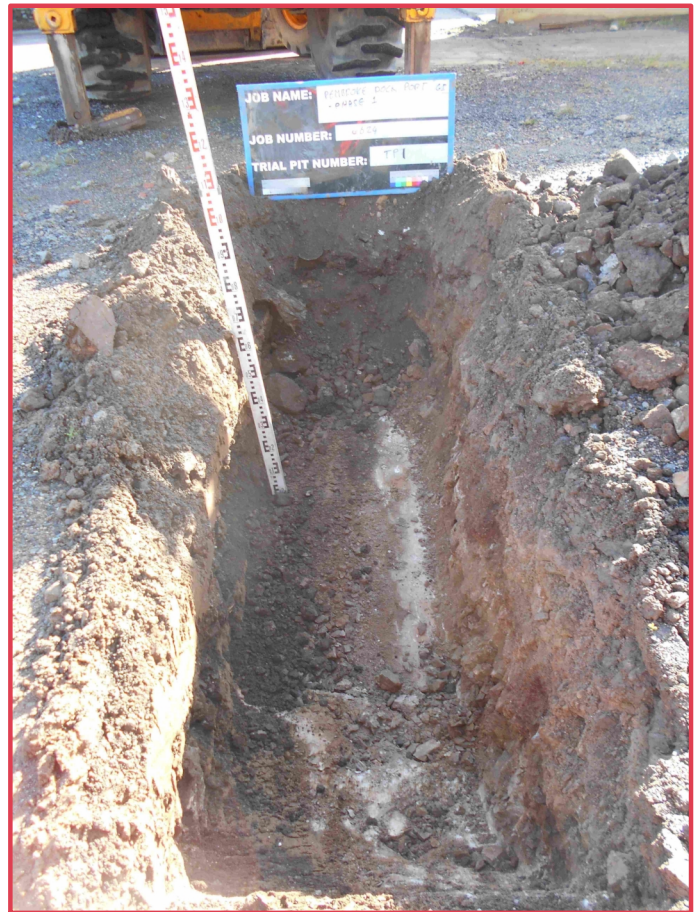
*Right:-
TP01 pit*

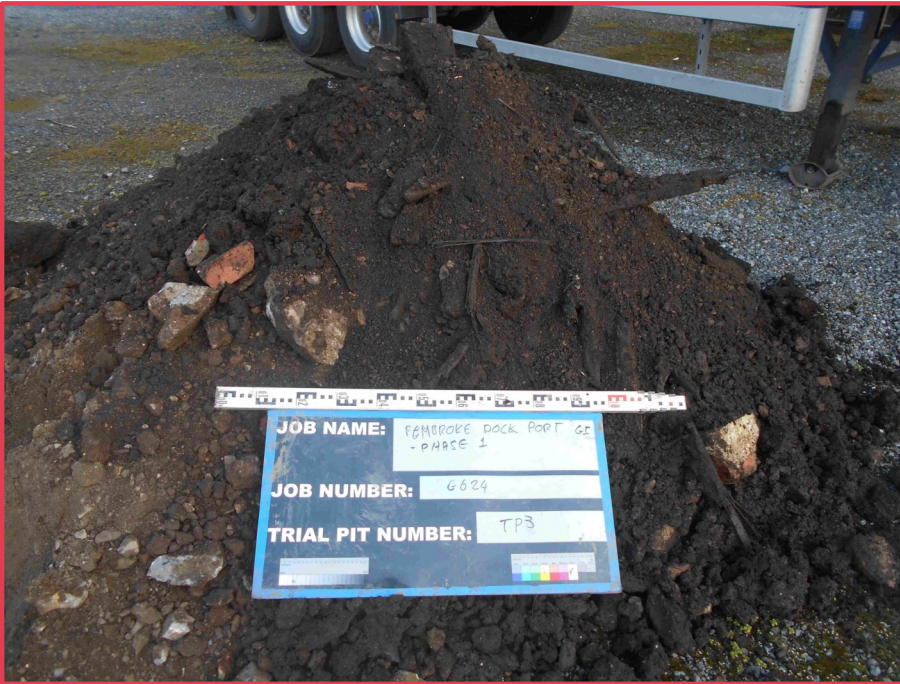
Above:- TP03 spoil

There was no visual evidence of contamination in any of the trial pits. In TP3 there was a faint odour of domestic refuse and rotting material but there was nothing uncovered in the ground which obviously corresponded to the smell. TP10 gave off an odour of burnt wood and there was associated burnt wood material recovered during excavations. Burnt wood recovered from the pit was in the form of individual items within the made ground and material arisings were not considered to be part of a larger strata of burnt material waste.

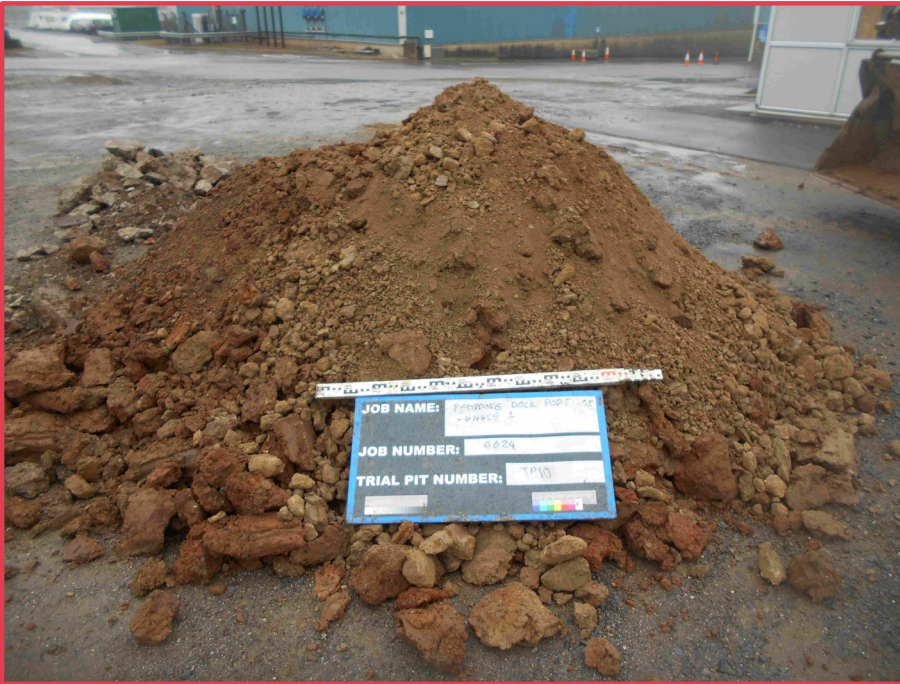
Above:- TP10 spoil

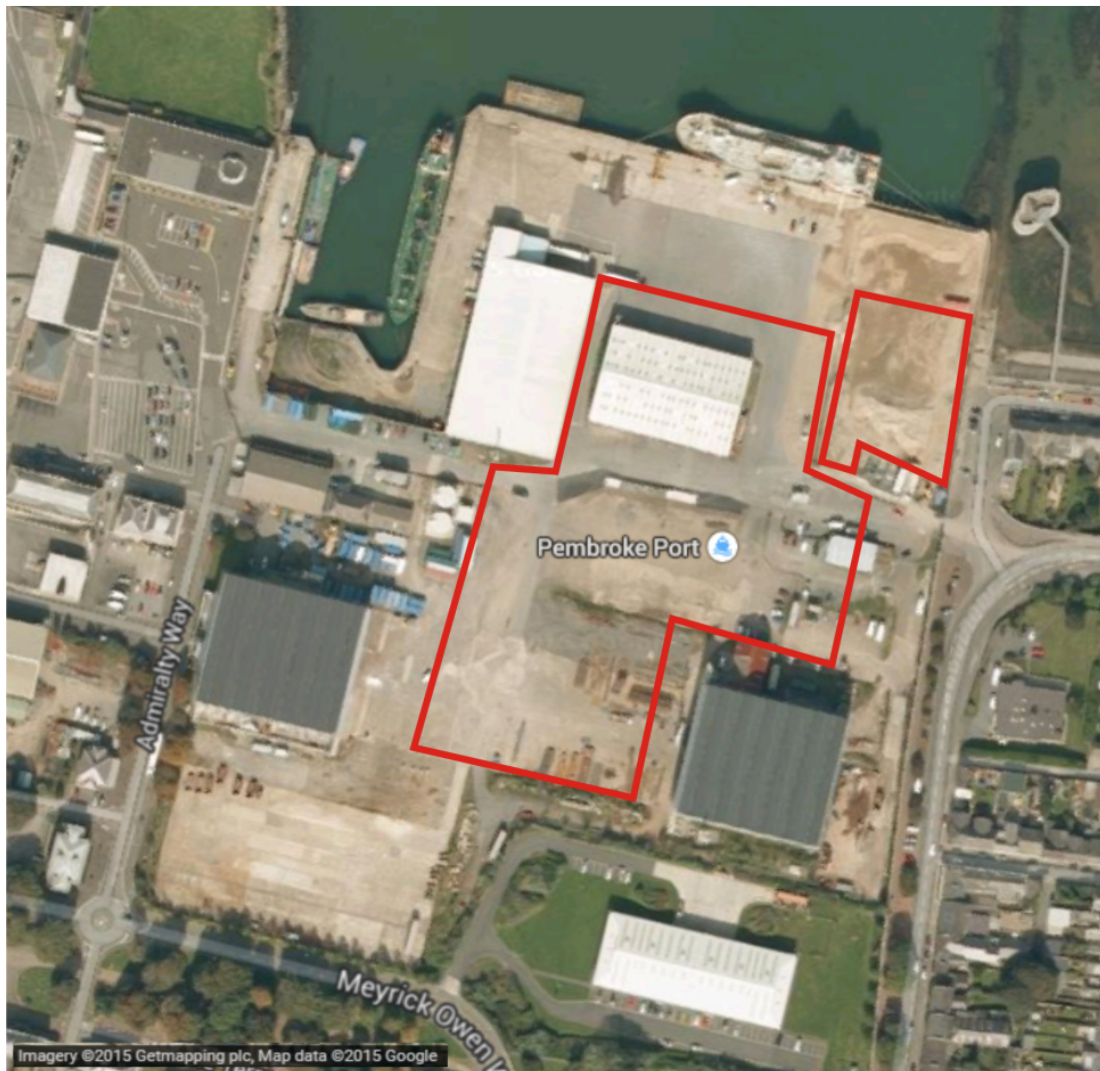
Plate 1 – Area surveyed outlined in red

The Client has requested the investigation to cover the survey area as shown in Plate 1.

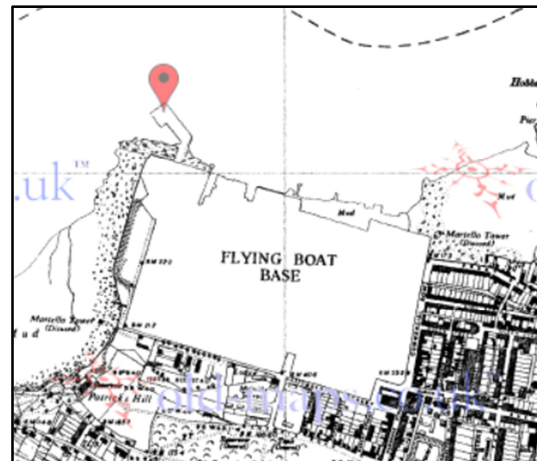
1953

The site was originally a dockyard but was then used as a flying boat station during and after the Second World War before returning to a cargo dock. Plate 2 shows three historical maps of the site, these show railway lines and several ramps and docks on the northern harbour edge. These have progressively been filled in to make the squared off dock wall that exists today.

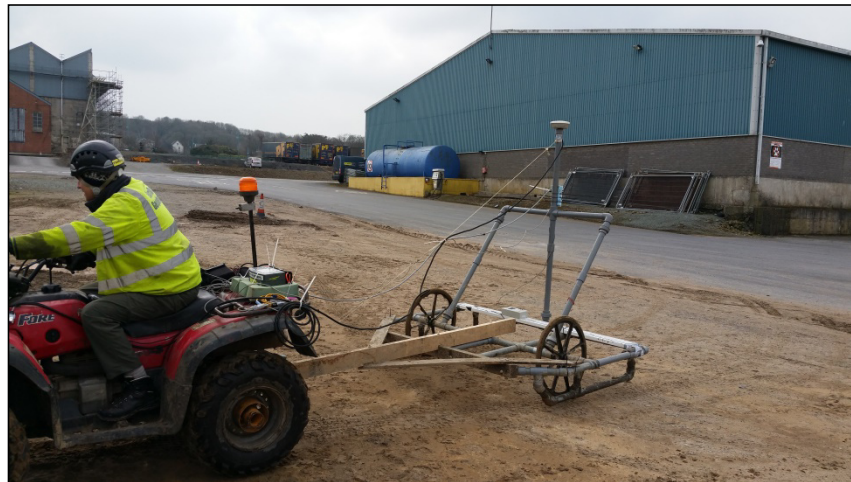
A *GEOMETRICS G858* magnetic gradiometer was towed behind a quad bike to acquire total magnetic field data along a series of approximate 3m spaced survey lines (Plate 1). Readings along the survey lines were taken at approximately 0.2m intervals and positioned using a GPS NMEA string from a Trimble ProXT DGPS system mounted above the sensors.

Plate 1 – Towed G858 Magnetic Gradiometer being used at the site

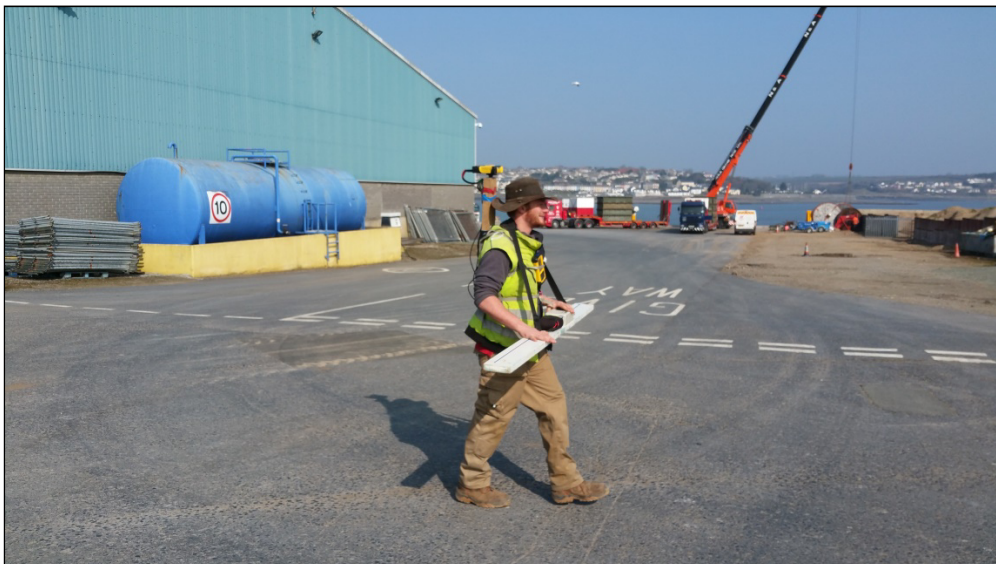
The instrument was configured to transmit five frequencies effectively investigating different depth ranges from approximately 0-7m bgl. The actual depth of investigation is a function of the selected frequency and resistivity of the underlying geology. Deeper frequencies tend to suffer from a high signal-to-noise ratio making the results uninterpretable. In practical terms a particular frequency is used for interpretation that most clearly shows subsurface responses.

Plate 2 - Geophex GEM-2 with Trimble DGPS positioning being used at the site

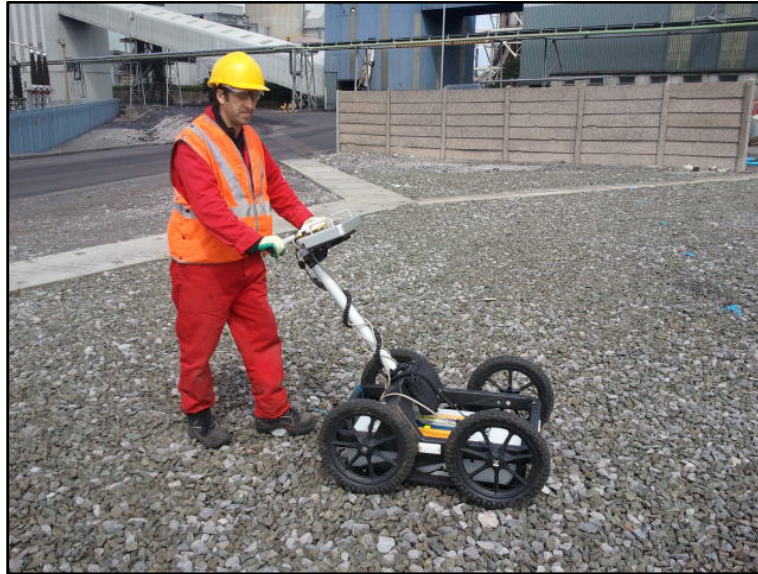
A *MALA RAMAC* radar system with shielded 250MHz antennae mounted within a cart was used to acquire grids of radar data over the selected areas as shown in Figure 1. The survey grids comprised local grids of parallel 1m spaced profile lines which were subsequently translated to OS coordinates for presentation (Plate 3).

Plate 3 – MALA RAMAC 250MHz GPR cart system (library photograph)

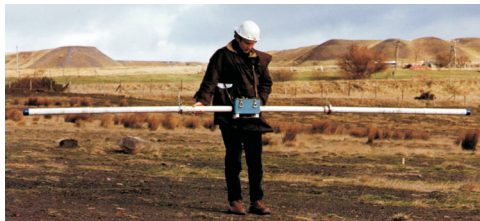
EM-31
(Exploration depth ~3 to 5m)

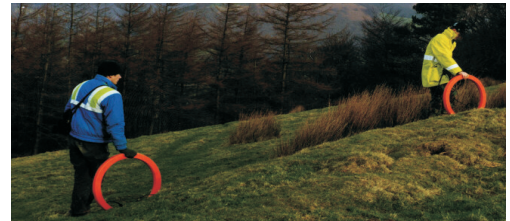
EM-34
(Exploration depth ~7.5 to 60m)

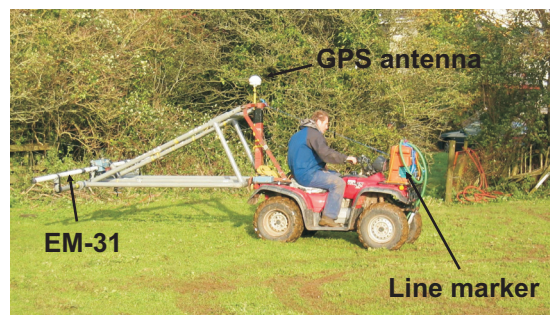
Conductivity data plot

The electromagnetic (EM) technique involves the generation of an EM field at the surface and measuring the response of the ground as it propagates into the subsurface. The main components of an EM survey instrument are a transmitter (for the generation of primary field) and receiver (for measuring the induced secondary field). The instrument functions by inducing current into the ground via a transmitter coil which causes the generation of secondary electromagnetic fields in any ground conductors present within the depth range of the particular instrument. These secondary fields are measured at a receiver coil and the instrument can record ground conductivity and in-phase component (metal indicator) at each survey station.

Electromagnetic (EM) surveys are carried out using man-portable instruments with readings taken on a regular grid or along selected traverse lines. If site conditions permit, the EM instrument may be mounted/towed behind a quad bike and positional control is provided by dGPS. The selection of the particular EM instrument (GEM2/EM-38/EM-31/EM-34) is based on the required penetration depth of the survey.

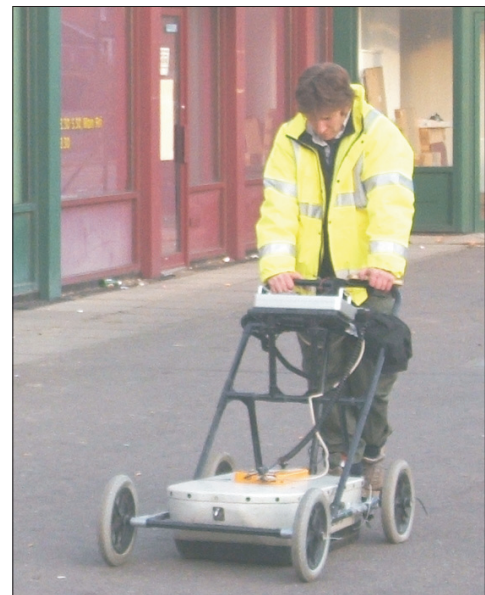
GPR Survey in progress

In order to improve the quality of the recorded radar data, a number of processing routines can be applied to the data using dedicated software (REFLEX). The final radar sections are converted to depth by applying a conversion velocity, which is usually based on an average velocity value for the local sediments. Without any additional calibration the measured depth to a particular feature is likely to be resolved within a 20% error margin depending on the local velocity structure.

The main limitations affecting radar surveys are the presence of conductive materials near surface (e.g., clay and water) which reduce penetration, and blocky material which scatters signal.
