Pembroke Port, Pembroke Dock

Preliminary Bat Roost Assessment

856531

JULY 2017

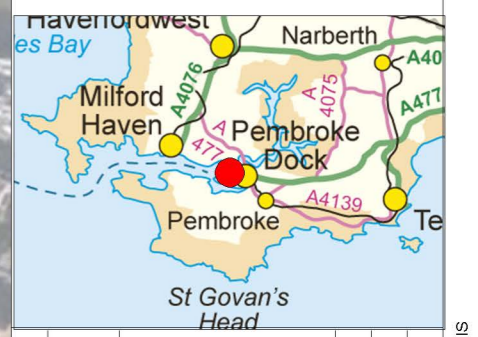
Figure 2
Preliminary Building Bat Roost Inspection
with Target Note

2. Greater Horseshoe Bat roosts are located in The Commodore Hotel, c. 35 m outside the site boundary (Biodiversity Solutions 2014) and in Building B10 (confirmed via DNA analysis of droppings found during this building inspection survey). These are likely to be linked and at least three nocturnal surveys will be required prior to redevelopment works commencing. This species is very susceptible to disturbance and information gained through these surveys will contribute to an assessment of the potential effect of the proposed works on the species and may inform the approach to mitigation, if required.

4. Possible bat droppings were identified but could not be collected from building B48 due to a lack of internal access. If access is not gained to fully assess the building, at least three nocturnal surveys are recommended to determine the presence or likely absence of roosting bats. Additionally, Building B52, c. 8 m outside the site boundary, is recommended for an internal inspection to assess the need for further surveys.

A total of 50 buildings, 47 within and 3 outside the site boundary, were surveyed and are illustrated in *Figure 2*. Building B9 was scoped out of the survey as it will not be affected by the proposed works.

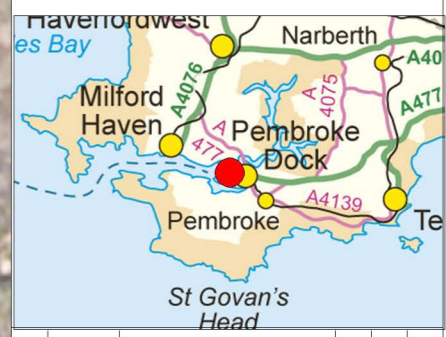
Figure 3
Ground Level Tree Assessment Results with Target Note

Trees were surveyed from ground-level and features that might be used by roosting bats were described and categorised according to Collins et al (2016). Each tree is given a category during the ground-level surveys (see *Table 1*) based on its potential for roosting bats. Where accessible and safe, potential roosting features were inspected with the use of a ladder and endoscope to look for evidence of roosting bats (*i.e.* droppings, polished surfaces, urine staining and dead or alive bats).
