## 6 PHASE 5

### The post-war port

#### Structure 5.1 - Building 3, Building 4 and Connecting Wall (Former Admiralty Piro Store and Store)

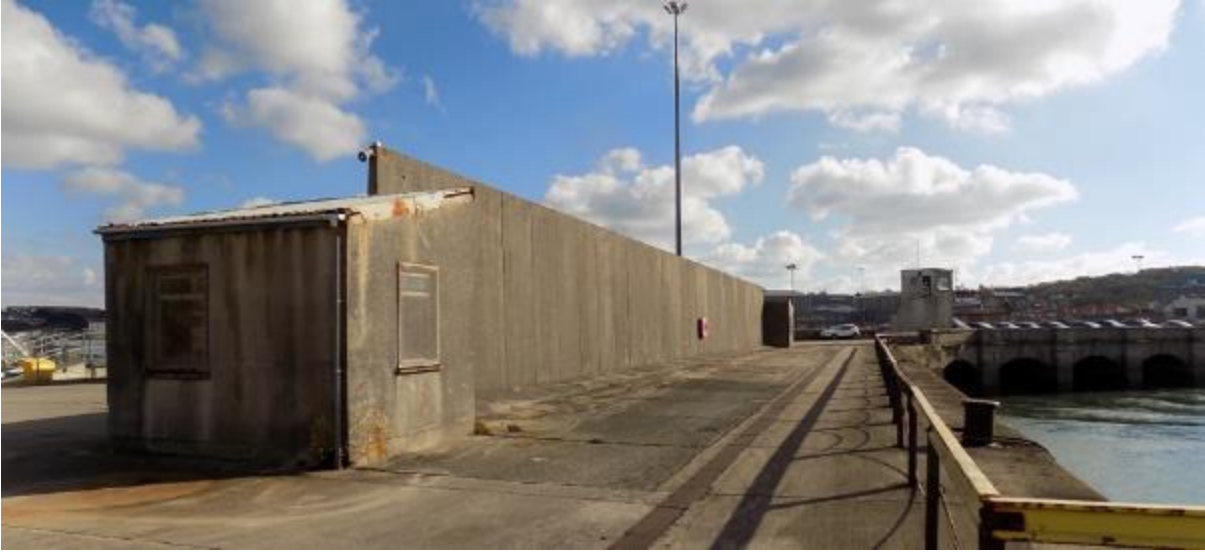
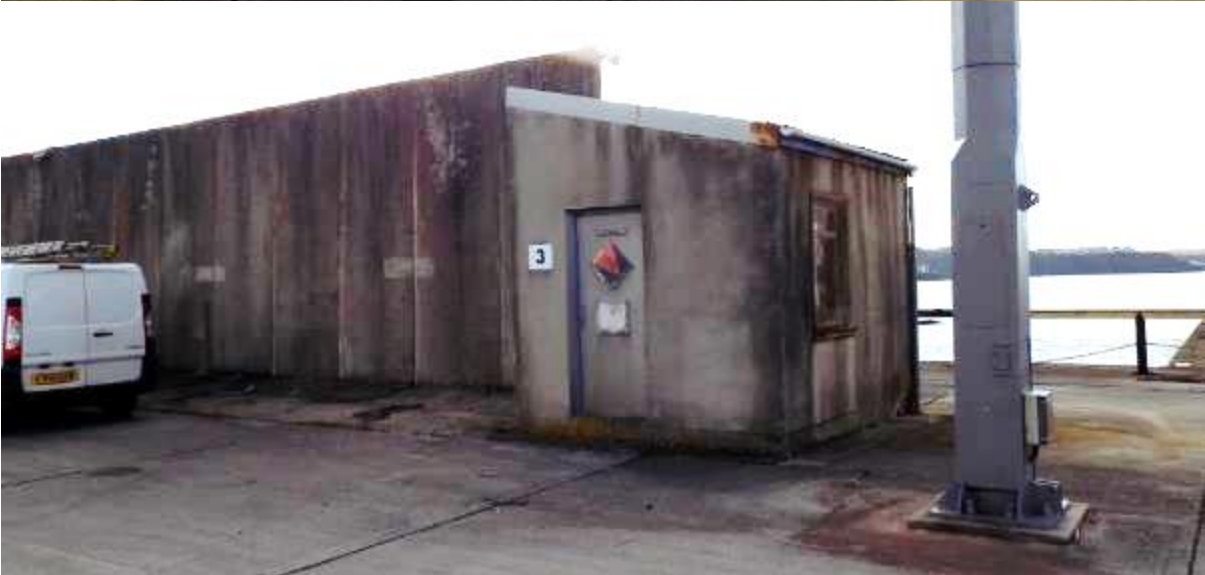
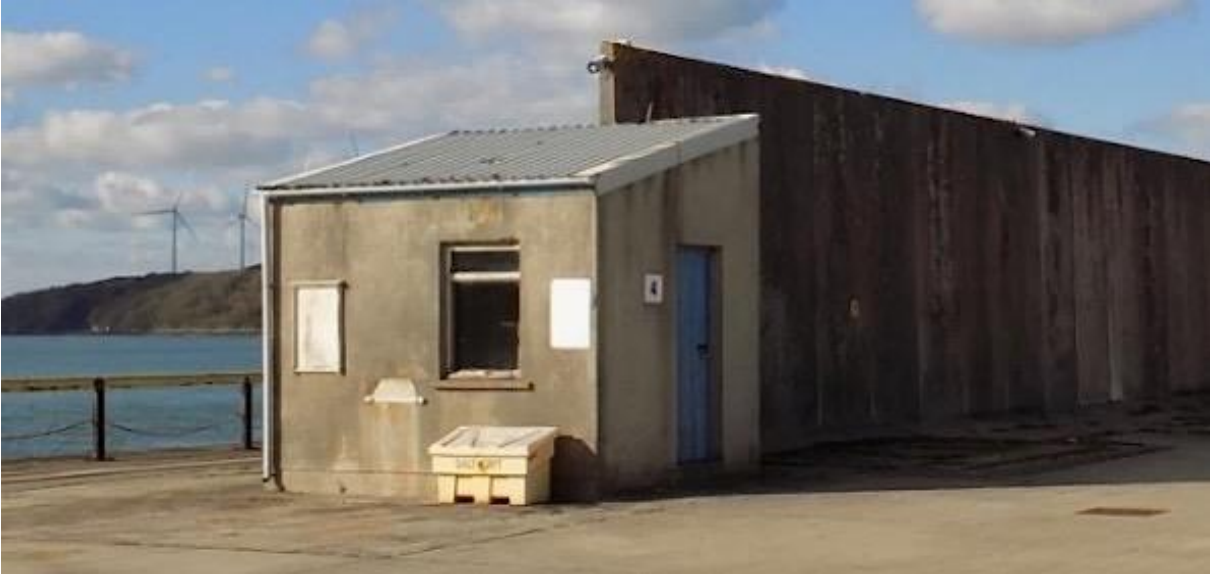
- 6.2 Located on Carr Jetty at north-west corner of dockyard.
- 6.3 Two small rendered sheds with mono-pitch roofs, with tall connecting reinforced concrete wall.

- 6.8 Buildings 2, 3 and the connecting wall lie in a part of the dockyard with no public access. They are experienced as small isolated structures with little immediately apparent historic purpose.

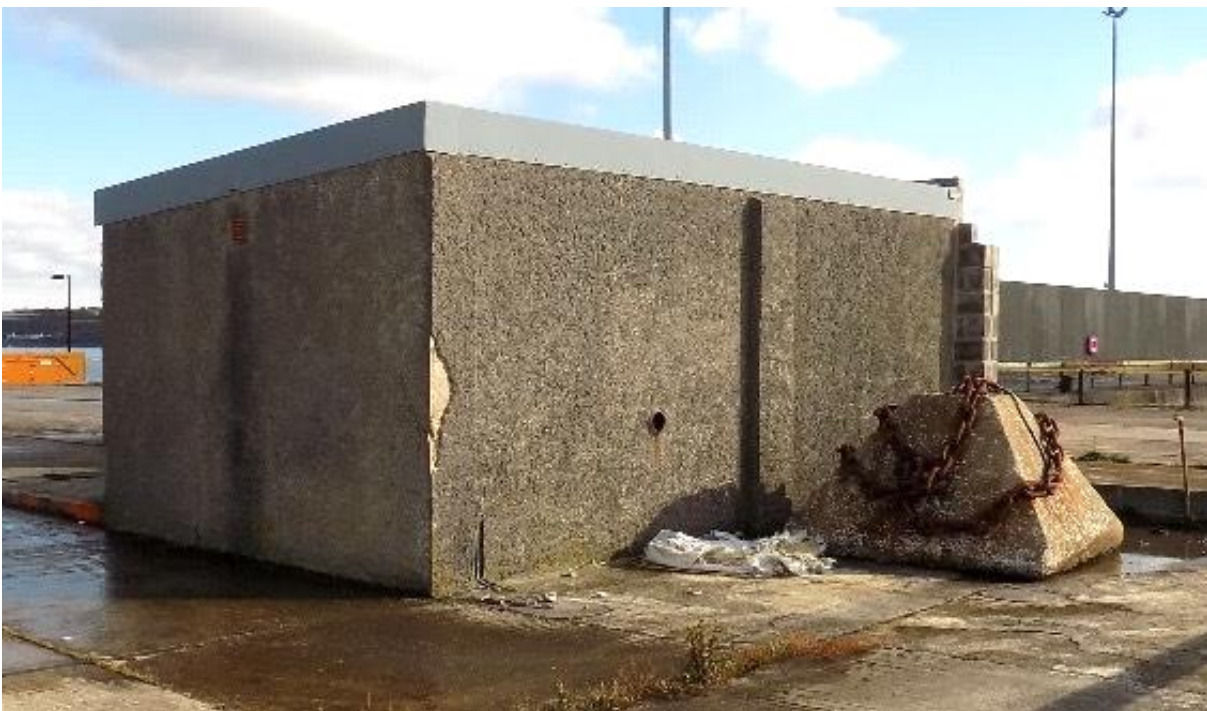
- 6.13 Located on Carr Jetty at north-west corner of dockyard.
- 6.14 Small early post-war flat-roofed shed, formerly abutting larger Stores (now demolished). Pebble-dashed brick with shallow-pitch corrugated asbestos roof. Two pairs of double doors on east elevation. South elevation incorporates concrete block fabric remaining of Building 2 (Grit Blast Bay), now demolished.

- 6.19 Building 1 lies in a part of the dockyard with no public access. It is experienced as a small isolated and altered structure with little immediately apparent historic purpose.

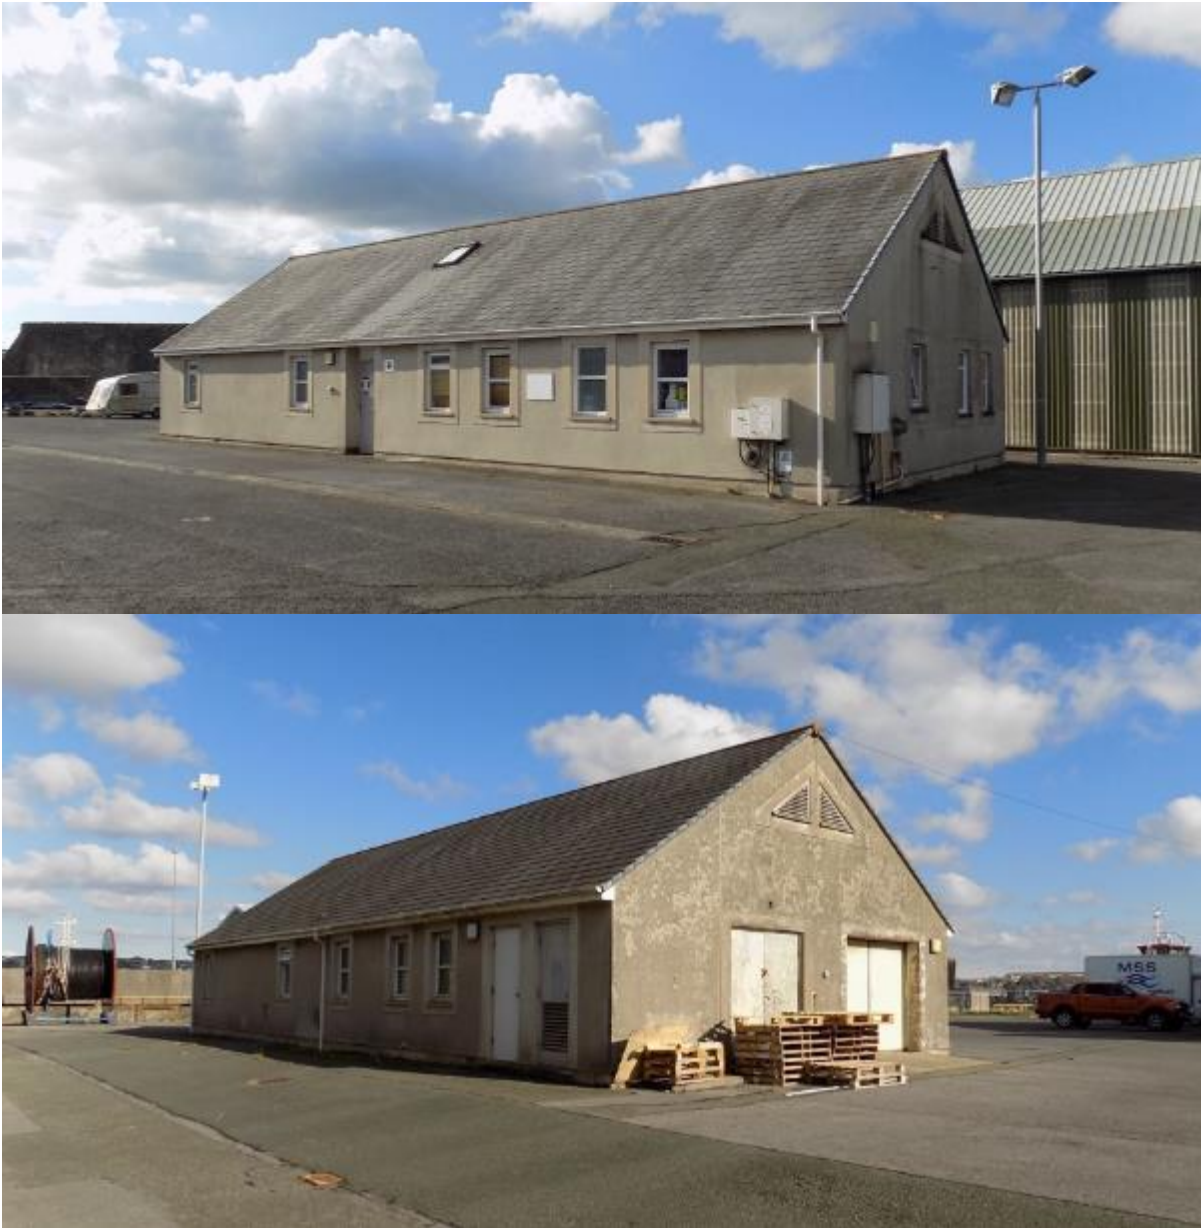
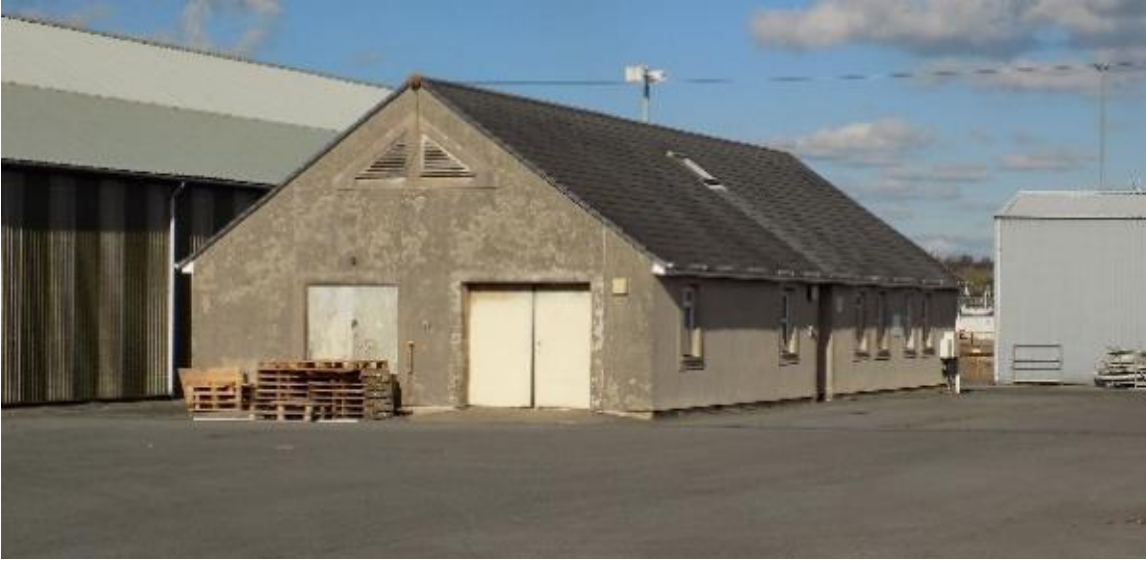
6.46 Single-storey office and store. Roughcast rendered with concrete tile pitched roof. Contrasting concrete margins to doors, windows and triangular gable vents. Windows replaced with upvc.

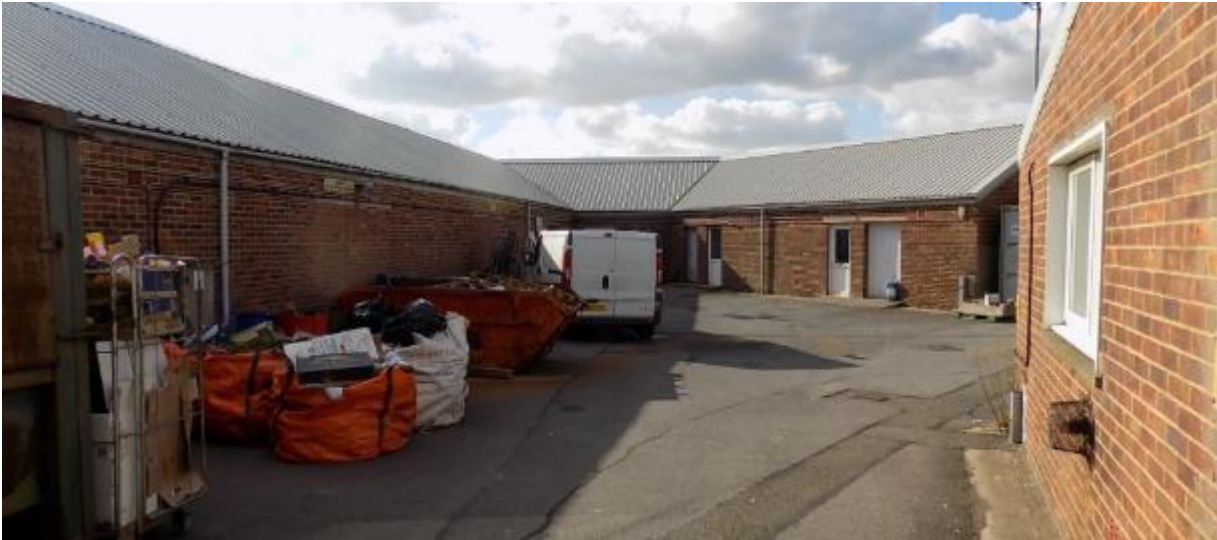
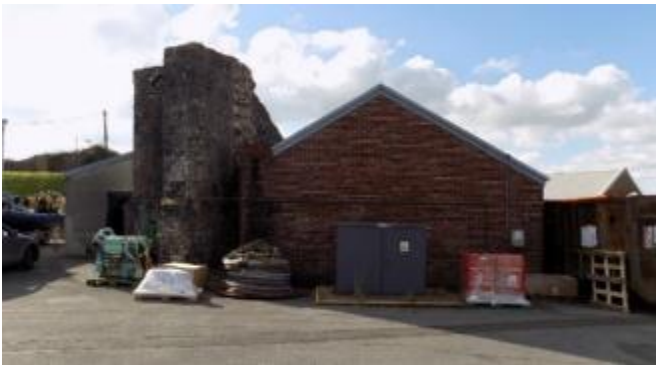
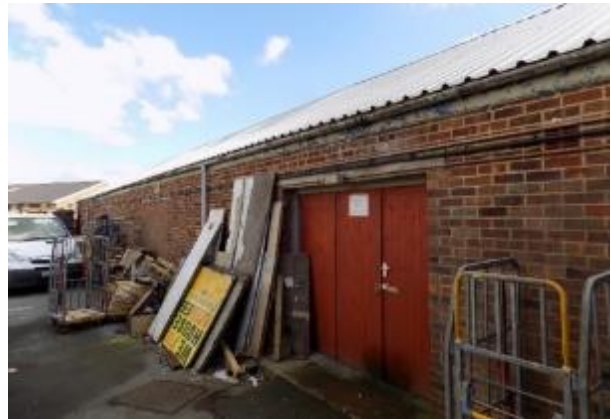
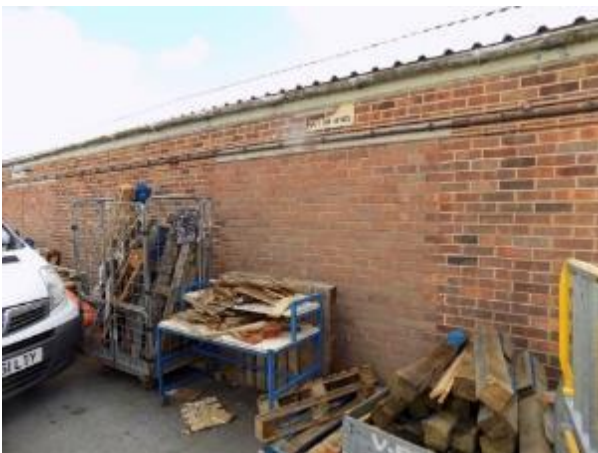
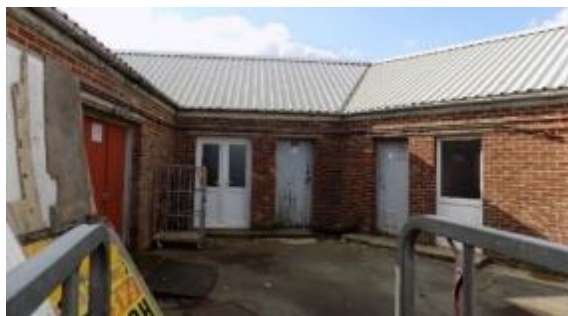
- 6.87 Situated at the north-west corner of the dockyard, adjoining the walls of the former Pater Fort (**Structure 1.2**).
- 6.88 Circa 1955, V-plan arrangement of small single-storey lock-ups. Red brick, reinforced concrete lintels. Pitched roofs clad with modern profiled steel sheet. Replacement upvc windows. Some replacement doors, some doorways blocked. Interior not inspected. Originally Lay-Apart Stores for storing non-essential stores not required on board vessels based at the much-reduced post-1926 Admiralty dockyard.

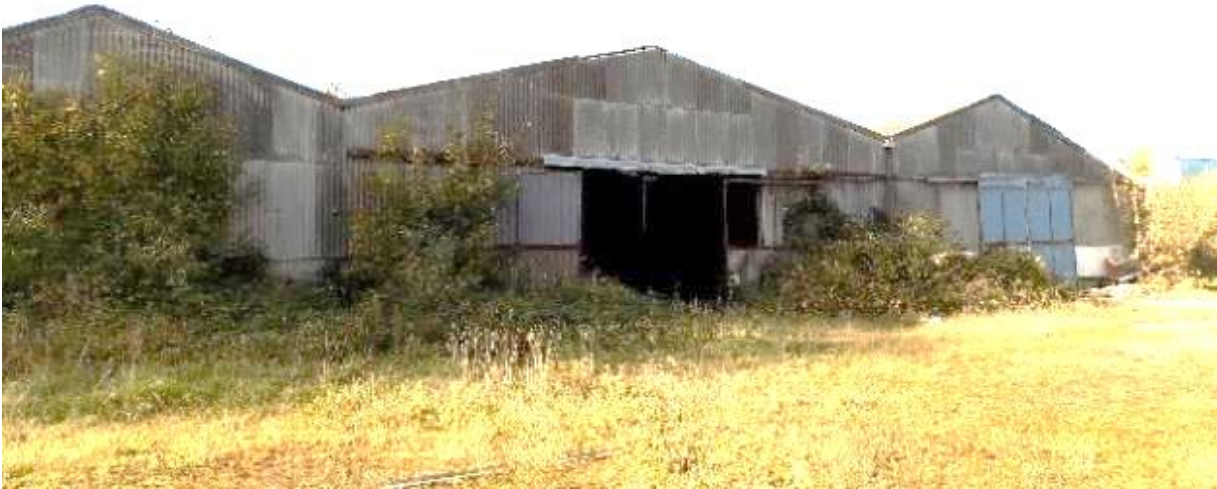
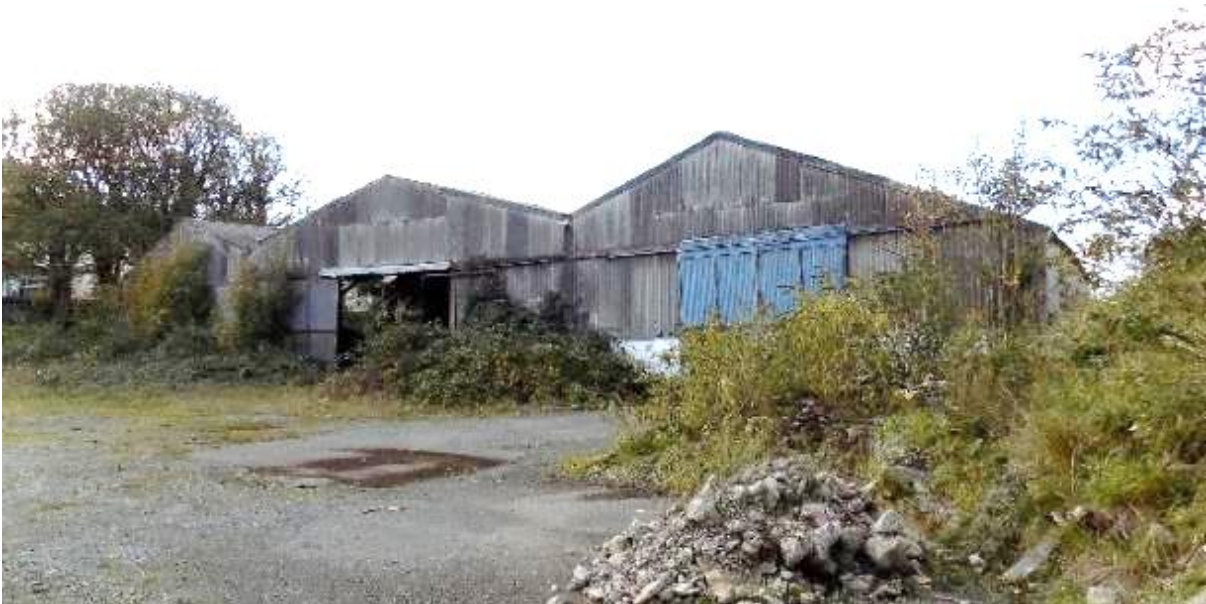
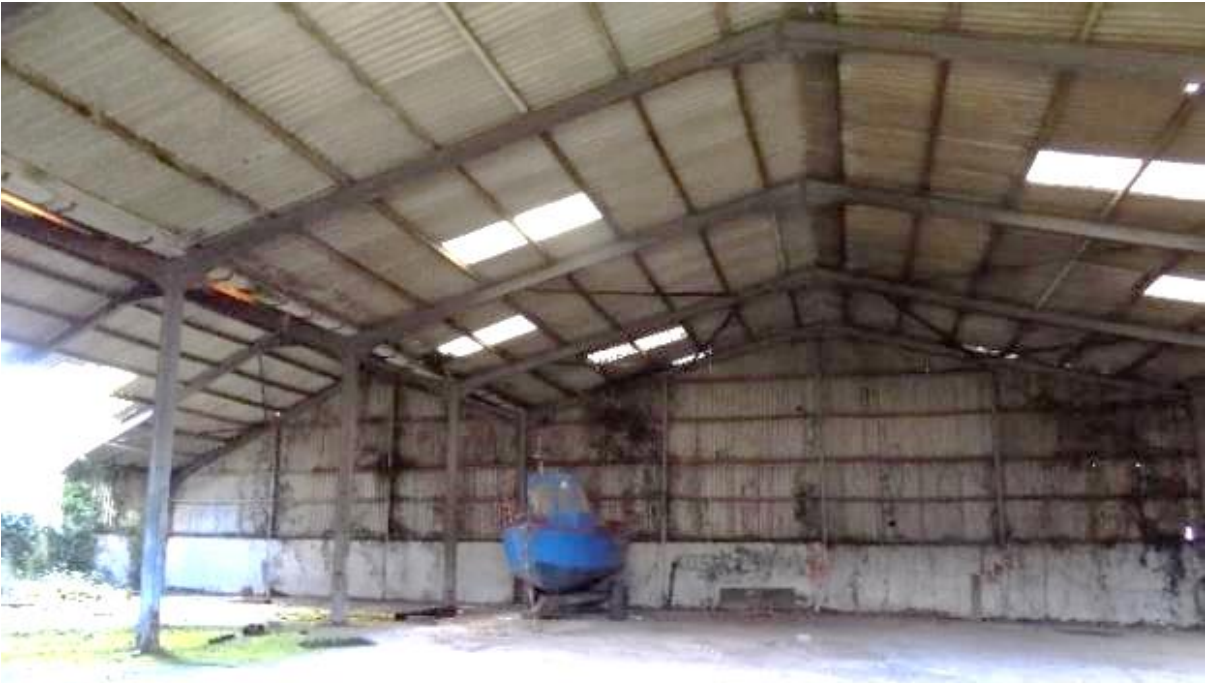
6.330 These featureless modern buildings are experienced as rapidly declining basic and functional modern warehouse-like structures of no heritage significance, surrounded by scrub that prevents what would otherwise be adverse impacts on the settings of important heritage assets.

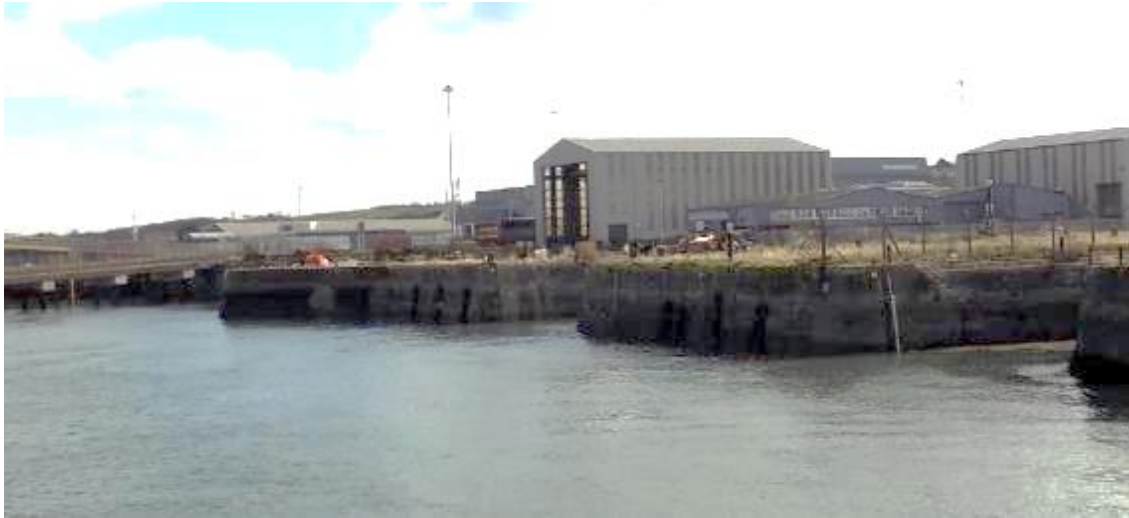
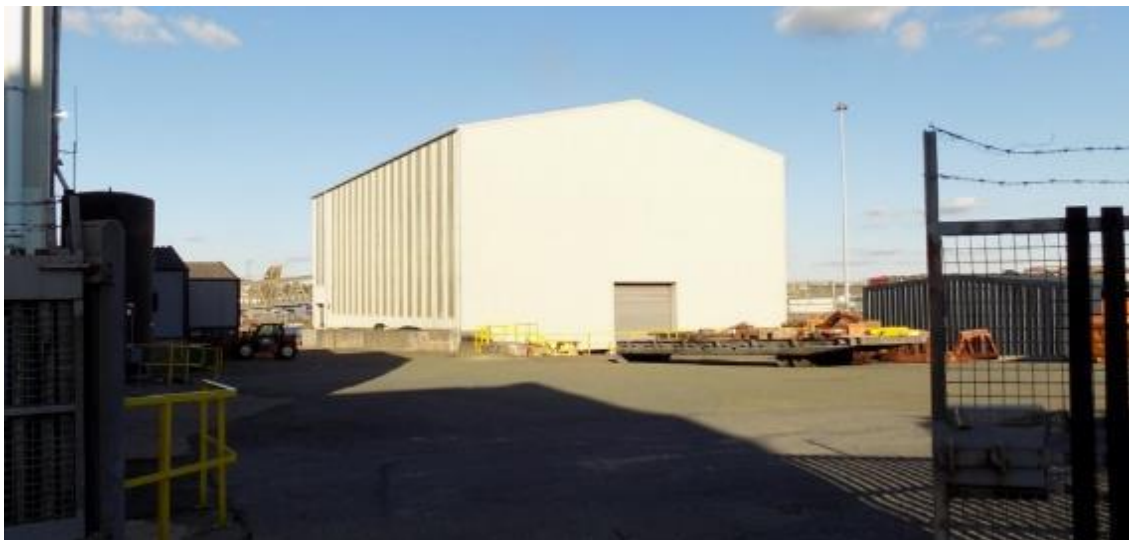
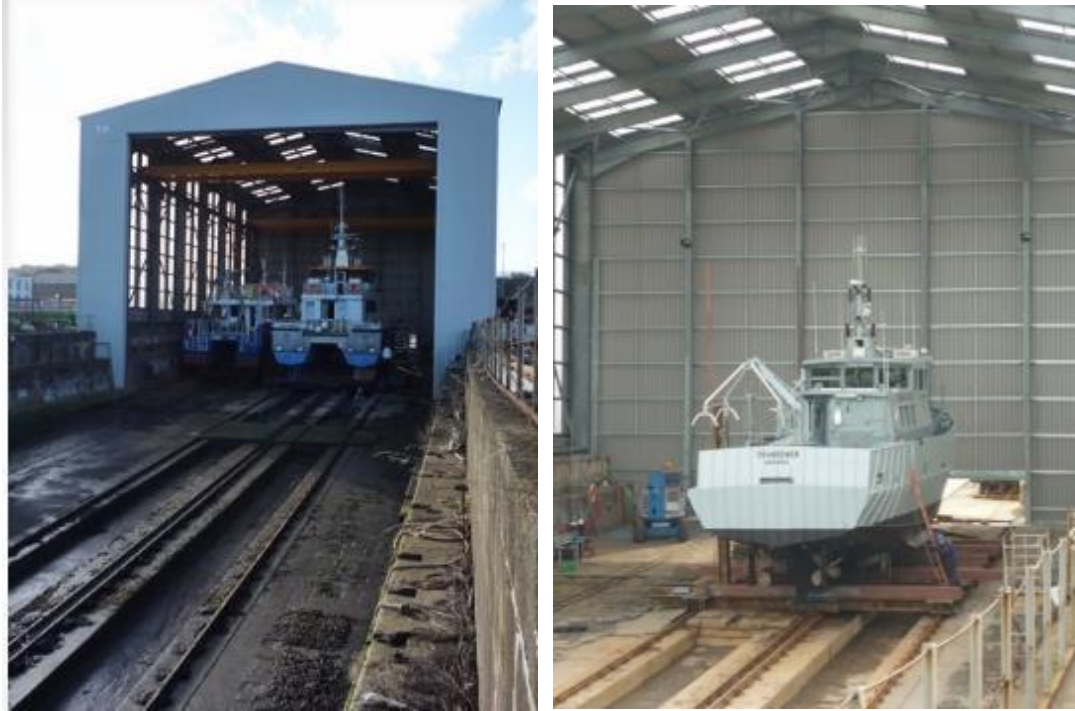
6.340 Located in a prominent position on the dockyard's waterfront, the Mainstay Marine slipway cover is of no historic or architectural interest. The modern slipway cover is nevertheless reminiscent of

the timber structures that enclosed many of the dockyard's slipways in the 19<sup>th</sup> and early 20<sup>th</sup> centuries and is thus not regarded as being inappropriate or intrusive.

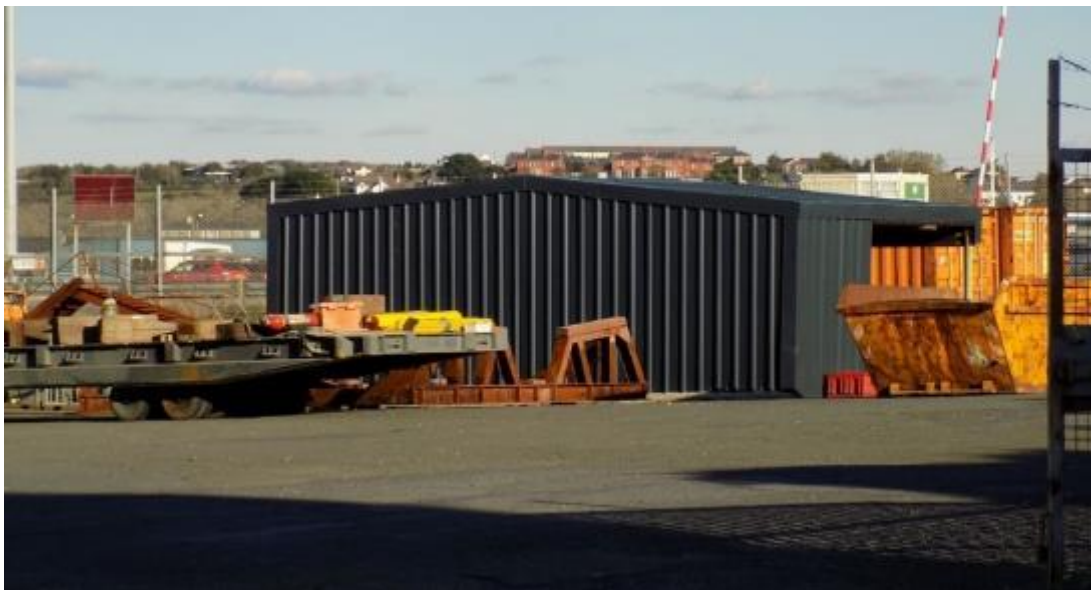
6.349 Of clearly very modern origin, this small modern shed is of no heritage significance.

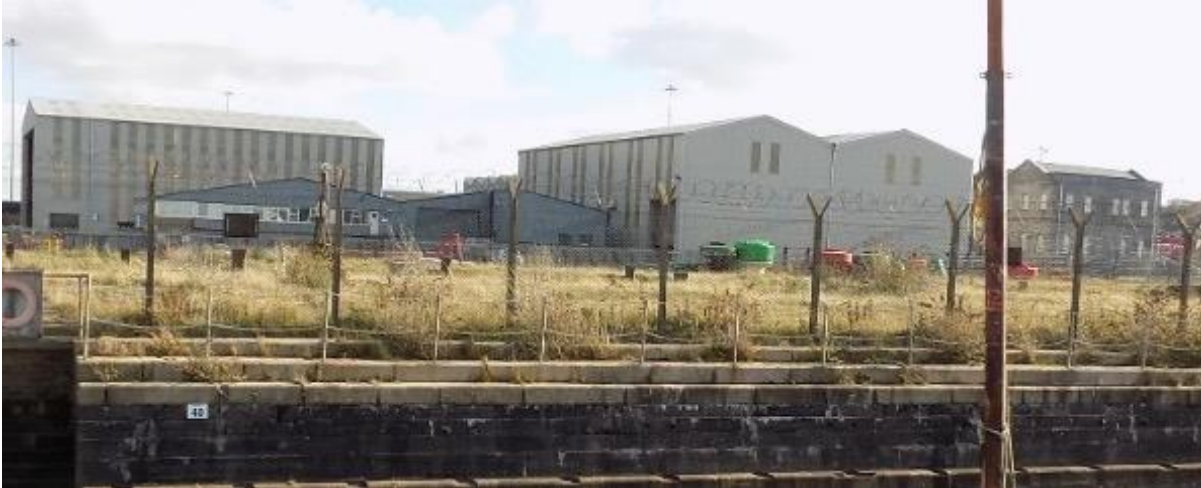
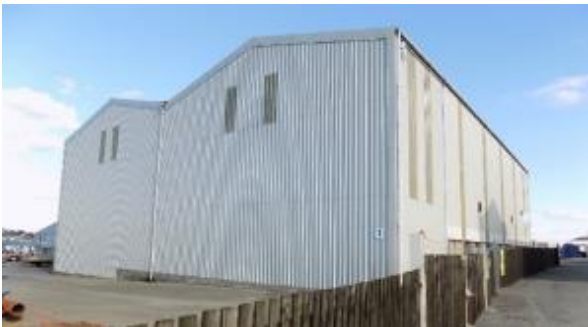
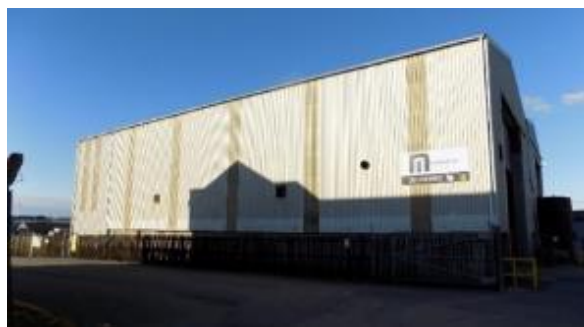
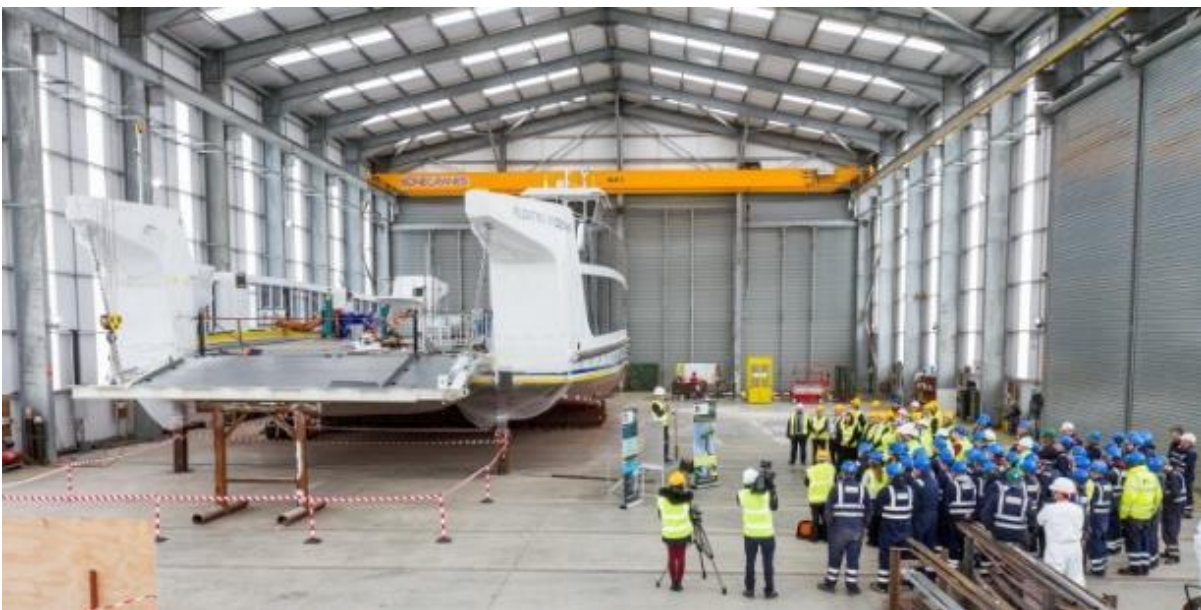
- 6.358 Located in a prominent position on the dockyard's waterfront, the Mainstay Marine Workshops Nos 1, 2, 3 and 4 are of no historic or architectural interest. Because of their relatively modest scale and historically-appropriate function, the buildings are not regarded as being particularly inappropriate to their location.

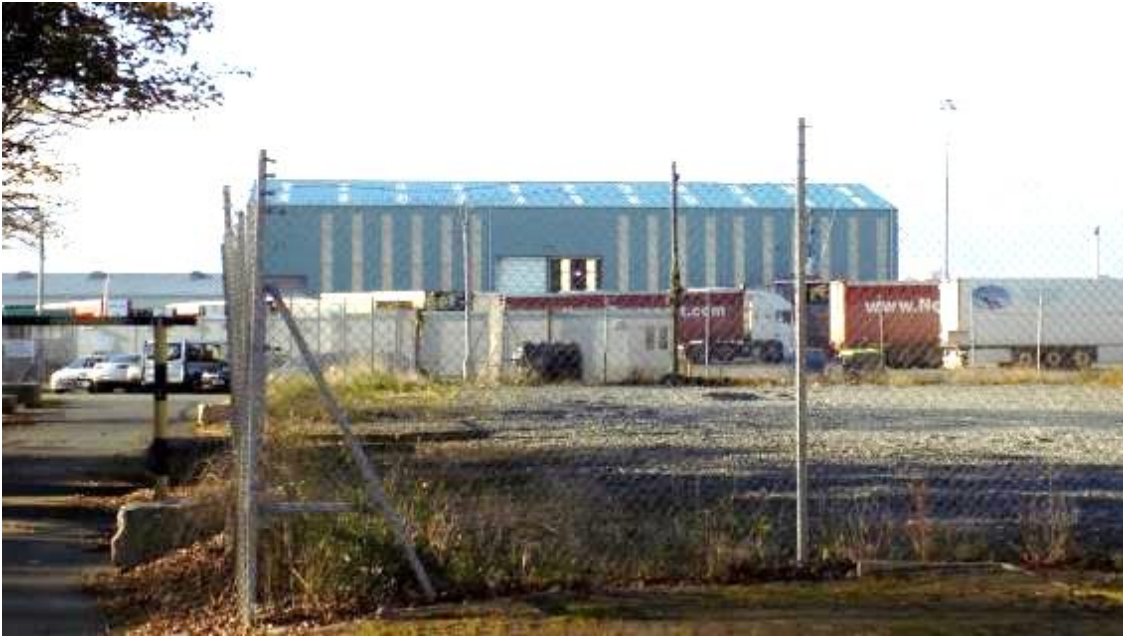
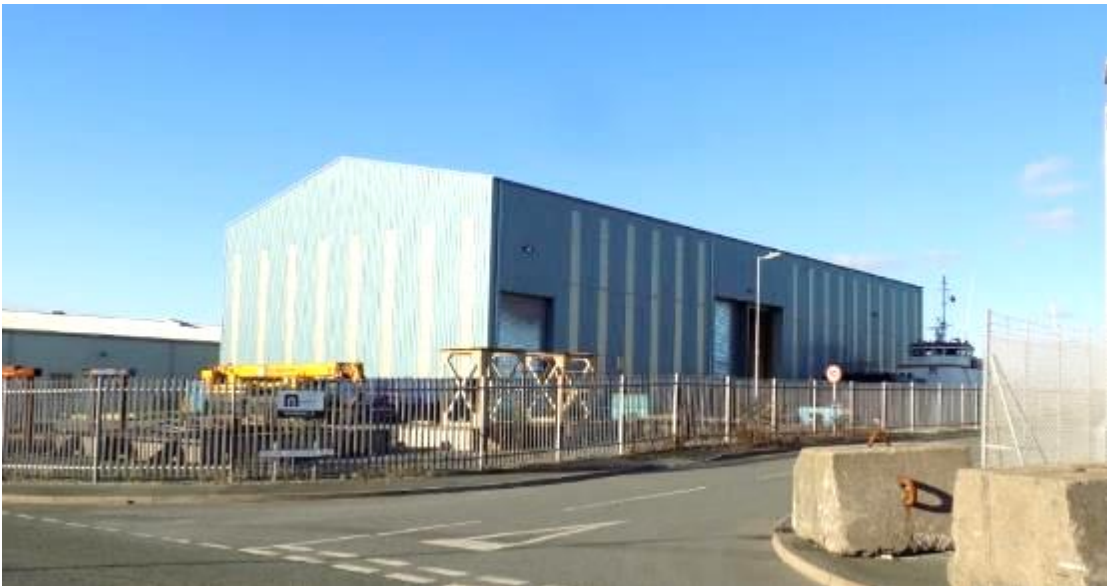
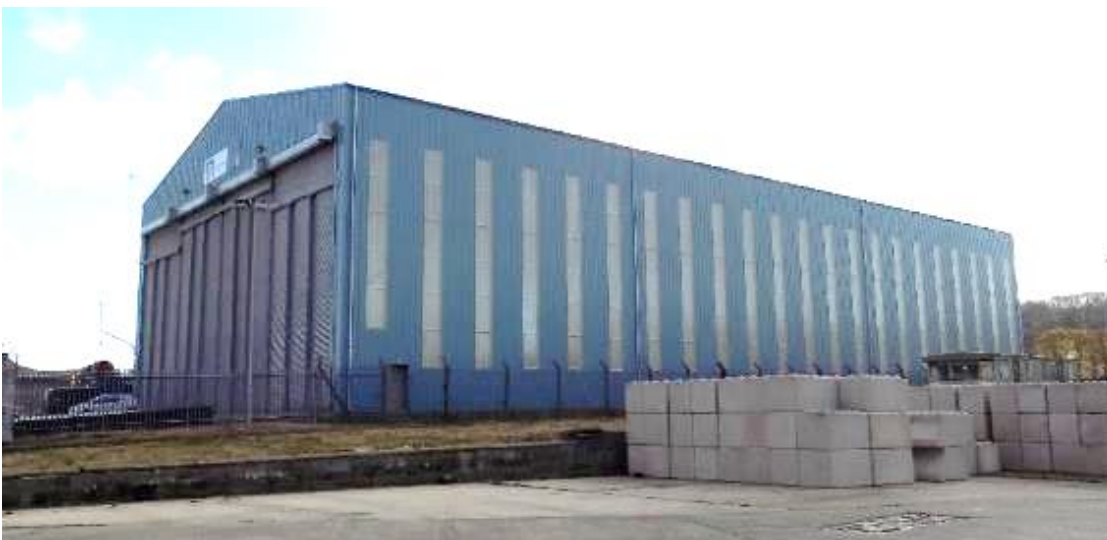
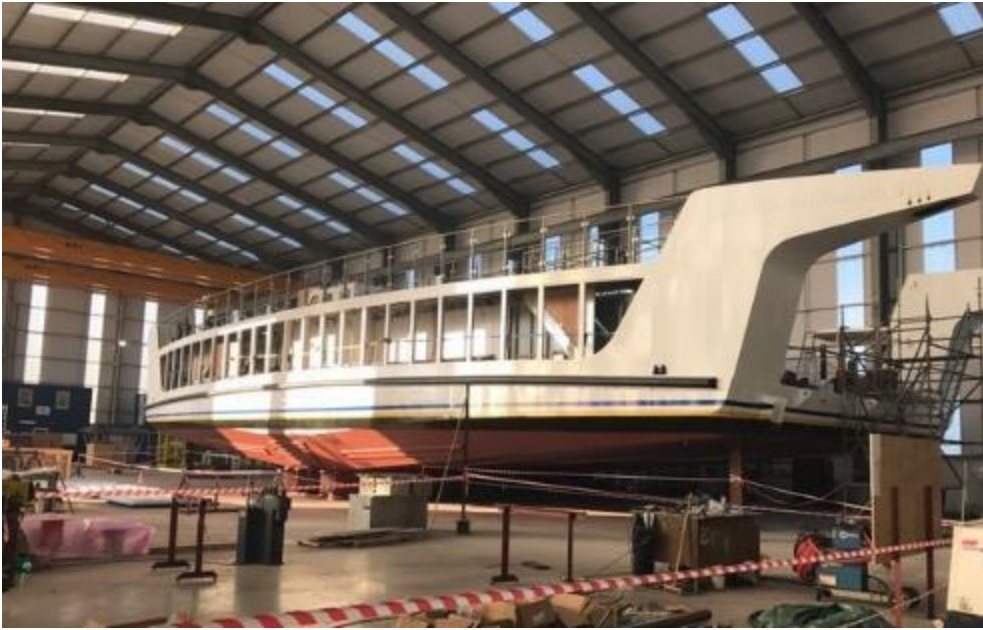
6.367 Built on the site of the RAF barrack buildings (and before that the steam sawmills and smithery) this very large modern shipbuilding shed separates the historic buildings in the eastern part of the dockyard from the western cluster.

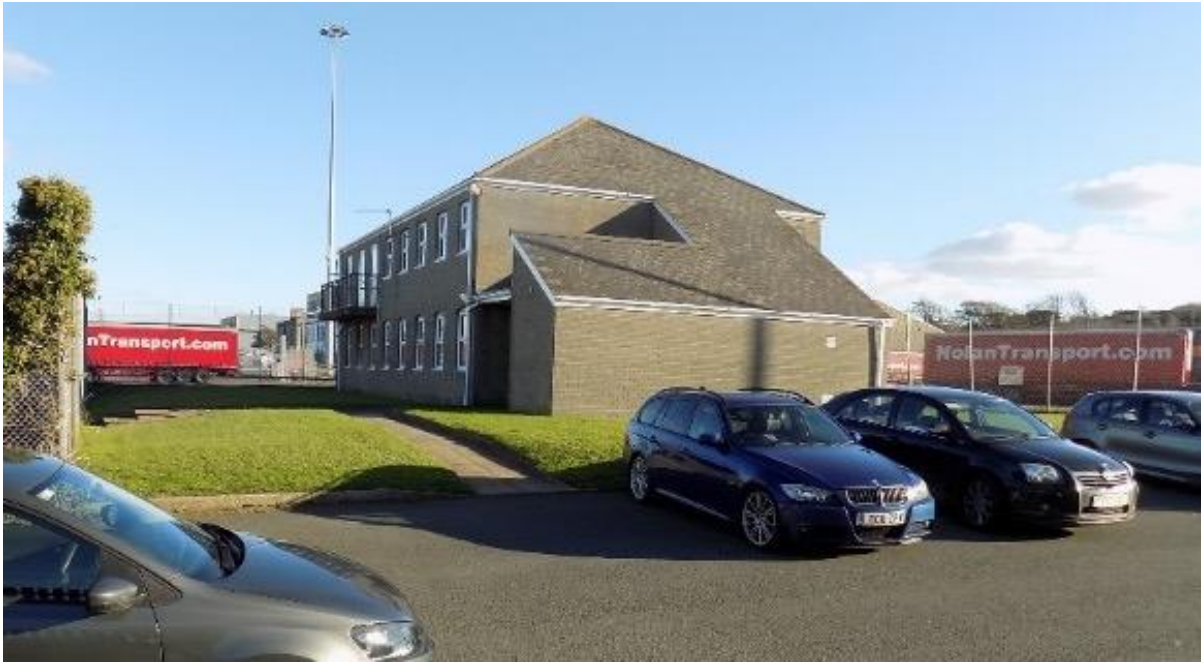
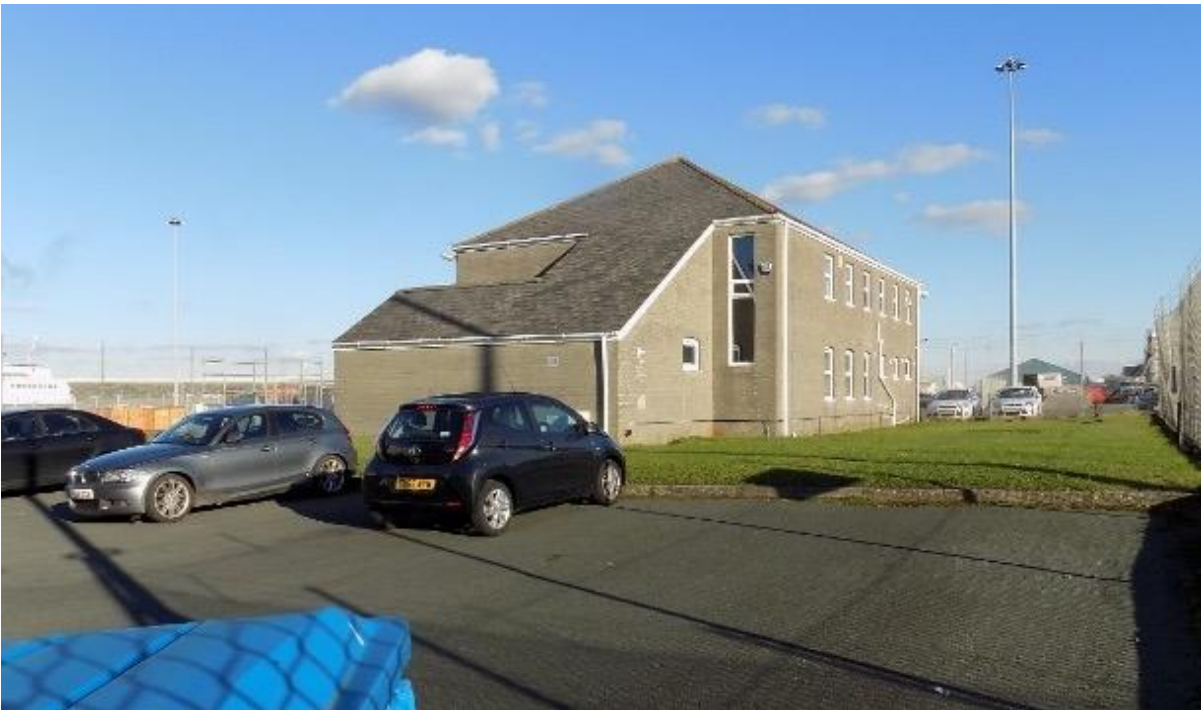
6.376 Admiralty House is a rather plain modern office building that appears to have no historic relationship to the Admiralty's continued use of the western part of the dockyard up to 2008. It appears to have no significant architectural interest and no historic interest. Located on the western edge of the Irish Ferries terminal, its setting is largely dominated by hardstandings and modern shipyard buildings.

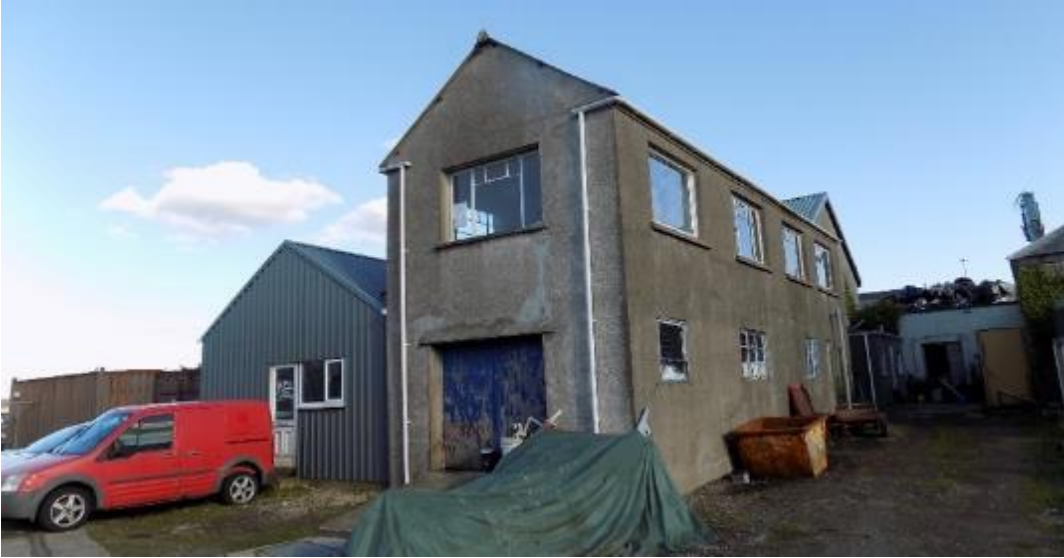
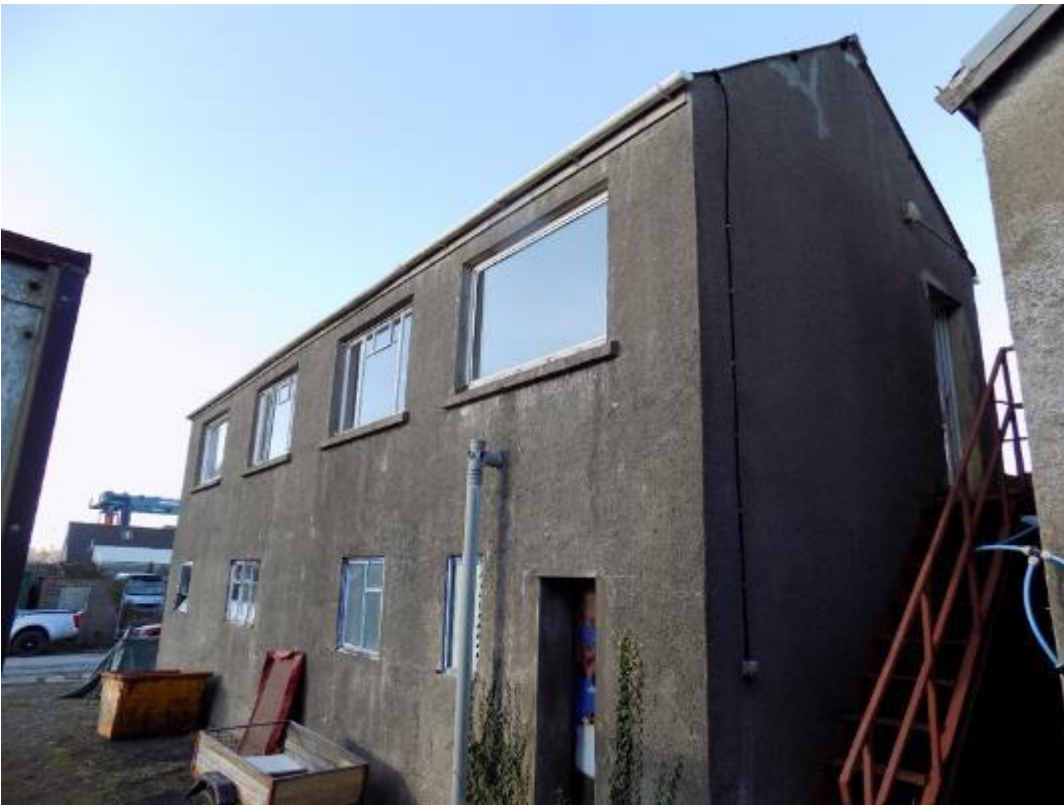
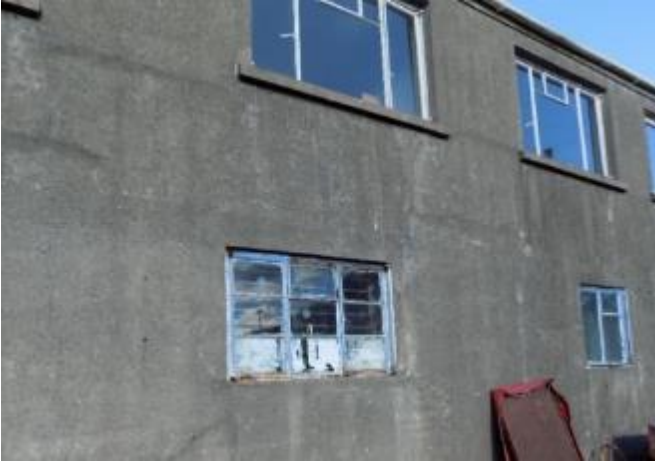
6.386 Whilst the Former Hayes Canteen is substantially unaltered and forms part of a coherent group of now declining buildings and structures that survived in shipyard use after 1926, the Former Hayes Canteen is of only negligible significance because of its low architectural quality and post-war date.

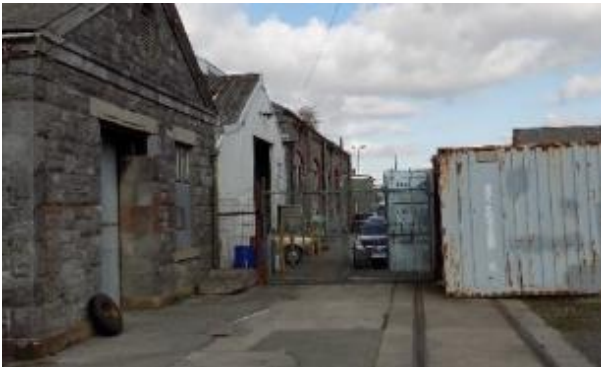
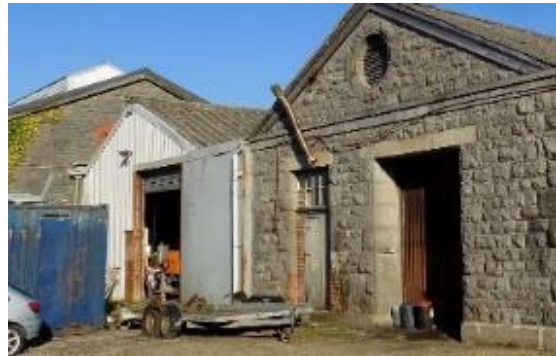
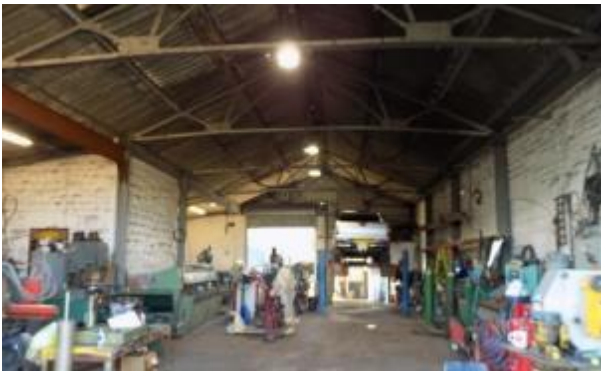
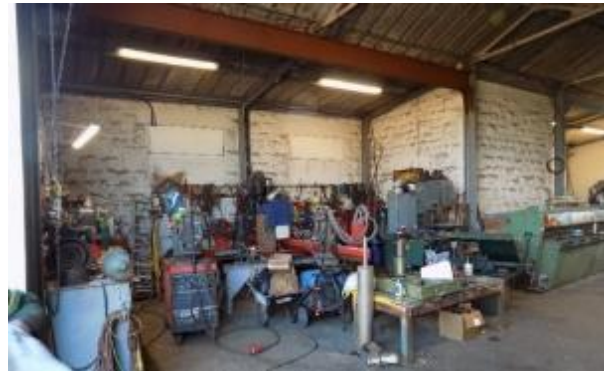
- 6.395 Whilst the Former Hayes Building 5H Stores (MHPA Unit 18) is substantially unaltered and forms part of a coherent group of now declining buildings and structures that survived in shipyard use after 1926, the building is of only negligible significance because of its post-war date, ancillary use and functional construction.
