## 6 PHASE 5

### The post-war port

#### Structure 5.1 - Building 3, Building 4 and Connecting Wall (Former Admiralty Piro Store and Store)

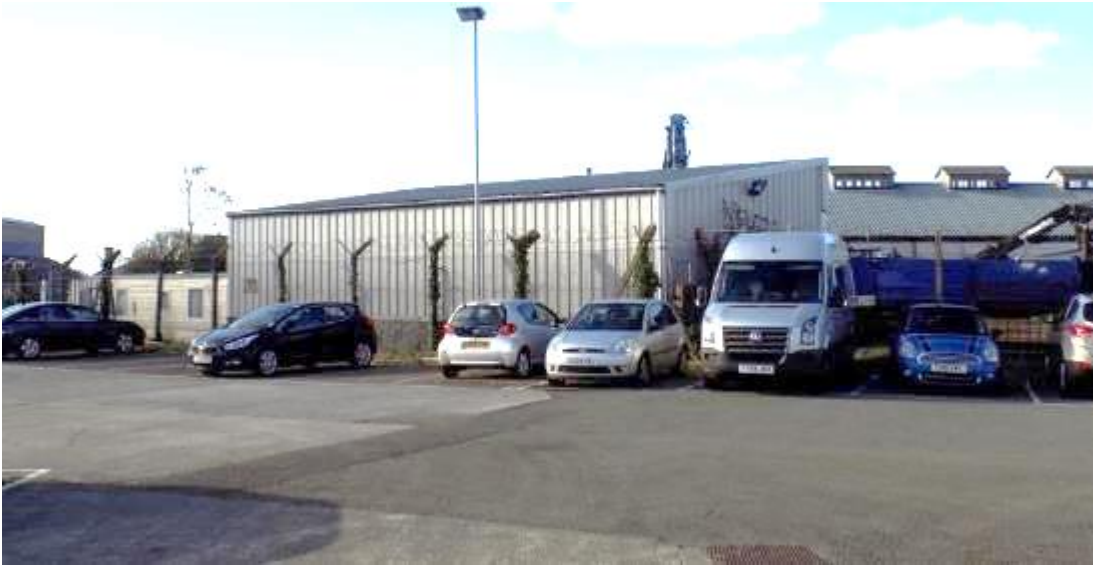
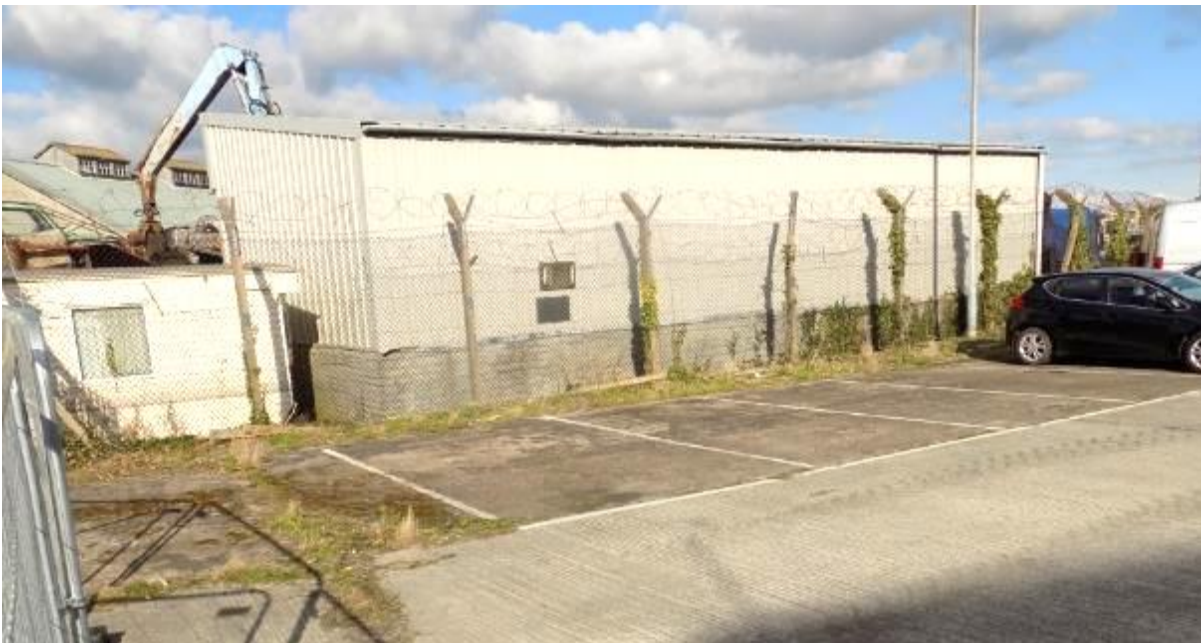
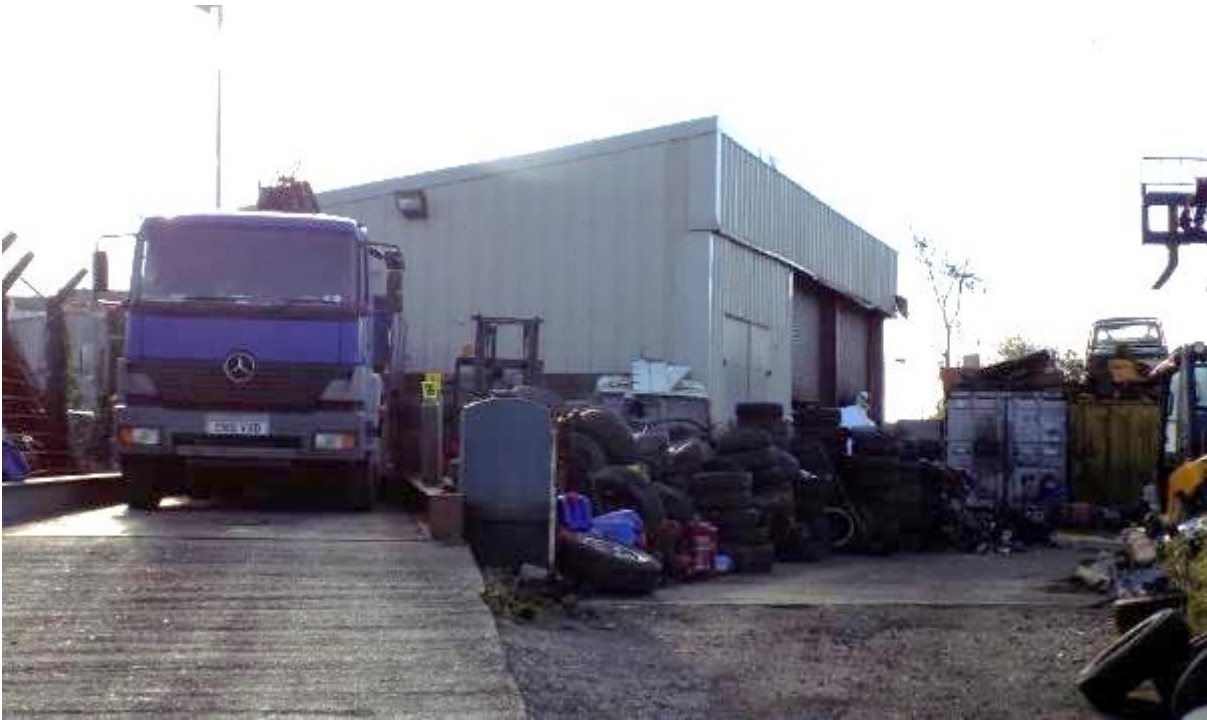
6.404 Whilst visible from within the public part of the dockyard, this building is not visually prominent. It nevertheless detracts from the other buildings within the enclave of declining commercial premises towards the western end of the dockyard, most of which have survived from the dockyards 'iron-clad' era or earlier.

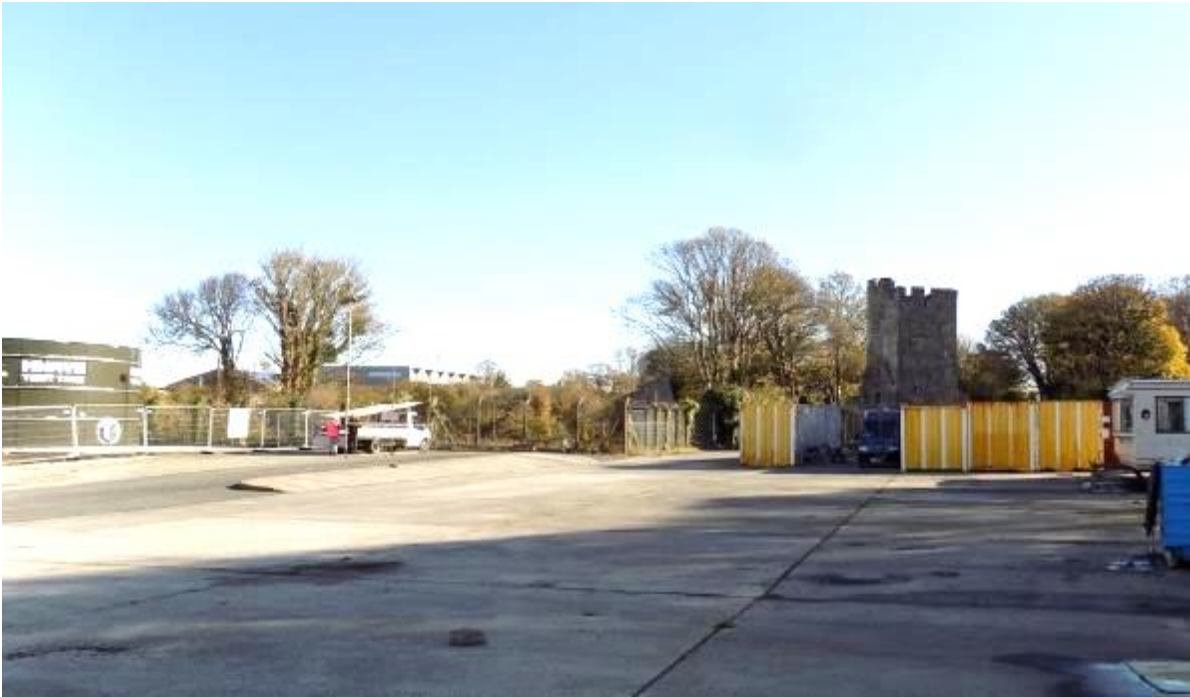
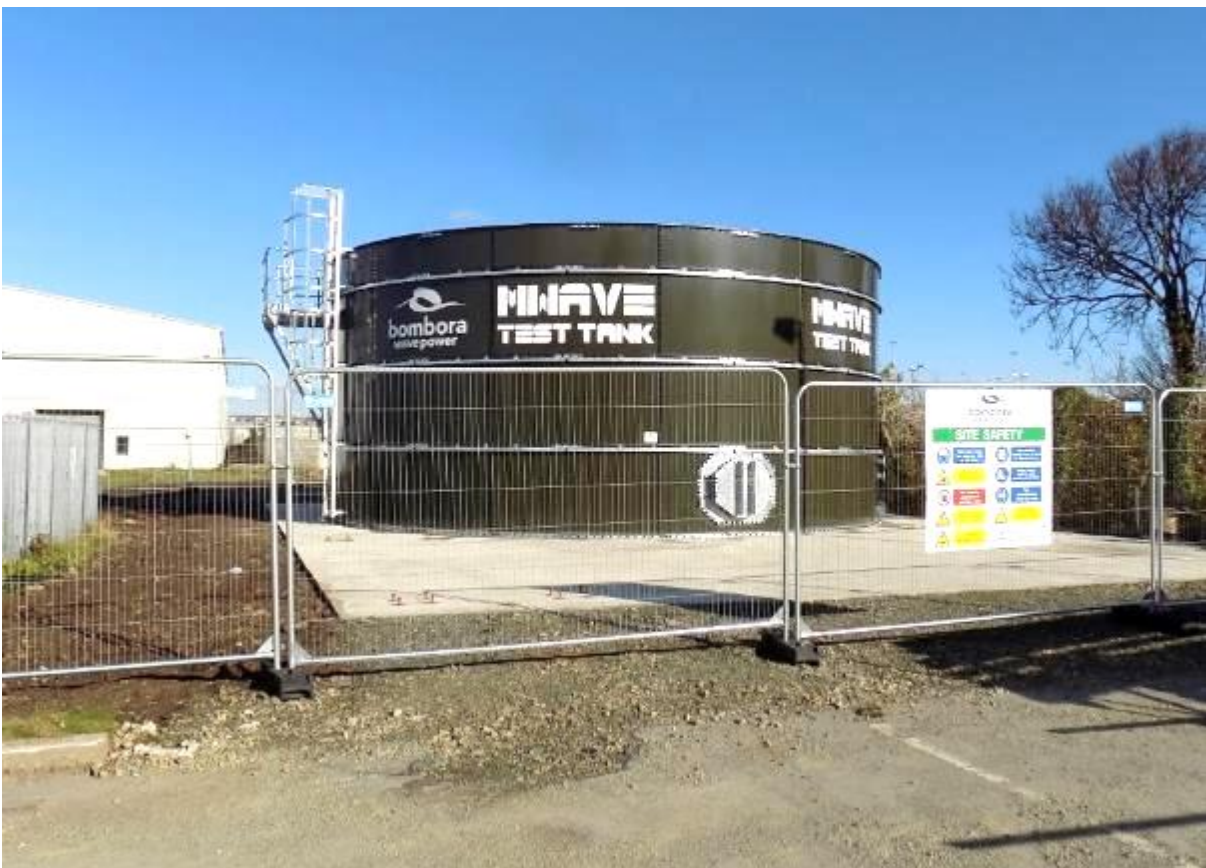
6.413 This modern pre-fabricated structure is of no architectural or heritage interest. Whilst located in a relatively discreet part of the dockyard with no public access, it is an alien feature when seen in the context of the Paterchurch Tower (**Structure 1.1**).

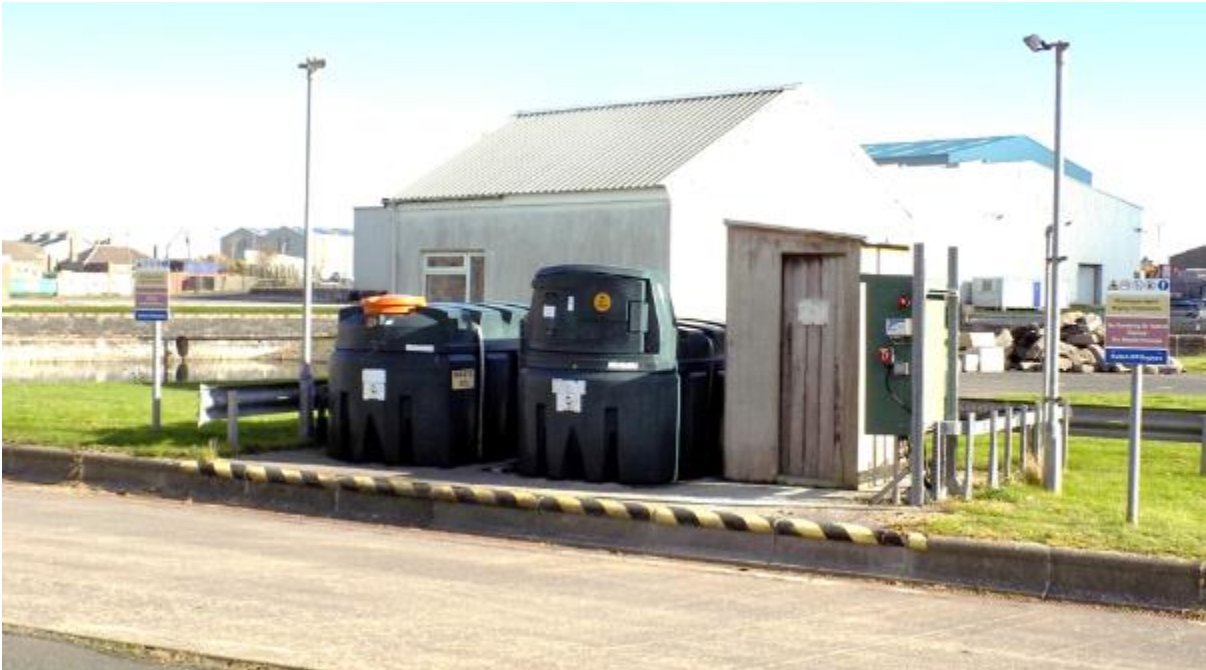
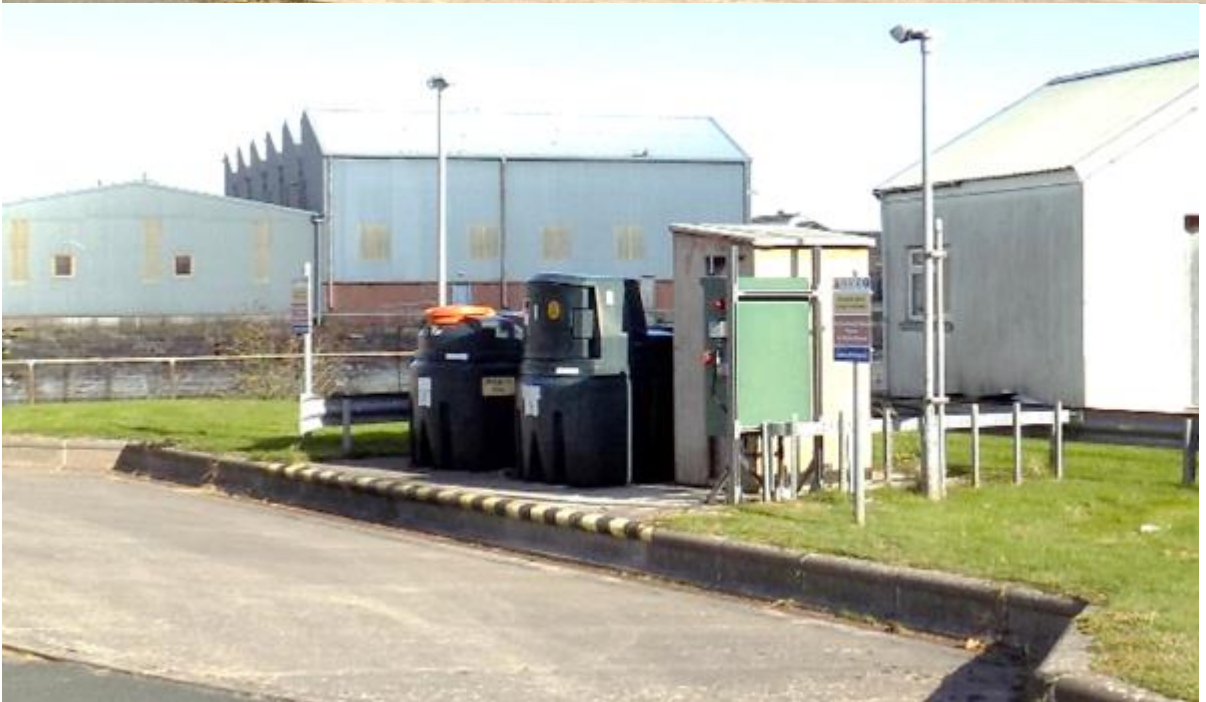
6.422 This recent facility is of no architectural or heritage interest. Whilst the Waste Oil Point lies in a part of the dockyard with no public access, the shed element sits easily with the 1930s and 1940s structures nearby, because of commonality of materials and functional appearance.
